EDUCATIONAL ADEQUACY ASSESSMENT

School: Valley View Elementary School Capacity of Building:
363 students (based on building sq. ft.)
381 students (functional design capacity)

Configuration: Grades (4K-5th)
Date of Assessment: October 25th, 2013

Evaluator(s): Abie Khatchadourian (EUA)

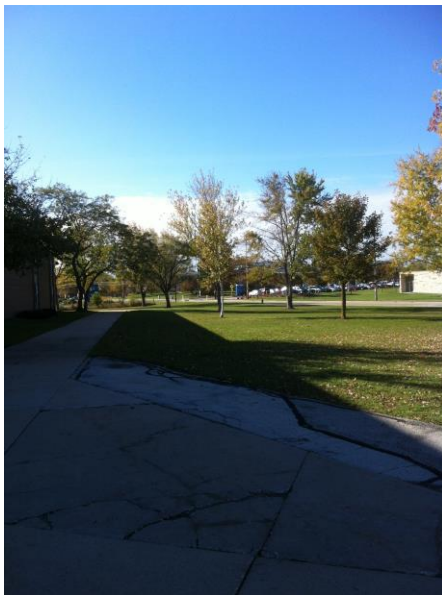
Well maintained landscaping.

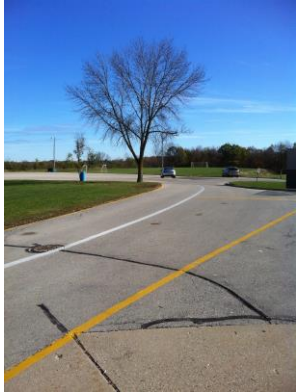
- Vehicular circulation is one-way in at the southern curb cut and out at the northern curb cut. This circulation is not ideal, requiring buses and cars to enter at the same location and drop off in parallel in the mornings exiting from two lanes of the north parking lot. During pickup times, however, cars circulate in the back of the school to the south in the playground area to the southwest while buses remain on the upper grade and circulate northward.

Current Drop-off/pick-up

1. Consider a new curb cut to the south of the existing (near the building sidewalk to the south) so as to permit a drop off lane to be added in front of the entire school and to the north east of the building. This would permit better proximity to the school entrance and permit parent vehicles to line up to drop off students. Buses could be rerouted to drop students at the playground gymnasium entrance by constructing a new drive down to the playground at the south side of the building.
 - a. Relative to the cars, this approach would not be invasive as regards to several deciduous trees presently located in the west green space. This approach would be an improvement for students in inclement weather and could be used for parent drop offs during the school day as well when buses are not queued and waiting.

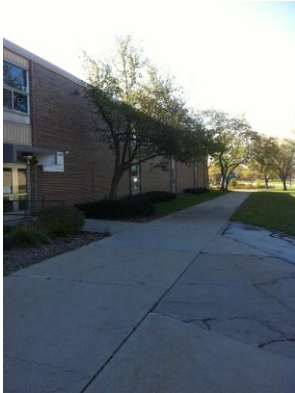
Possible new area for parent drop off and pickup

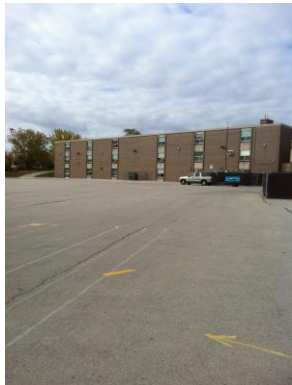
Possible new area for bus drop off and pickup

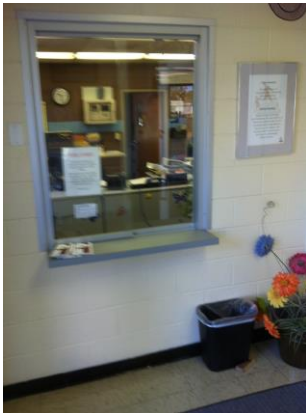
Inside main entrance.

- Guest has uncontrolled access to school after entering primary doors.
 - Interior reception is physically connected to entrance.
 - There is no video surveillance of the entrance.

1. Consider adding electronically controlled locks and video surveillance at all entries so that entries can be monitored and controlled from a central location.
2. Explore methods of controlling student and visitor access to the school once inside.

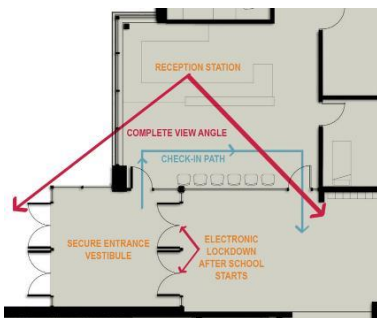
Recommended secure entry sequence.

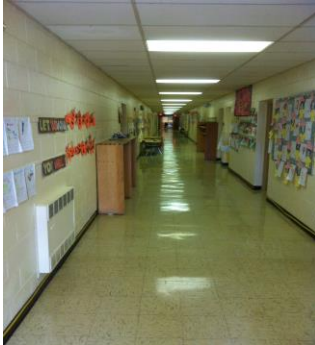
Typical Corridor

- Corridor width varies. Typical width is approximately 9'.
 - This width accommodates student storage in some areas, reducing effective width down to 8'.

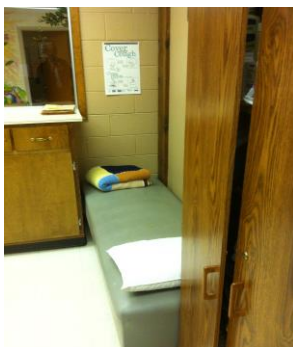
Health Room

- Size of area is adequate. The room has a connected sink and toilet room, though this room is small and does not comply with handicapped accessibility standards; consider upgrades to this room size and amenities.

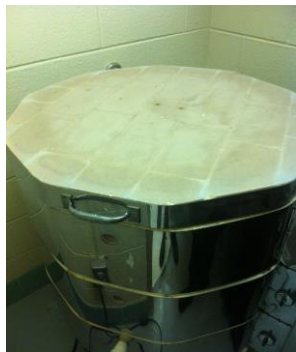
Art Kiln

- Kiln location.
 - There is a dedicated kiln room.
- Storage.
 - Art storage is handled in the room with full-height storage casework as well as perimeter casework above and below counters. A storage closet has a rolling storage unit as well as additional workspace. The casework may not have been designed for art room use and appears to be inefficient for large media storage such as art sized sheets of paper and supplies.

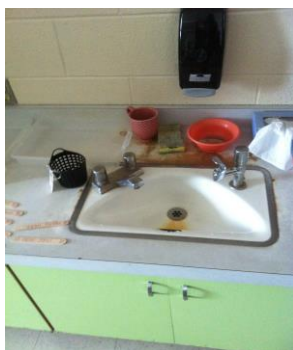
Art room sink.

- Furniture is large and inflexible, making room difficult to reconfigure for different types of art and/or presentation/lecture.
- Access to water.
 - Two sinks are provided. Art rooms typically provide 4-6 clean-up stations to minimize clean-up time waiting.

1. Consider furniture systems that would allow for increased classroom flexibility.
2. Consider larger, deeper sinks that could potentially be used by 2 students at a time.
3. Consider some modifications to casework to be more art storage appropriate.
4. Consider an option to relocate the Art Room to an upper floor to increase day lighting and to position the function closer to the majority of the upper grades.

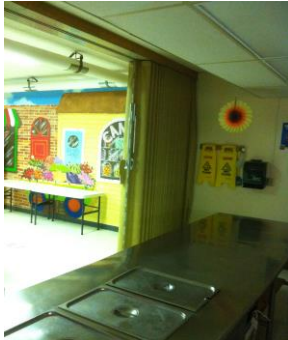
Cafeteria/Kitchen Divider is frayed and should be replaced

1. Kitchen facilities are adequate.
2. Replace frayed/torn divider between the serving counter and Cafeteria.
