Menomonee Falls School District
Benjamin Franklin - Facility Study
Historical Plan

eppstein uhen : architects
EUA No. 313258-01

BUILDING INSPECTION REPORT

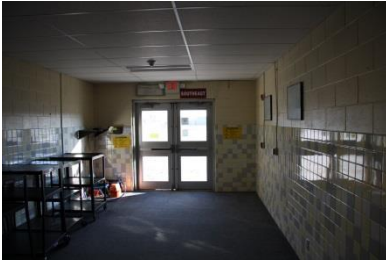
Light visible at door threshold indicates lack of proper weather seal

- Expected life span 20 years for steel, 30 years for aluminum/ FRP systems
- Current Condition – Good to fair
- Most of the exterior doors and frames are aluminum and in good condition.
 - A few exterior doors are not properly weather-sealed and weather-tight. Gaps at the threshold allow water into the building and create leaks.
- There are steel doors and frames in fair condition.
 - All Steel exterior doors showed signs of damage. Dings, scratches and dents in steel will allow rust to begin faster and corrode easier than aluminum.
 - Some steel doors have areas of rusting on the interior and exterior. The lower portion of exterior steel door and frames are prone to rust and deterioration faster than aluminum is. Steel systems are not thermally broken causing condensation to form on the interior which results in steel corrosion.

1. Replace all exterior steel doors and frames with new FRP (fiber reinforced plastic) doors in aluminum frames.
 - Aluminum door and frame systems have internal gasketing less prone to abuse, will not rust or corrode, have improved screw holding power, can be welded to keep doors straight and will not require painting.
2. Provide new weather-striping at aluminum exterior doors where gaps in existing weather-striping are present.

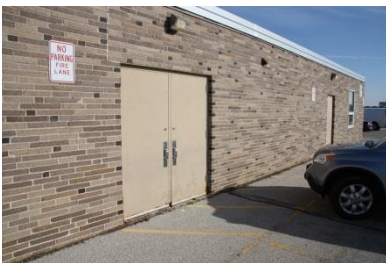
Rust at steel door and frame base

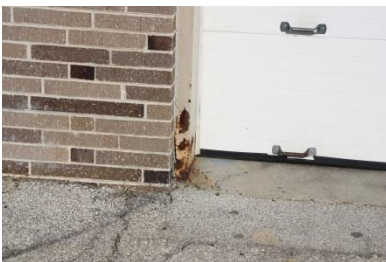
Rusted frame at overhead door

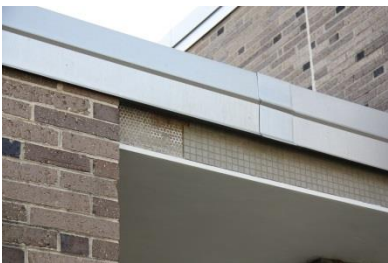
- Life Expectancy – same as building
- Current Condition – good
- Building soffits are plaster and in fair condition.
 - There was some cracking within the soffit plaster.
- A metal fascia is provided around the building. This is generally in good condition.
 - At entrance doors there is a decorative tile just below the metal fascia. Some of those tiles have fallen off.
- There is rust on some mechanical vent louvers.

Missing tiles on fascia

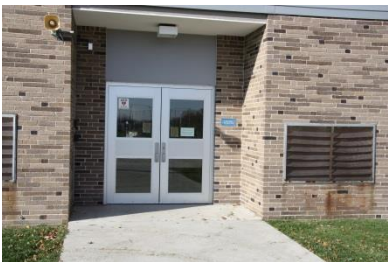
Rusting mechanical louvers

1. Replace/repair any damaged mechanical louvers.
2. Patch cracked soffits.

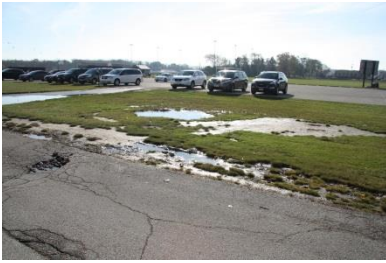
Standing water between drive around school and south parking

- Concrete and asphalt were reviewed independently. See appendix for reference reports.
- Standing water is present in green space between south parking lot and drive lane around school.
 - Standing water also present on access road from south parking lot to drive around school.
- Playing fields for athletics and Phy Ed appear to be in good condition.
 - The backstop fence at the baseball field is rusting.
 - The bleachers, for the baseball field and football field, have rusted top guard railings.
- Playground spaces appear to be in good condition.
 - Basketball hoops were removed and left in grass alongside southern parking lot.

1. Replace fence at baseball field.
2. Replace guardrail at football and baseball field bleachers.
3. Address drainage between south parking lot and drive lane around school.
4. Remove discarded basketball hoops.

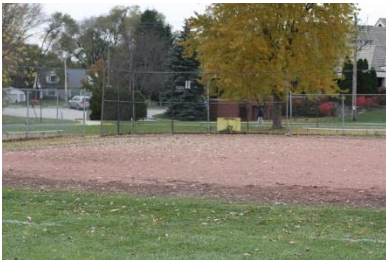
Rusting baseball field fence

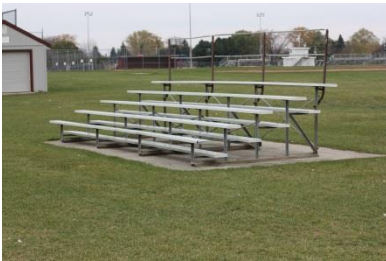
Rusting top rail of bleachers at baseball field

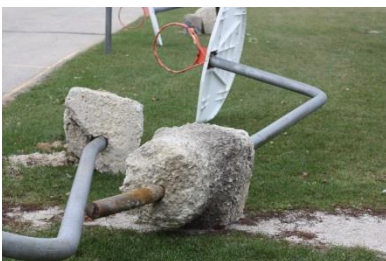
Removed basketball hoop along south parking lot

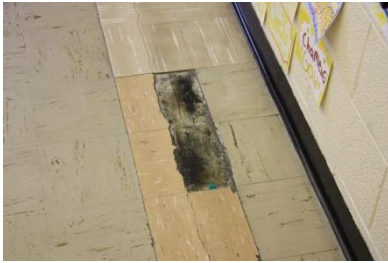
Damaged 9"9" VCT tile on second floor

- The majority of first floor classrooms and hallways have 12"x12" VCT tiles in good condition.
 - Second floor Classrooms have 9"x9" VCT tiles original to the building and in poor condition.

- 9"x9" tile have been known to contain asbestos.
 - The second floor has a few cracked and damaged floor tiles.
 - Patching of damaged tiles has been done with mismatched tile colors.

1. Continue annual maintenance for VCT flooring.
2. Consider replacing older VCT in classrooms and hallways.
3. Consider replacing tile wall base.

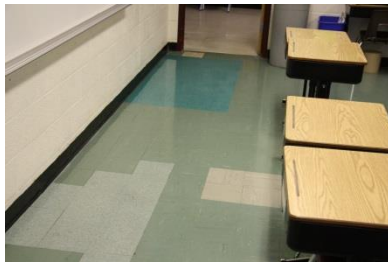
Mismatched tile colors

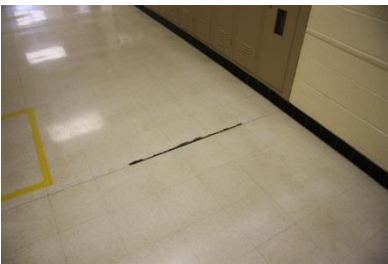
Second floor hallway damaged VCT

- Second floor Hallways have 12"x12" VCT tiles in poor condition.
 - Most tiles are stained and a few are cracked and damaged.
- Wall base is in good to poor condition.

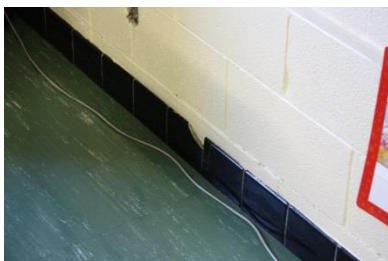
Chipped wall base tile

- Most of the building has a rubber base however some classrooms and hallways on the second floor still have the original tile wall base.
 - A few of the wall base tiles in the second floor classrooms and hallways are chipped.

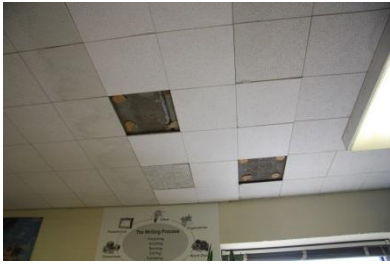
Missing adhered ceiling tile

- Expected life span 15 years
- Current Condition – good to poor
- Majority of Classrooms and all hallways on the first floor have 2'x4' lay-in ceiling tile, in good condition.
 - Acoustical lay in ceilings have tendency to sag over time and discolor.
 - Ceiling grid discolors as well.
- The second floor classrooms have adhered ceiling tiles in poor condition.
 - There are multiple classrooms where the glue has failed and tiles have dropped.
 - Because of the age of the adhesives used they may contain asbestos.
- The Hallways on the second floor have 2'x4' lay-in ceiling tiles in fair condition.
 - The ceiling grids and tile have discoloration and some staining.

1. Consider adding a lay-in ceiling in classrooms containing the glued on ceiling tile.
2. Replace acoustical lay-in ceiling tile where damaged or water-stained.
3. Consider replacing hallway 2'x4' lay-in ceiling tile on second floor.

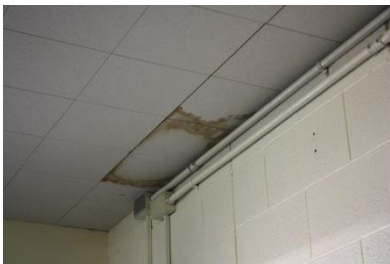
Stained adhered ceiling Tile

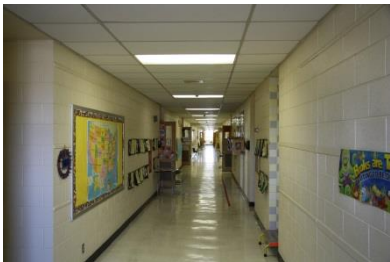
Second floor hallway ceiling tile

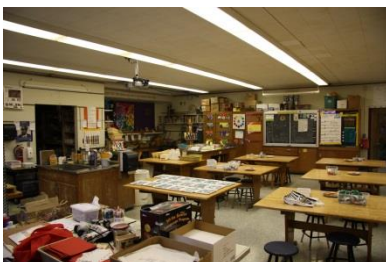
- Cubbies located in the hallways at the early childhood development are in good condition.
- The Lockers on the second floor are in fair condition.
- Art room casework is in poor condition and well worn.

- Some cabinets do not remain closed.
 - The wood veneer of, many of the cabinets, are extremely worn.
 - Steel drawer slides experience ball bearing slide failures, friction and worn surfaces. Hinges lose their loading ability over time due to door weight, pressure applied when opened by hanging on them, frequent open /close and poor adjustment.

Art room casework

1. Replace Art casework with more durable countertops and casework.

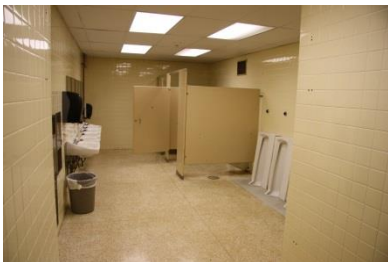
Non-renovated restroom

- Current Condition - Good
- Refer to ADA report for accessibility recommendations
- Majority of finishes are new and in good condition. The only restrooms not renovated were in the basement.
 - Ceramic Floor and Wall Tile (expected life span 40 years) – good
- Ceiling- (expected life span 15 years) good
 - Restrooms have 2'x4' lay in ceiling.
- Toilet Partitions -(expected life span 15 years) good
- Accessories – (expected life span 8-10 years) good
- The single-fixture restrooms between kindergarten classrooms appear to be original to the building. The single fixture restrooms in the early choild development area are new.

1. At non-renovated restrooms: Remove and replace all finishes: ceilings and wall and floor tile. Replace toilet partitions with anti-graffiti plastic type. Paint all walls that are not tiled. Some restrooms may need to be reconfigured due to accessibility requirements.
2. Refer to MEP reports for fixture, ventilation and lighting recommendations.
3. See Section 3 – Educational Adequacy Assessment for additional recommendations.

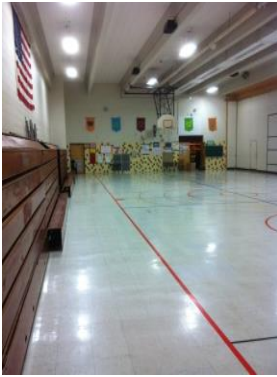
Gymnasium

- Current Condition – fair to poor
- Some of the adhered acoustical ceiling tiles are beginning to fall.
- The VCT (Vinyl Composition Tile) is in poor condition.
- Basketball backboards are in good condition.

1. Consider replacing the gymnasiums VCT floor.
2. Remove the adhered acoustical ceiling tiles.
3. See Section 3 – Educational Adequacy Assessment for additional recommendations.

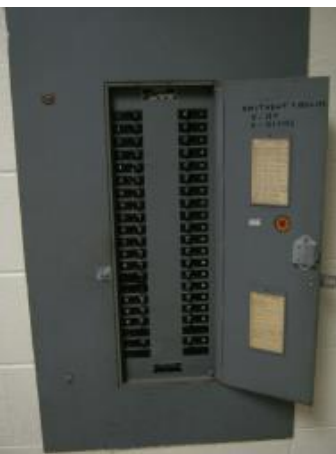
Branch Panel

- Most of the branch panels in the facility are old Kinney type.
- There are approximately 17 existing panels that are over 30 years old and should be scheduled for replacement.
- There are newer Square D NQ type panels for computer circuits.

1. Keep existing new QO panels in place; add additional circuits if required.
2. Replace existing Kinney panels.
3. Replace all old feeder wires.

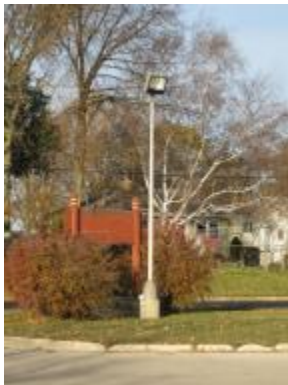
Exterior Lighting

1. We would recommend replacement of the existing exterior fixtures with new LED type to increase efficiency and lower maintenance cost.
2. As increased security is addressed, the district may consider adding security lighting around the perimeter of the facility.
3. Provide a new LiteKeeper exterior lighting control panel to improve the exterior lighting control.

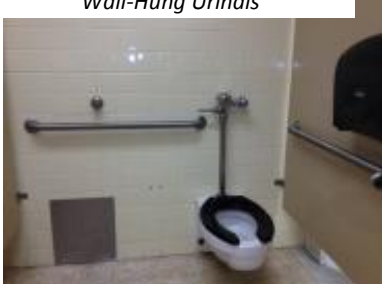
Original Water Closet

- Toilet rooms located on the main level were renovated in 2010 and are in excellent condition. Rooms are ADA compliant.
- Toilet rooms located in the lower level are in poor condition. Urinals and water closets appear to be original to the building. Lavatories have been replaced and are in good condition however, all piping serving these fixtures is exposed.

1. The lower level toilet rooms should be scheduled for renovation. Rooms should be modified for ADA compliance.
2. Provide continual maintenance on the renovated fixtures on the first floor.
3. Insulate exposed water supply piping servicing lower level lavatories.

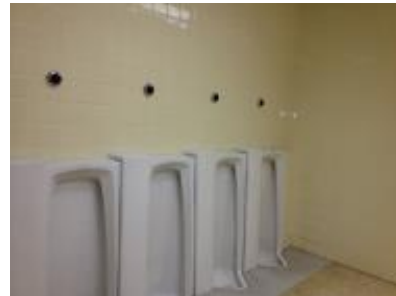
Original Urinals

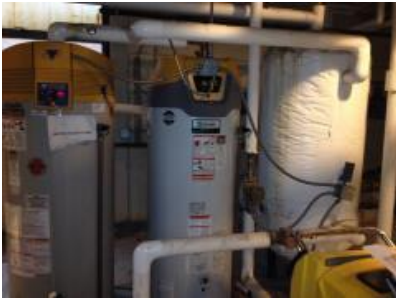
Domestic Hot Water Heating
Equipment

- The existing domestic water heating system consists of two (2) sealed combustion domestic water heaters and a storage tank. The system appears to be significantly over-sized for the actual building demand. The water heaters have approximately 10 years of useful life left.
- The existing hot water circulation pump is in good condition.

1. Schedule the water heating system for replacement. The water heaters should be resized to accommodate the actual hot water demand for the building.

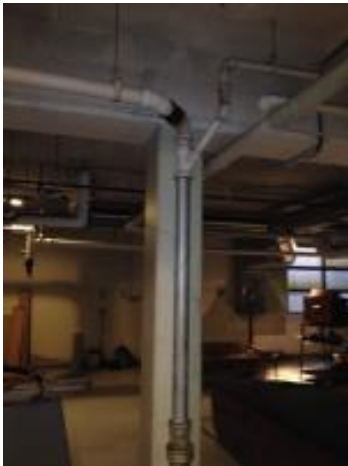
Original Sanitary Piping

- The sanitary waste and vent piping is a mixture of cast-iron, galvanized and schedule 40 PVC. Schedule 40 PVC waste and vent piping was used for the 2010 renovated toilet rooms and classroom sinks. Waste and vent piping for the lower level toilet room and kitchen remain original cast-iron waste piping and galvanized vent piping.
- An interior grease interceptor has been provided to support the existing kitchen. The grease interceptor is located in the lower level boiler room and appears to be in good condition.

1. Provide continual cleaning and maintenance on the existing grease interceptor.
2. Schedule the remaining original cast iron piping for replacement.
3. We recommend that a building of this age video-inspect the interior sewers below the floor to determine the internal condition of the piping.
