Menomonee Falls School District
Riverside - Facility Study
Historical Plan

eppstein uhen : architects
EUA No. 313258-01

BUILDING INSPECTION REPORT

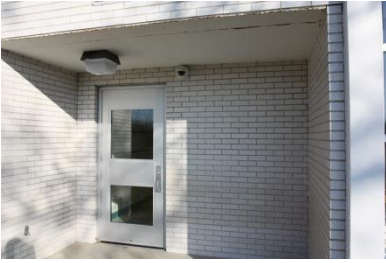
Typical exterior door

- Expected life span 20 years for steel, 30 years for aluminum/ FRP systems
- Current Condition – Good
- The exterior doors and frames are aluminum and in good condition.

1. None. Renovation

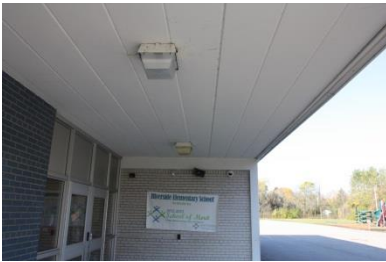
Entrance soffit

- Life Expectancy – same as building
- Current Condition – good
- Building soffits are exposed precast concrete and are generally in good condition.
 - The soffits need to be painted.
 - The soffits are created from the underside of the roof structure, which create an undesired thermal issue at these locations. The structure runs from conditioned space to unconditioned space without a thermal break. This allows cold/warm temperatures to penetrate the conditioned space and reduces the efficiency of the building envelope.
- A metal fascia is provided around the building. This is generally in good condition.
- The steel window well grates have areas of rusting and are in fair condition.
- Louvers below windows are dented and damaged in areas.

1. Repaint soffits.
2. Replace/repair any damaged mechanical louvers.

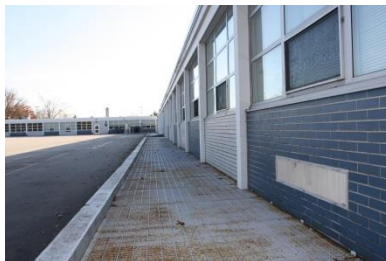
Window well grate

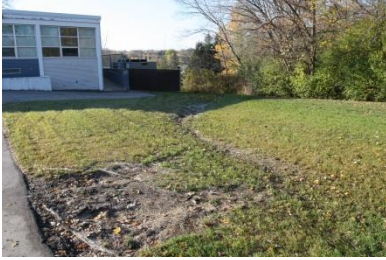
Playground drainage issues

- Concrete and asphalt were reviewed independently. See appendix for reference reports.
- Water runoff from the asphalt playground has created a bare spot.
- Playing fields for athletics and Phy Ed appear to be in fair condition.
 - Bare spots were present within the athletic fields.
- The fence along the property line has rusted and become overgrown with vegetation.
- Playground spaces appear to be in good condition.

1. Replace fence along property line.
2. Address drainage at west end of asphalt playground.
3. Repair turf at athletic fields.

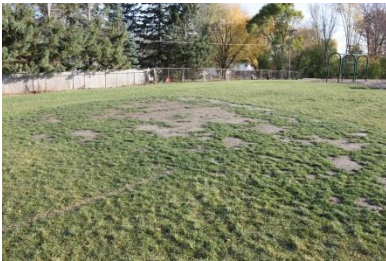
Athletic fields

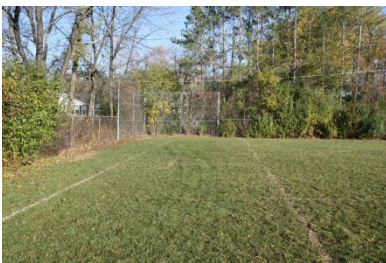
Perimeter fence

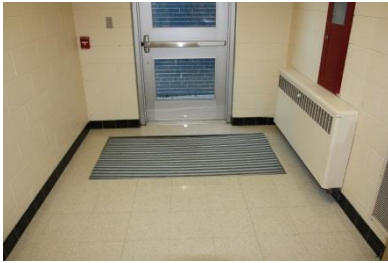
Recessed floor mat

- Expected life span 20 years
- Current Condition – Range of good to fair depending on age.
- VCT (Vinyl Composition Tile) –The VCT is in good to fair condition.
 - Hallways have 12"x12" VCT tiles in good to fair condition.
 - At exterior doors there were cracked tiles.
 - Classrooms have 12"x12" VCT tiles in good to fair condition.
 - A few classrooms on the second floor have older VCT, and repairs in those areas have been done with non-matching tiles.
- Wall base is in good to fair condition.
 - Most of the building has a rubber base however a small portion of the first floor still contains the original tile base.
- Recessed walk off mats are installed at all of the vestibules. These are original to the building.

1. Continue annual maintenance for VCT flooring.
2. Consider replacing older VCT in classrooms.
3. Consider replacing tile wall base.
4. Replace recessed floor mats with walk-off carpet tiles for more flexibility and easier maintenance.

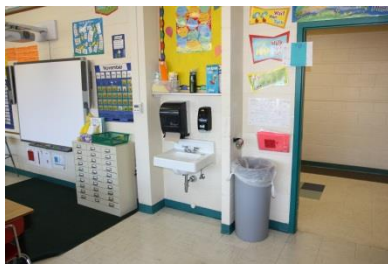
Older VCT in classroom / newer
VCT in hallway

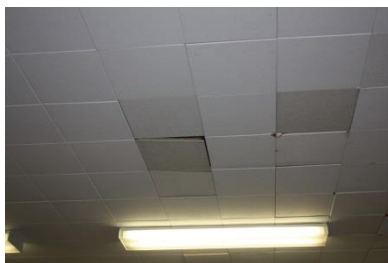
Falling acoustical ceiling tile

- Expected life span 15 years
- Current Condition – fair to poor
- Classrooms have adhered ceiling tiles in poor condition.
 - There are a few areas where the glue has failed and tiles have dropped.
 - Because of the age of the adhesives used they may contain asbestos.
- Hallways have 2'x4' Acoustical lay in ceilings that are in fair to poor condition.
 - Acoustical lay in ceilings have tendency to sag over time and discolor.
 - Ceiling grid discolors as well.

1. As adhered tiles fail, consider adding dropped lay-in ceilings.
2. Replace acoustical lay-in ceiling tile where damaged or water-stained.
3. Consider replacing hallway 2'x4' lay-in ceiling tile.

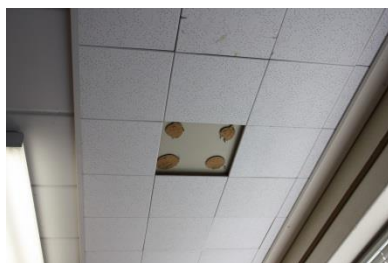
Missing ceiling tile

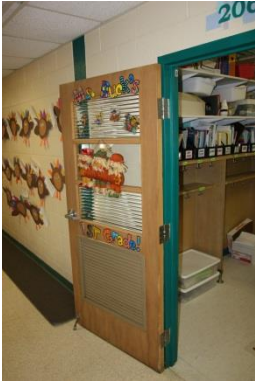
Typical classroom door

- Expected life span 40 years with periodic maintenance
- Current Condition – Fair
- The majority of doors are in Fair condition
 - Many of the doors facing veneers have tears and chips.
 - Grilles in typical classroom doors are dented and damaged.
- Some locksets have been updated to meet accessibility requirements however most door knobs are original to the building.
- Intruder lock function is not provided on original door knobs.
- Metal door frames can be repaired and painted. Door chips and scratches can be sanded, filled and restrained to revive an old door. Depending on severity of door or frame damage, it may be cost effective to replace the entire door and frame.

1. Replace or refinish doors in poor condition.
2. Paint damaged door frames.
3. Replace door hardware to be ADA compliant.

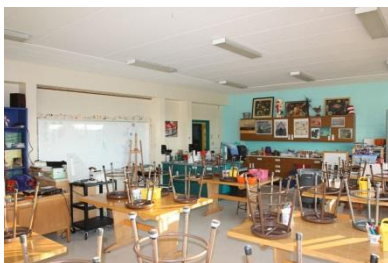
Art room casework

- Expected life span 20-25 years
- Current Condition – fair
- Typical classroom casework is in fair condition
 - Casework limited to storage shelves at windows.
- Corridor/classroom cubbies are in similar condition.
 - Cubbies are located in the classrooms.
- Art room casework is in fair condition and well worn.
 - Some cabinets do not remain closed.
 - Plastic laminate is prone to chips, dents, and delamination. In wet areas, the backing plywood swells and causes adhesive to let go.
 - Steel drawer slides experience ball bearing slide failures, friction and worn surfaces. Hinges lose their loading ability over time due to door weight, pressure applied when opened by hanging on them, frequent open /close and poor adjustment.

1. Replace Art casework with more durable countertops and casework.

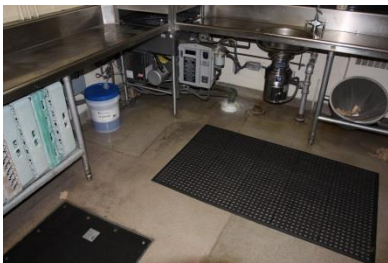
Patched flooring in kitchen

- Current Condition – fair condition
- Flooring – good condition.
 - The flooring in the cafeteria is VCT (Vinyl Composition Tile) and in good condition.
 - The flooring in the Kitchen is in Fair condition.
- Ceiling Tile – Poor condition.
 - The cafeteria has adhered ceiling tiles in poor condition.
 - There are a few areas where the glue has failed and tiles have dropped.
 - Because of the age of the adhesives used they may contain asbestos.
- Wall Base – Good condition

1. Consider Updating flooring in Kitchen
2. As adhered tiles fail, consider adding dropped lay-in ceilings.
3. See Section 3 – Educational Adequacy Assessment for additional recommendations.

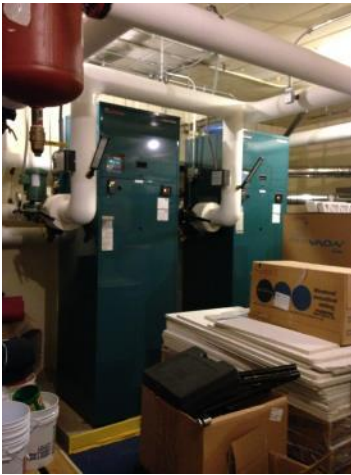
Hot Water Boilers

- The boiler plant is in good condition. With recommended maintenance, the boilers should continue to serve the facility for approximately 15-17 more years.
- Boiler water chemical systems are in place and are reported to be maintained.
- Insulation at most piping is of adequate thickness.
- Thermometers and gauges are present and appear to be working at all locations.
- Piping is adequately supported where observed.

1. Continue preventative maintenance on the hot water boilers and pumping system.

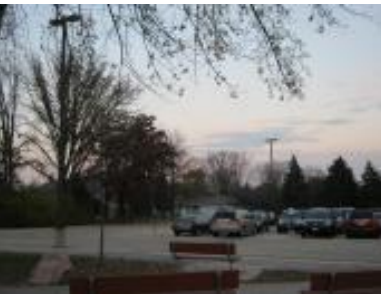
Exterior Parking Lot Pole

- The majority of the outdoor lighting consists of wall-mounted or parking lot pole lighting that have metal halide lamps.
- Half of the exterior lighting circuits do not work.

1. We would recommend replacement of the existing exterior fixtures with new LED type to increase efficiency and lower maintenance cost.
2. As increased security is addressed, the district may consider adding security lighting around the perimeter of the facility.
3. Add LED light fixtures at all building entrances for safety and security.
4. Provide new exterior lighting circuits and LiteKeeper lighting control.

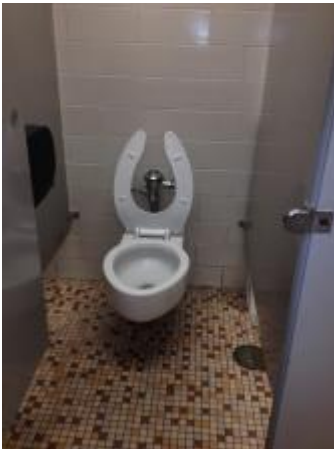
Typical Water Closet

- Toilet room fixtures are generally in poor condition. The majority of these fixtures are original to the building.
- Water closets and urinals are flush valve style fixtures. Urinals are operated on a timer. This style of fixture wastes a significant amount of water in a years' time.
- Lavatories are wall-hung and appear to be original to the building and are not ADA compliant. Minor modifications would be required to make these fixtures compliant.
- Lavatory faucets have been replaced. The faucets are in fair condition.

1. All toilet room fixtures would need to be replaced and the rooms would need to be renovated to comply with current ADA requirements.

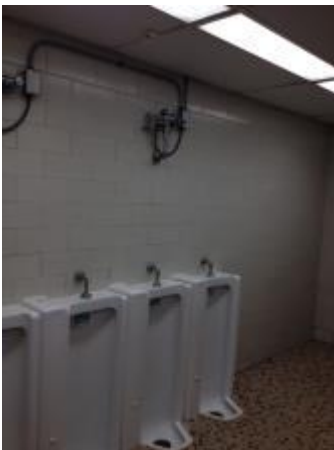
Urinals with Timer Controls

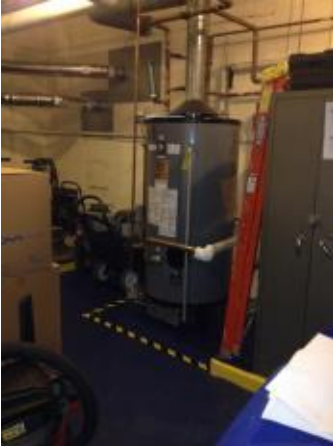
Domestic Water Heater

- A 100 gallon gravity-vented, gas-fired water heater was installed to provide domestic hot water.
- The water heater is in good condition however it is fairly inefficient per today's standards. The water heater has approximately 10 years of useful life left.

1. Schedule the water heating system for replacement. Provided two (2) new sealed combustion water heaters sized appropriately for the current building demand.

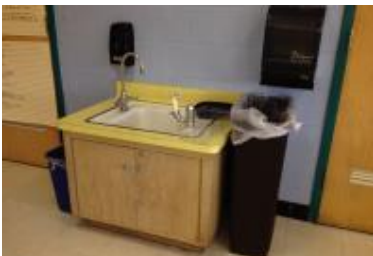
Classroom Sink - Lower Level

- Classroom fixtures are original to the building and are in poor condition. None of the fixtures are ADA compliant per today's requirements.
- Art room sinks have been updated and are in good condition. The sinks are provided with plaster traps which also appear to be in good condition.

1. All classroom fixtures should be scheduled for replacement.

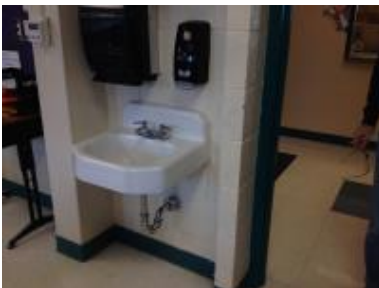
Classroom Sink - First Floor
