Menomonee Falls School District
Shady Lane - Facility Study
Historical Plan

eppstein uhen : architects
EUA No. 313258-01

BUILDING INSPECTION REPORT

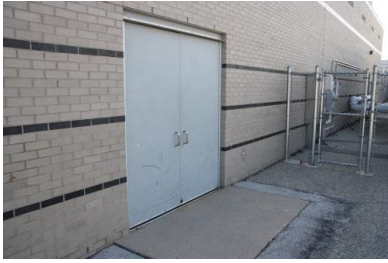
Dented and rusted steel door

- Expected life span 20 years for steel, 30 years for aluminum/ FRP systems
- Current Condition – 90% Good 10% Fair
- The majority of the exterior doors and frames are aluminum and in good condition.
- The aluminum door to the courtyard has a poor seal causing air and weather to enter the building. New weather stripping is required.
- There are steel doors and frames in fair condition.
 - All Steel exterior doors showed signs of damage. Dings, scratches and dents in steel will allow rust to begin faster and corrode easier than aluminum.
 - Some steel doors have areas of rusting on the interior and exterior. The lower portion of exterior steel door and frames are prone to rust and deterioration faster than aluminum is. Steel systems are not thermally broken causing condensation to form on the interior which results in steel corrosion.

1. Replace all exterior steel doors and frames with new FRP (fiber reinforced plastic) doors in aluminum frames.
 - Aluminum door and frame systems have internal gasketing less prone to abuse, will not rust or corrode, have improved screw holding power, can be welded to keep doors straight and will not require painting.

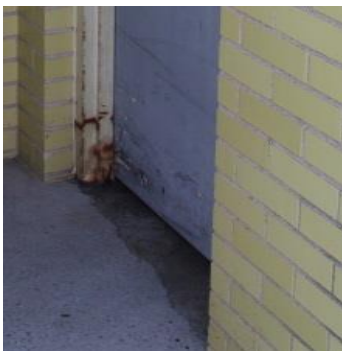
Rusted steel door and frame

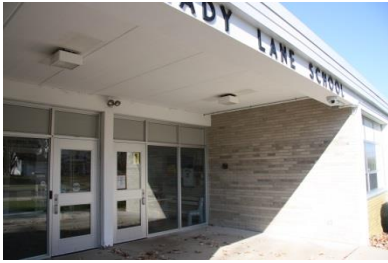
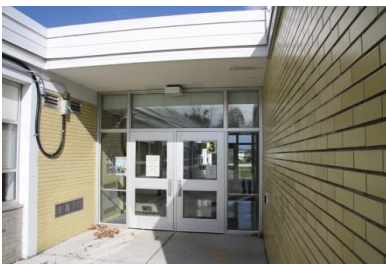
Entrance soffit

- Life Expectancy – same as building
- Current Condition – good
- Building soffits are exposed precast concrete and are generally in good condition.
 - The soffits need to be painted.
 - The soffits are created from the underside of the roof structure, which create an undesired thermal issue at these locations. The structure runs from conditioned space to unconditioned space without a thermal break. This allows cold/warm temperatures to penetrate the conditioned space and reduces the efficiency of the building envelope.
- A metal fascia is provided around the building. This is generally in good condition.

1. Repaint soffits.

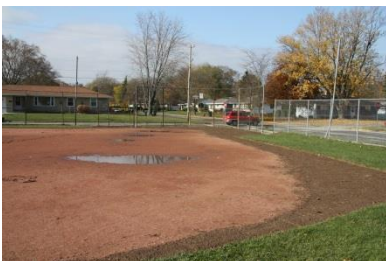
- Concrete and asphalt were reviewed independently. See appendix for reference reports.
- Playing fields for soccer, athletics and phy ed appear to be in good condition.
 - Standing water was observed on baseball field.
- Portions of the fence around the ball field have significant rust.
- Playground spaces appear to be in good condition.
 - The playground equipment is surrounded by a wood border with no ADA accessible access point.
- There is a drainage issue at the north service drive and sidewalk.

Ponding water at baseball field

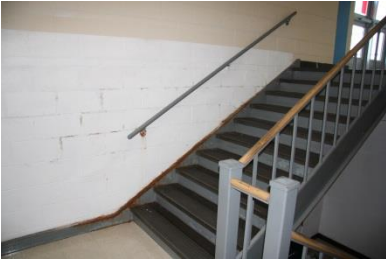
Northwest stairwell water damage

- The northwest stairwell has signs of water infiltration causing rust damage to stair stringer.
 - The water infiltration is possibly due to the addition of a ramp on the exterior side of the wall.

1. Investigate cause of water infiltration at northwest stairwell. The addition of the ramp along the exterior of the wall may be the cause.
 - a. Verify the ramp surface is pitched away from building.
 - b. Excavation of ramp may be necessary to investigate cause of water penetration.

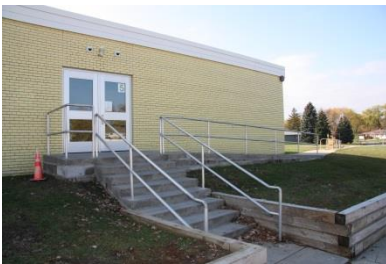
Ramp at Northwest stairwell

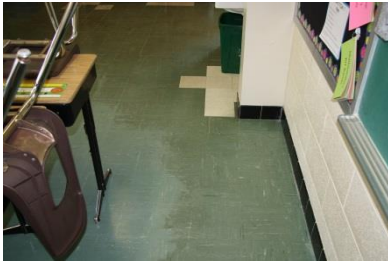
Non-matching VCT

- Expected life span 20 years
- Current Condition – Range of good to poor depending on age.
- Carpet – There are limited amounts of carpet in the building; primarily in the music room
 - Music room carpet in good condition.
 - Classrooms use large rugs.
- VCT (Vinyl Composition Tile) –The VCT is in good to poor condition.
 - Hallways have 12"x12" VCT tiles in good to fair condition.
 - At exterior doors there were cracked tiles.
 - The majority of Classrooms have 9"x9" vct tiles, which are original to the building and, in poor condition.
 - 9"x9" tile have been known to contain asbestos.
 - There were many areas where the tiles were worn on the edges.
 - Damaged tiles have been repaired with non-matching tiles
- Wall base tile is in Poor condition.

1. Continue annual maintenance for VCT flooring.
2. Consider replacing 9"x9" VCT in classrooms.
3. Consider replacing wall base.

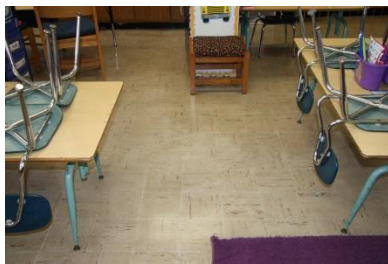
Edges worn on VCT

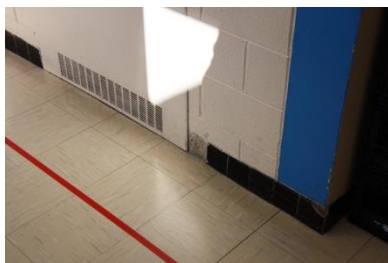
Chipped and missing wall base tile

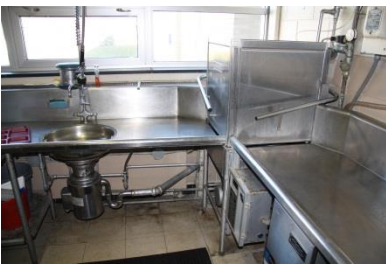
- Current Condition – good condition
- Flooring – Good condition.
 - The VCT flooring in the Kitchen is in Poor condition.
- Ceiling Tile – Good condition.
- Tile Base – Poor condition
 - There are numerous missing and cracked base tiles.
- Half of the existing tables are original and built-in the walls.
 - Very limited flexibility in arranging the space.

Damaged VCT flooring in kitchen

1. Update Cafeteria furniture.
2. Update wall tile base.
3. Update flooring in Kitchen
4. See Section 3 – Educational Adequacy Assessment for additional recommendations.

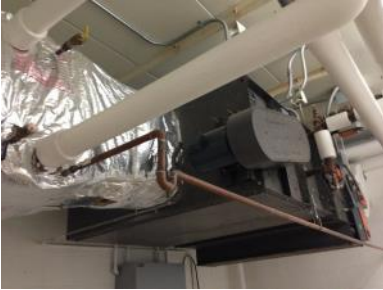
- The 1995 and 2009 air handling units have been well maintained and are in good condition.
- The 1960 air handling equipment that continues to serve the music and art rooms and the lower level storage area have been well maintained but have exceeded their expected service life.

Lower Level Air Handling Unit

1. The air handling equipment from 1960 has exceeded expected service life. Plans should be made for replacement within the next 3 years.
2. Continue with the current maintenance program on the 1995 and 2009 air handling equipment and chilled water system.
3. Provide ventilation for the lower level computer lab to comply with code requirements.

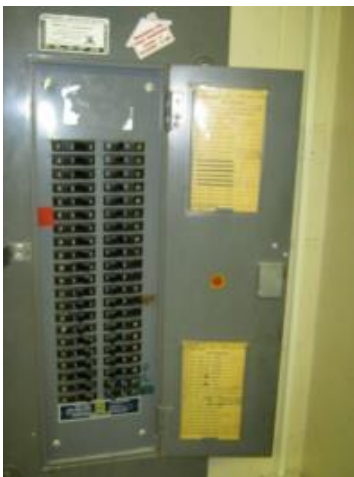
Branch Panel

- Most of the branch panels in the facility have been upgraded to Square D NQ type.
- There is an existing Square D fused disconnect power panel in the lower level mechanical room that are over 50 years old and should be scheduled for replacement.
- There are approximately five (5) existing Square D fused branch circuit panels that are over 30 years old and should be scheduled for replacement.

1. Keep existing new NQ panels in place; add additional circuits if required.
2. Replace existing Square D fused power panel.
3. Replace existing Square D fused branch circuit panels.
4. Replace all old feeder wires.

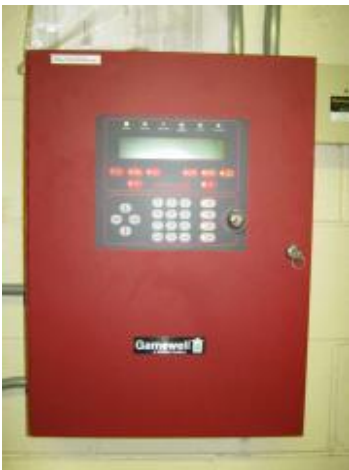
- The fire alarm system is a Gamewell IF602 addressable type. There are duct smoke detectors and manual pull stations.
- The classrooms and corridors do not have horn strobe devices.
- An annunciator is located near the front entrance.

Fire Alarm Control Panel

1. Provide horn strobe devices in all classrooms and corridors per code. Provide strobe devices in all offices per code.
2. Provide new Simplex addressable fire alarm system

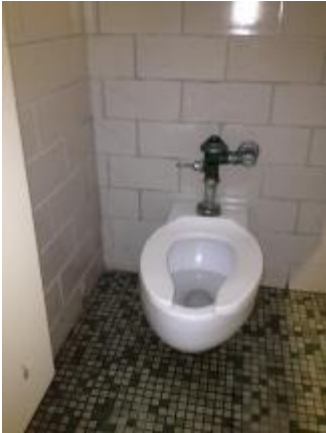
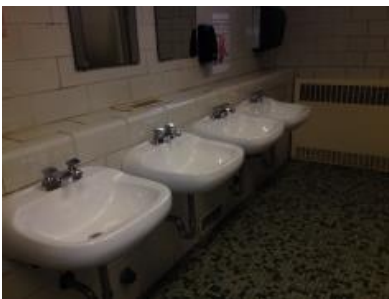
Water Closet

Lavatories

- Toilet room fixtures are generally in poor condition. The majority of these fixtures are original to the building.
- Water closets and urinals are flush valve style fixtures. Urinals are operated on a timer. This style of fixture wastes a significant amount of water in a years' time.
- Lavatories are wall-hung and appear to have been replaced in the last 5-7 years. The lavatories are in good condition.
- A new ADA toilet room was provided on the first floor.

1. All toilet room fixtures need to be replaced and the rooms would need to be renovated to comply with current ADA requirements.

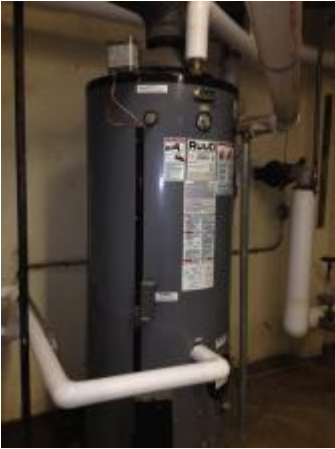
Water Heater

- A 100 gallon gravity-vented, gas-fired water heater was installed to provide domestic hot water. The water heater has approximately 10-15 years of useful life left.
- The water heater is in good condition however it is fairly inefficient per today's standards.
- A few classrooms were without hot water.

1. Schedule the water heating system for replacement. Provided two (2) new sealed combustion water heaters sized appropriately for the current building demand.
2. Investigate lack of hot water in a few classrooms.
