eua eppstein uhen : architects
Menomonee Falls School District
Vally View - Facility Study
Historical Plan

BUILDING INSPECTION REPORT

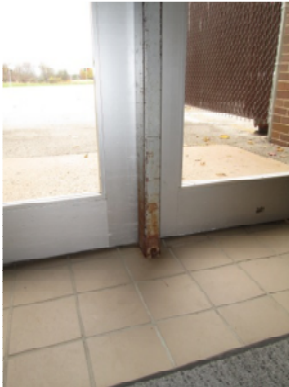
Rusted hollow metal door frame

- Expected life span 20 years for steel, 30 years for aluminum/ FRP systems
- Current Condition - fair
- Steel doors have areas of rusting on the interior and exterior. The lower portion of exterior steel door and frames are prone to rust and deterioration faster than aluminum is. Steel systems are not thermally broken causing condensation to form on the interior which results in steel corrosion.

1. Replace all exterior steel doors and frames with new FRP (fiber reinforced plastic) doors in aluminum frames. Include replacement of all exterior door hardware.

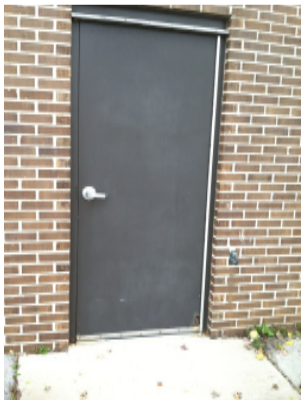
Hollow metal door and frame

- There are exterior doors in the gymnasium that do not fully function and open and close. This is a safety concern for emergency egress.
- Aluminum doors are in good condition.

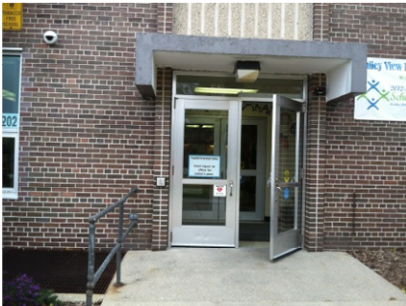
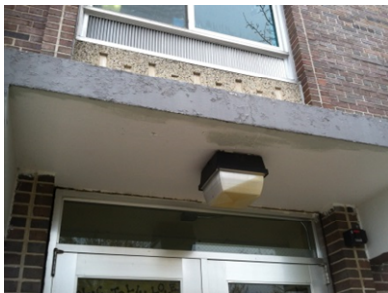
Main entrance canopy

- Life Expectancy – same as building
- Current Condition – good to fair
- The building has two canopies – one at the main entry and one at secondary entry.
 - Canopies need to be painted.
- A metal fascia is provided around the building. This is generally in good condition.

1. Repaint main entrance and secondary entrance canopies.

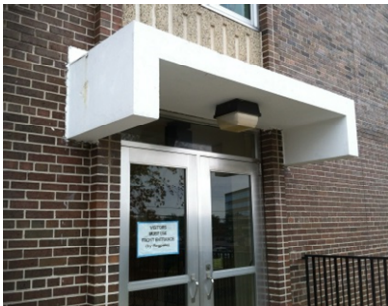
Secondary entry soffit

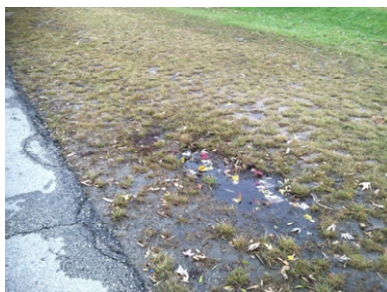
Playground drainage issues

- Concrete and asphalt were reviewed independently. See appendix for reference reports.
- The site slopes from west to east. Water drains from the higher portion at the front of the site, down a hill to an area of playground.
 - Wood chips are frequently washed away from playground area.
- On the east end of the asphalt playground, there is a bioswale. Area of grass between asphalt and bioswale is frequently wet and muddy. Drainage appears to be very poor.
 - Staff reported there is asphalt below the grass and at one time grass was planted over the asphalt.
- Fences along the property line are falling over.
- Playground spaces appear to be in good condition.
- Playing fields for soccer, athletics and phy ed appear to be in good condition.
- There is no outside storage for lawn or grounds equipment.

1. Address drainage at east end of asphalt playground.
2. Replace property fences.
3. Provide outside storage shed.
4. Consider providing additional site lighting.

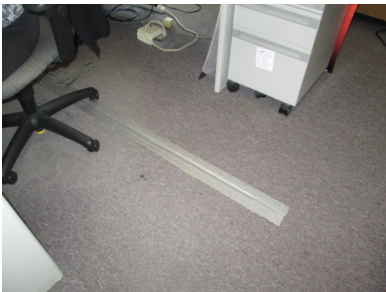
Office carpet

- Expected life span - 20 years
- Current Condition - good
- Carpet – There are limited amounts of carpet in the building; primarily in offices.
 - Office carpet is in poor condition.
 - Classrooms use large rugs.
- VCT (Vinyl Composition Tile) – is dated, but in good to fair condition.
 - There are areas of cracked, failed tile. (See Specialty Areas in report.)
- Quarry tile in the kitchen is original but holding up well.
- Recessed walk off mats are installed at all of the vestibules. These are original to the building.
- Wall base is in fair condition.

1. Continue annual maintenance for VCT flooring. Consider replacing VCT.
2. Replace recessed floor mats with walk-off carpet tiles for more flexibility and easier maintenance.
3. Replace all carpeting.

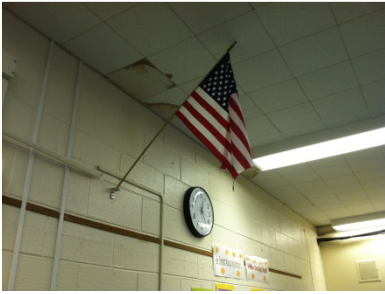
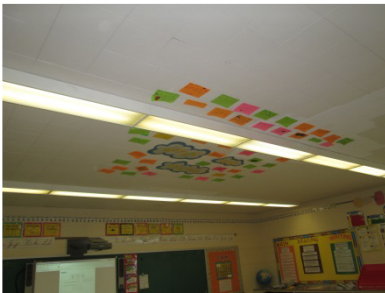
Stained / damaged ceiling tile

- Expected life span 15 years; replaced in 2011
- Current Condition – fair
- Acoustical ceilings are generally in fair shape with several areas of water-damaged or discolored tile, most noted in the computer lab.
 - Acoustical lay in ceilings have tendency to sag over time and discolor.
 - Ceiling grid discolors as well.
- Typical classrooms have adhered ceiling tiles. There are a few areas where the glue has failed and tiles have dropped.

1. Replace acoustical lay-in ceiling tile where damaged or water-stained.
2. As adhered tiles fail, consider adding dropped lay-in ceilings.

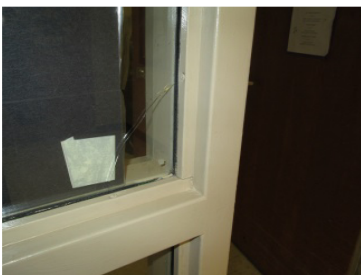
Broken glass

- Expected life span 40 years with periodic maintenance
- Current Condition - fair
- A majority of doors appear to be in good-fair condition, however due to the use and continued operation of interior wood doors the facing veneer will chip and tear over time and experience scrapes and dents.
- Doors have settled and do not open and close properly.
- Some locksets include an "ADA-attachment" however most door knobs are original to the 1966 building.
- Intruder lock function is not provided.
- Metal door frames can be repaired and painted. Door chips and scratches can be sanded, filled and restrained to revive an old door. Depending on severity of door or frame damage, it may be cost effective to replace the entire door and frame.
 - Grilles in typical classroom doors are dented and damaged.
- Noted area of broken glass in sidelight.

1. Replace or refinish doors in poor condition.
2. Paint all door frames.
3. Adjust doors so that they latch properly.
4. Replace door hardware to be ADA compliant.

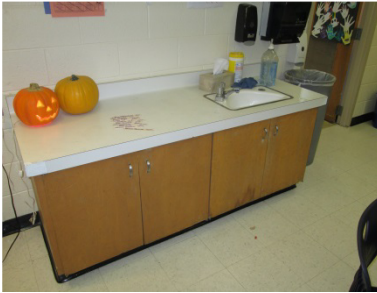
Typical classroom casework

- Expected life span 20-25 years
- Current Condition - fair
- Typical classroom casework is in fair condition and well worn.
 - Some cabinets do not remain closed.
 - Plastic laminate is prone to chips, dents, and delamination. In wet areas, the backing plywood swells and causes adhesive to let go.
 - Steel drawer slides experience ball bearing slide failures, friction and worn surfaces. Hinges lose their loading ability over time due to door weight, pressure applied when opened by hanging on them, frequent open /close and poor adjustment.
- Sink / faucet – see plumbing report.
 - Areas of the countertop at the sink are well worn and deteriorating.
- Corridor/classroom cubbies are in similar condition.
 - Cubbies are typically located in the classrooms. Additional cubbies were placed in the corridors.
- Blinds are worn and damaged.

1. Replace casework in typical classrooms.
2. Replace Art casework with more durable countertops and casework.
3. Consider replacing the blinds at all windows.

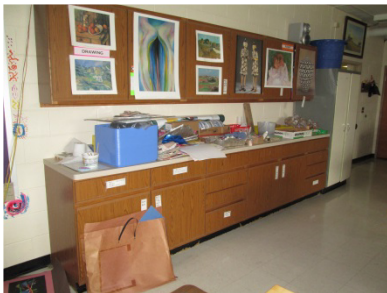
Art casework

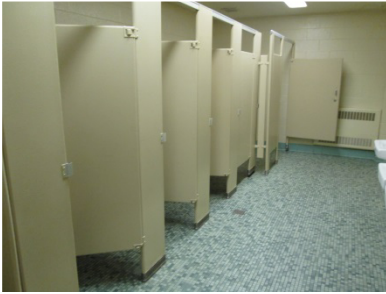
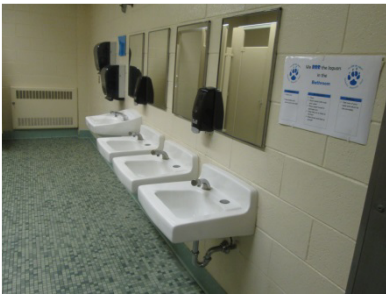
Typical restroom

- Current Condition - fair
- Refer to ADA report for accessibility recommendations
- Finishes are worn and dated but in fair condition. They are original to the 1966 building.
 - Ceramic Floor and Wall Tile (expected life span 40 years) – fair, older grout holds bacteria
 - Ceiling- (expected life span 15 years) fair
 - Toilet Partitions -(expected life span 15 years) fair
 - Accessories – (expected life span 8-10 years) good
- Public restrooms on first and second floor are centrally located.
 - A single stall was modified to provide accessibility.
- The single-hole restrooms between classrooms are original to the building.
- An accessible restroom and shower is provided in the 1997 addition with direct access to the gym.

1. All restrooms: Remove and replace all finishes: ceilings and wall and floor tile. Replace toilet partitions with anti-graffiti plastic type. Paint all walls that are not tiled. Some restrooms may need to be reconfigured due to accessibility requirements.
2. Refer to MEP reports for fixture, ventilation and lighting recommendations.

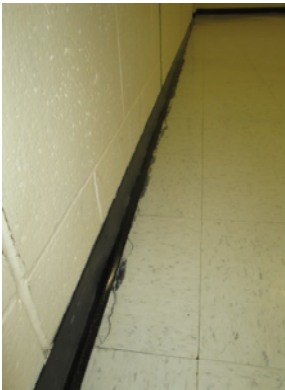
- Current Condition – good condition
- Areas of flooring along east wall are damaged. The main gym floor appears to be in fair to good condition.
- Southeast corner of gym has hollow sound when ball is bounced.
- Basketball backboards and wall mats are in good condition.
- A stage is provided in the gym. This is accessed by stairs and a ramp.

Gym floor at east wall

1. District could consider mudjacking the gym floor below the hollow spot.
 - a. Mudjacking is a method of raising or supporting a concrete slab-on-grade by boring holes at selected locations and pumping in a concrete mixture.

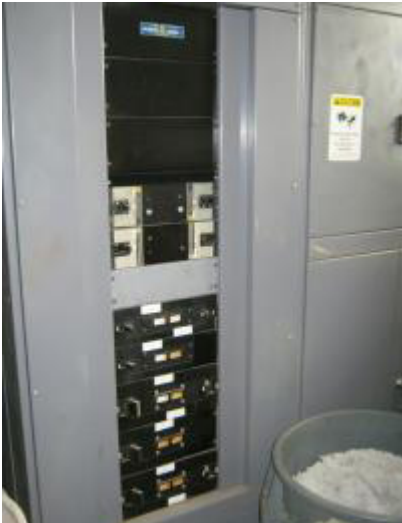
- The facility is fed with a 1,000 amp 208Y/120 volt 3 phase, 4 wire electric service. There is a pad-mounted utility transformer on the north side of the building. The service age is dated to the original construction of the 1966 building. Historical electrical data provided by We Energies indicates the maximum demand for the east service is 97 KW. This equates to approximately 270 amps. This demand data was taken over the past 24 months.
- There is an old Square D main switchboard located in the electrical room.
- No surge suppression device was present on the main service gear.
- The chiller has a separate dedicated 480Y/277 volt 3 phase electric service.

Service Panel

1. The service has capacity for future loads but the main switchboard is approximately 45 years old and is nearing the end of its useful lifespan. A new main switchboard should be installed.
2. We do recommend all electric services be provided with surge devices.
3. Add phase monitoring relays to service for electrical system protection.

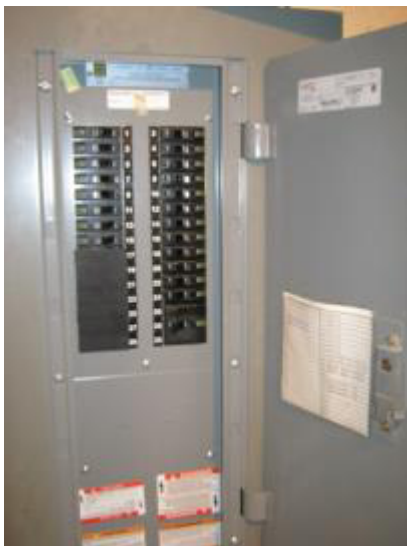
Branch Panel

- Most of the branch panels in the facility have been upgraded to Square D NQ type.
- There are approximately 3 existing Square D fused panels that are over 45 years old and should be scheduled for replacement.

1. Keep existing new NQ panels in place and add additional circuits if required.
2. Replace existing Square D fused panels.
3. Replace all old feeder wires.

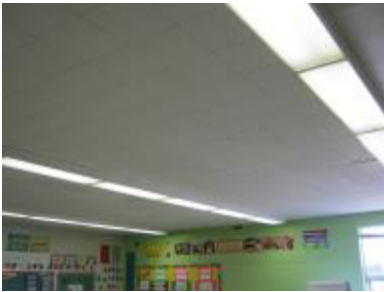
General Lighting

- All of the fixtures in the building use T12 lamps.
- There are acrylic lens 2x4 fixtures in the corridors and 1x4 surface acrylic lens modular in the classrooms. Lighting motion sensors were not present in most areas. No day lighting sensors were present.
- The gym has metal halide high bay fixtures.

1. Replace all existing fixtures with T12 lamps with new architectural 2x4 fixtures that use T8 lamps and electronic ballasts.
2. Provide new 2x4 fluorescent high bay light fixtures in the Gym.

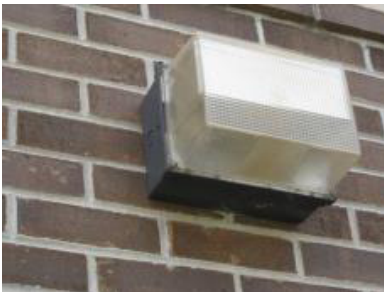
Exterior Lighting

- The majority of the outdoor lighting consists of wall-mounted or parking lot pole lighting that have metal halide lamps. The parking lot currently has minimal lighting.

1. We would recommend replacement of the existing exterior fixtures with new LED type to increase efficiency and lower maintenance cost.
2. As increased security is addressed, the district may consider adding security lighting around the perimeter of the facility.
3. Add additional parking lot pole fixtures for increased security.

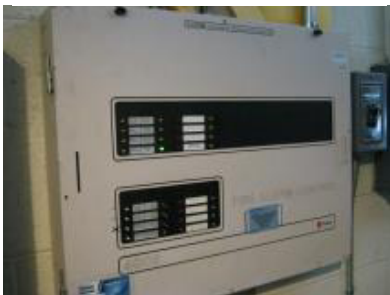
Fire Alarm Control Panel

- The fire alarm system is a Simplex 4002 conventional zoned system. The facility does not have smoke detectors in corridors with open cubby areas. There are horn strobe devices in the corridors only. This fire alarm system is not expandable and does not meet current code.

1. Provide new addressable fire alarm system.

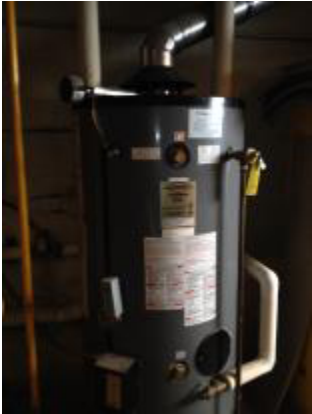
Water Heating Equipment

- A 100 gallon gravity-vented, gas-fired water heater was recently installed to provide domestic hot water. The water heater has approximately 10 years of useful life left.
- The water heater is in good condition however it is fairly inefficient per today's standards.
- Water softening equipment is located within the mechanical room. The water softening equipment appears to be sized appropriately for the building and is in fair condition.

1. Schedule the water heating system for replacement. Provided two (2) new sealed combustion water heaters sized appropriately for the current building demand.

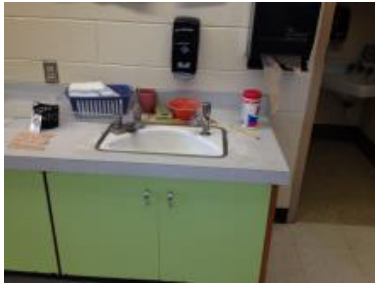
Classroom Sinks

- Classroom fixtures are original to the building and are in poor condition. None of the fixtures are ADA compliant per today's requirements.

- All classroom fixtures should be scheduled for replacement.

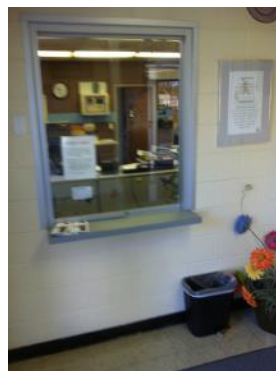
ITEM	ADA REFERENCE
1.	Main Entrance is accessible. Corridors and egress doors have accessible lever type hardware.	402, 404
2.	Classroom doors are not accessible. An accessible lever has been added to some of the doors.	404
3.	Main Office reception desk does not meet the requirements for accessibility.	308
4.	Classroom sinks are not accessible.	
RECOMMENDATION: 1. A service counter, maximum 34" above the floor is required for accessibility. Modify the existing reception desk. 2. Provide accessible door hardware for all doors.

Main office service counter is not ADA accessible

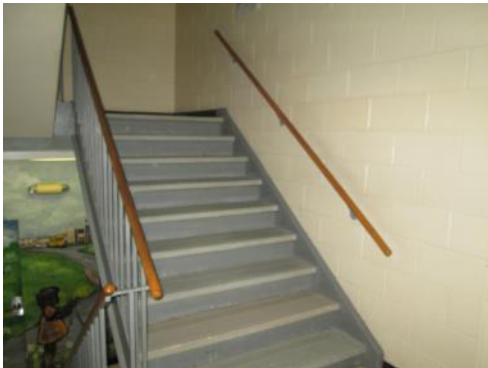
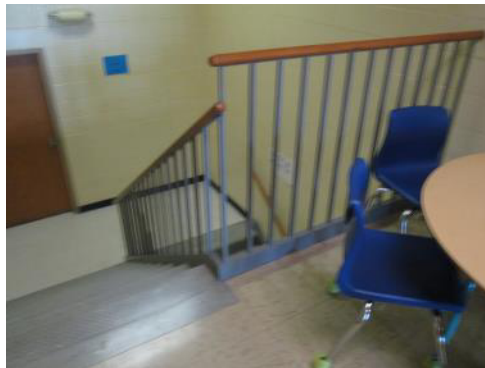
ITEM	ADA REFERENCE
1.	Stair handrails do not have compliant extensions.	505
2.	The ramp provided at the stage is accessible.	
RECOMMENDATION: 1. None.

Stair handrails
