Menomonee Falls School District
North Middle School - Facility Study
 Historical Plan

SCHOOL DISTRICT OF
MENOMONEE FALLS

BUILDING INSPECTION REPORT

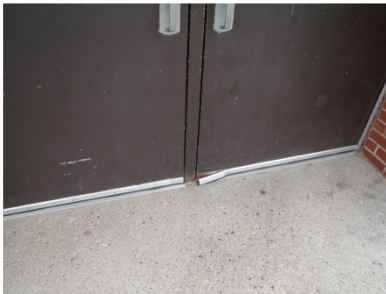
Damaged weatherstripping

- Exterior hinges and locksets are prone to fail most and are the most costly to replace. Screw holes may strip out losing holding power, doors may drop and no longer align between lockset and frame latch, closers will fail to due to over burden, and surface applied weatherstripping fails.

1. Replace all exterior steel doors and frames with new FRP (fiber reinforced plastic) doors in aluminum frames. Include replacement of all exterior door hardware.
 - Aluminum door and frame systems have internal gasketing less prone to abuse, will not rust or corrode, have improved screw holding power, can be welded to keep doors straight and will not require painting.

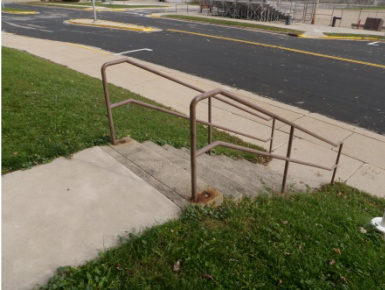
- Concrete and asphalt were reviewed independently. See appendix for reference reports.
- Replace all site railings and handrails, including railing at pool patio.
- Site fencing is failing down.

Site handrail

1. Replace site railings and handrails.
2. Replace/repair site fencing.
3. Repair retaining walls at loading.

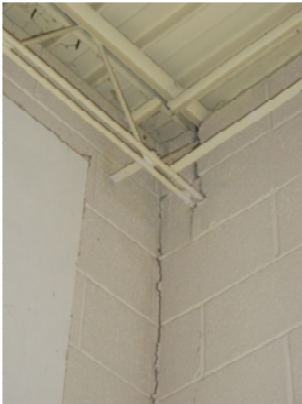
Cracked concrete block wall

- There are several walls, particularly in stairwells that have visible cracks.
- Paint is generally in good condition.
 - There are several areas in the Tech Ed spaces (1965 addition) where the paint is peeling.

1. Tuckpoint areas of cracked/damaged cmu and cut in controls joints.
2. Scrape walls and repaint areas of tech ed where paint is peeling.
3. Replace damaged ceramic tile (including wall base – see flooring report).
4. Reapply sealant to any control joints.

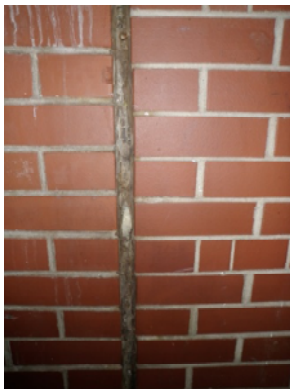
Deteriorated control joint

- Ceramic wall tile is provided in several areas. This is generally in fair shape; however there are portions of crack and damaged tile.
- In areas where control joints are provided, sealant has become deteriorated.

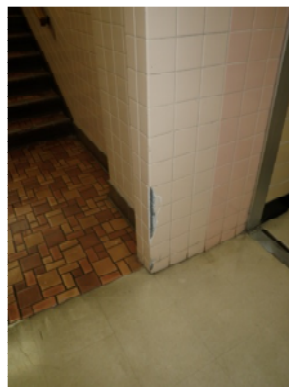
Damaged wall tile

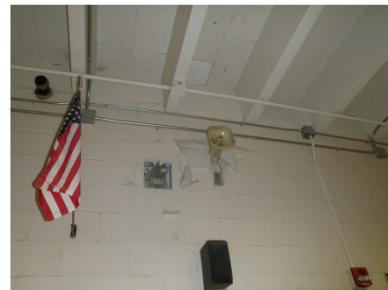
Peeling paint

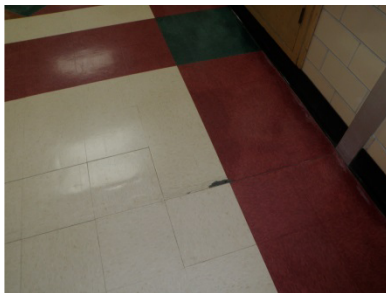
Damaged VCT

1. Replace all carpet – specifically office areas and library.
2. Continue annual maintenance for VCT flooring. Consider replacing VCT from 1999 project.
3. Consider replacing VAT.
4. Replace wall base in a majority of areas.
5. Replace recessed floor mats with walk-off carpet tiles for more flexibility and easier maintenance.
6. See specialty areas for additional recommendations.

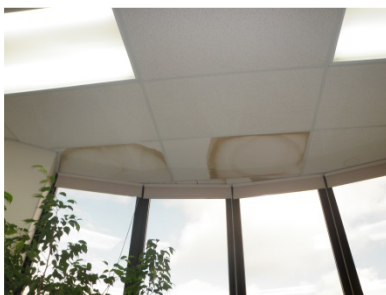
Stained ceiling tile

1. Replace acoustical lay-in ceiling tile where damaged or water-stained.
 - a. Consider replacing all aging ACT in the entire building.

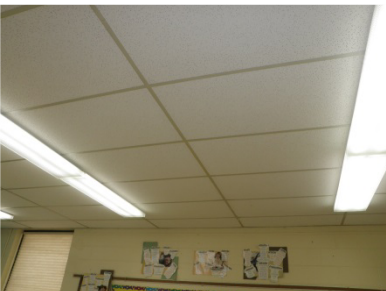
Discolored ceiling grid

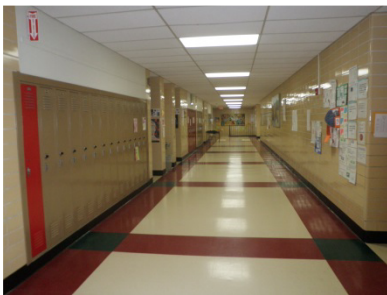
Lockers

- Expected life span 20-25 years
- Current Condition - good
- Casework is generally in good working condition; however a majority of the building furniture is in need of replacement.
- Corridor lockers are in good working condition.
 - There is some denting and damage. Locker paint is worn.

1. Repaint corridor lockers using electrostatic painting technique.

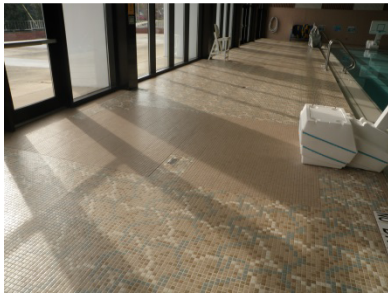
- Current Condition – good condition
- Pool deck tile in fair condition. There are areas of patching.
- Ceramic wall tile in pool area is in good condition.
- There are areas of staining on the ceiling tiles.
- There are several doors in the pool area that need to be replaced.
- Pool filtering equipment is aging.
- Bleachers are in good condition.

1. Consider replacing pool deck tile.
2. Consider replacing pool filtering equipment. Consider installing an emergency shutoff of water in the filter room.
3. See Section 3 – Educational Adequacy Assessment for additional recommendations.

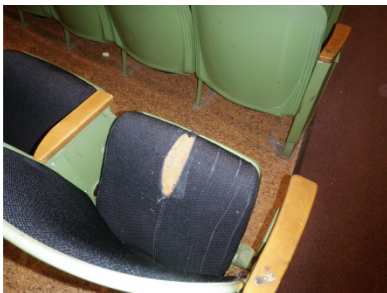
Auditorium seating

- Current Condition – fair condition
- Stage has a wooden floor which is well-worn.
- Carpet in seating area aisles is old and worn. VAT is provided underneath the seats.
- Ceiling Structure – fair.
- Seating fabric is old and worn. There are tears and rips in several seats.

1. Replace seating.
2. Refinish stage floor.
3. Update finishes in seating area (paint, flooring, etc.). Update finishes in Auditorium lobby, including ceiling and flooring.
4. See Section 3 – Educational Adequacy Assessment for additional recommendations.

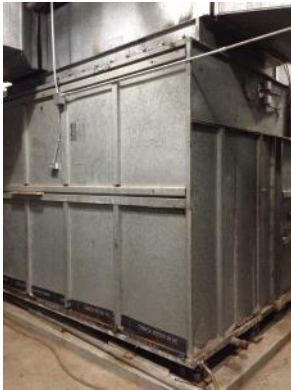
Multi-Zone Air Handling Unit

- The air handling units and unit ventilators installed in 2000 have been well maintained and are in good condition.
- The older air handling equipment has been well maintained but has exceeded its expected service life despite the renovation work performed in 2000. These units are in need of replacement.
- The chilled water system has also been well maintained and is in good overall condition.

1. Replace the remainder of the air handling equipment that was not replaced in the 2000 renovation project.
2. Continue with the current maintenance program on the 2000 air handling equipment and chilled water system.
3. Provide air conditioning for all spaces where it is currently not provided.

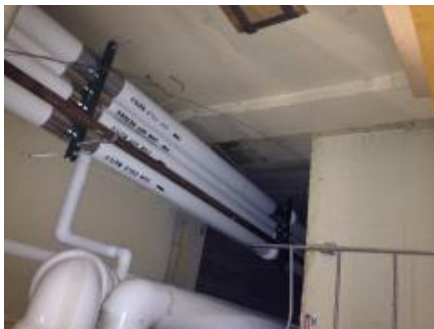
Water Piping at Tunnel

- The water supply piping for this building is a mixture of galvanized and copper piping. Much of the piping in the original building is run in the tunnel below the floor slab. Access to this piping is difficult.
- Some of the main supply piping has been replaced however most of the small branch piping in the walls serving fixtures and toilet rooms remain original to the building.
- The building is supported by a 4" water service and 4" water meter. This service appears to be appropriately sized for the building.
- Water pressure appears to be adequate throughout the building.

1. The remaining galvanized water piping should be scheduled for replacement.

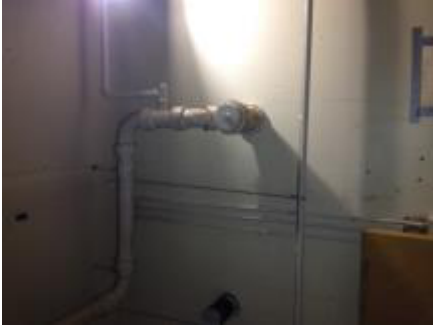
Sanitary Piping

- The existing sanitary waste and vent piping is a mixture of cast-iron, galvanized and schedule 40 PVC. Schedule 40 PVC waste and vent piping was used to repair piping failures.
- Schedule 40 PVC was used throughout the 1999 addition. This piping is in good condition.
- The owner indicated that the primary piping system is original and is in good condition. The system was viewed with a camera in 2012 and appeared to be in good condition.
- Two interior grease interceptors are located in the kitchen. Interceptors have been provided for the two-compartment sink and four-compartment sink. The grease interceptors are in good condition and appear to be adequately sized for its usage. Current codes also require the dishwasher to discharge through a grease interceptor.
- Art room sinks appear to have been replaced however only one classroom has been provided with plaster traps.

1. Original sanitary sewers should be scheduled for replacement.
2. Per code, a grease interceptor is not required until modifications are made to the existing kitchen, dishwasher or the original grease interceptor. At that time a new grease interceptor should be added for dishwasher.
3. Continually maintain the existing grease interceptor.
4. Provide plaster traps for all art room sinks

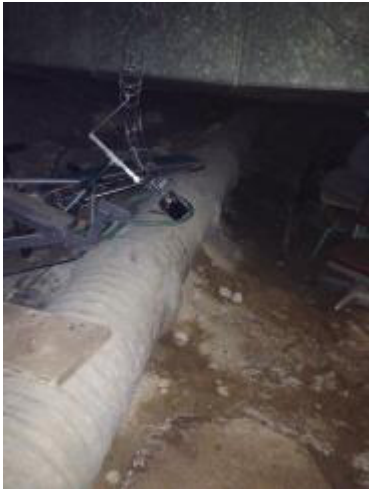
Storm Piping

- The pool building has a large 15" storm sewer that is exposed below the building. Per code, concrete storm piping is not permitted below the footprint of below and is allowed for exterior use only. This piping should be continually monitored and scheduled for replacement.

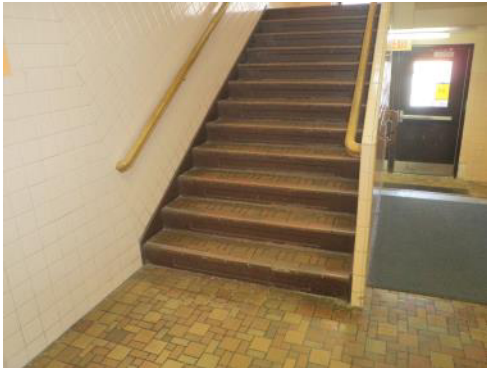
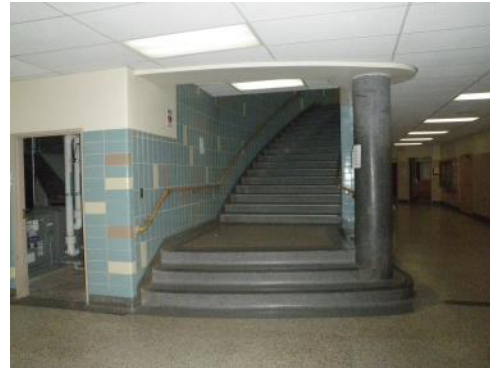
Handrail extensions

ITEM	ADA REFERENCE
1.	Stair handrails do not have compliant extensions. Handrail sizes are not complaint.	505
RECOMMENDATION: 1. As building renovations take place, replace all non-compliant handrails and guardrails.
