Menomonee Falls School District  
Menomonee Falls High School - Facility Study  
Historical Plan

eppstein uhen : architects  
EUA No. 313258-01

## BUILDING INSPECTION REPORT

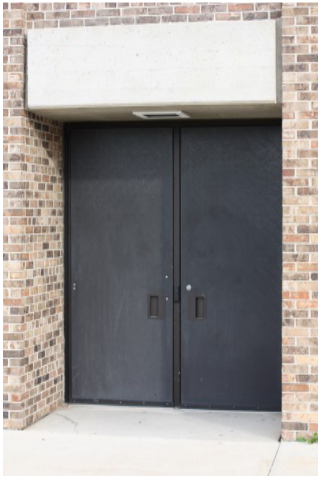
FRP door discoloring

1. Replace all exterior steel doors and frames with new FRP (fiber reinforced plastic) doors in aluminum frames. Include replacement of all exterior door hardware.
2. Replace all exterior steel coiling doors and frames.

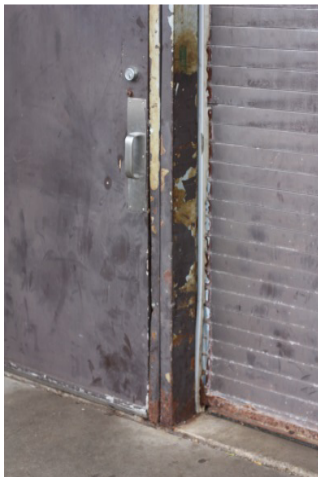
- Expected life span 20 years for steel, 30 years for aluminum/ FRP systems
- Current Condition - Good
- In general the exterior doors are either FRP doors in steel or aluminum frames or aluminum doors in aluminum frames, all of which are in good condition. However there are a few steel doors in steel frames and steel coiling doors that are in poor condition.
- Some of the FRP doors are beginning to discolor.
- The exterior steel door and frame in the auto shop has significant rusting and denting.
- The coiling doors in the auto shop and wood shop has significant rusting and general wear.

Rusted steel frame / Door

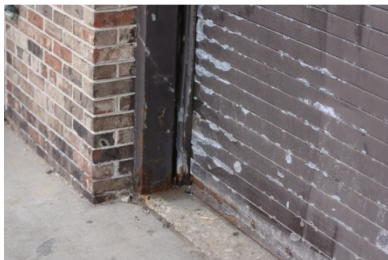
Rusted coiling door

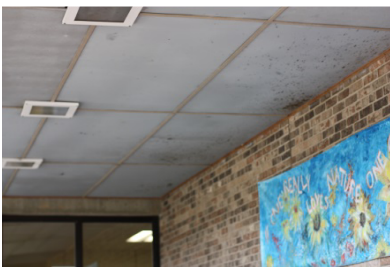
- Life Expectancy – same as building
- Current Condition – good to poor
- The building soffits range from good to poor condition
  - At the 2007 addition the soffits are in good condition.
  - At the 1969 portions of the building, the soffits are in poor condition.
    - Water stains, mold and rust were present on the soffits.
- The mechanical louvers have areas of rust.

Damaged Soffit

1. Replace soffits at 1969 portion of building
2. Paint mechanical louvers.

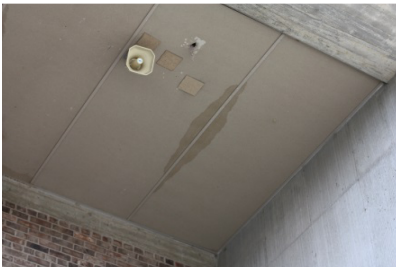
Damaged Soffit

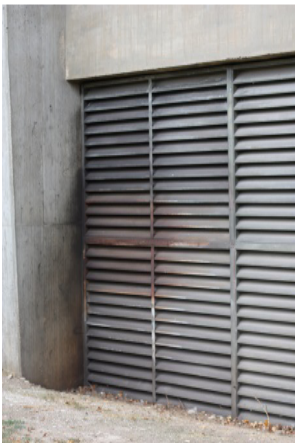
Rusted mechanical louver

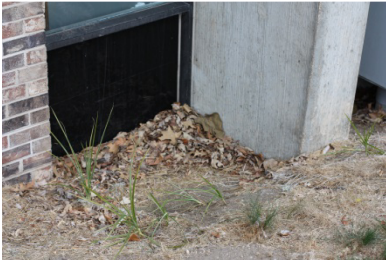
Grade pitching towards building

1. Paint all metals on site that show signs of wear or rusting.
2. Paint walls at baseball field dugout.
3. Reroof the storage shed.
4. Evaluate grading at east side of building to ensure water is draining away from building.

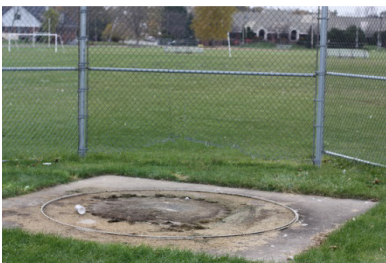
Damaged fence at field event

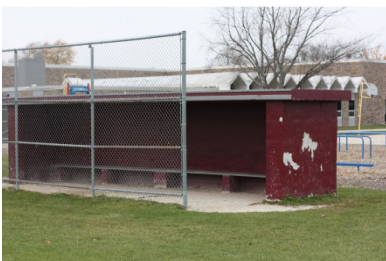
Chipped paint at dugout

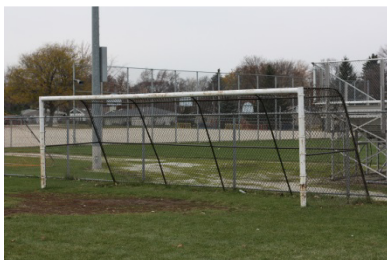
Rusted soccer goal

- Current Condition – good
- The building has play fields on north and west sides of the property all in good condition.
- The tennis courts are in good condition.
- The baseball field is in good condition.
  - The dugouts walls have areas where the paint has fallen off.
- The soccer fields are in good condition.
  - Some goals have areas of rust.
- A storage shed is located on the west end of the property.
  - The roof of the shed is missing roof shingles.
- The fences for field events have areas of damage and rust.
- The practice goal posts have areas of rust.
- On the east side of the school some areas of grading are pitched back towards the building.
- The competition football field and track complex are in good condition.
  - The Field goal posts have areas of rust.

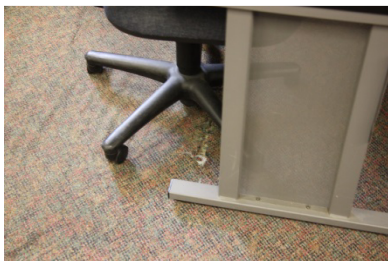
Torn and wrinkled carpet

- Expected life span - 20 years
- Current Condition – good to poor
- Carpet – There are limited amounts of carpet in the building; primarily in the computer labs and library, in poor condition.
  - There are areas of torn and wrinkled carpet.
  - The carpet finish is outdated.
- VCT (Vinyl Composition Tile) – The VCT is in good condition.
- Wall base is in good condition.

1. Continue annual maintenance for VCT flooring.
2. Replace carpet in computer labs and library.

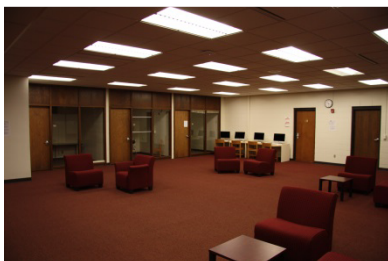
Carpet in library

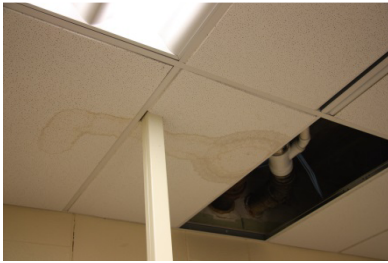
Stained / damaged ceiling tile

- Expected life span 15 years; replaced in 2007
- Current Condition – good
- Acoustical ceilings are generally in good shape with few areas of water-damaged or discolored tile.
  - Acoustical lay-in ceilings have tendency to sag over time and discolor.
  - Ceiling grid discolors as well.
- There were a few instances where ceiling tiles were removed and never replaced.
- When mechanical systems above ceilings are renovated, it is customary to remove and replace the entire ceiling at that time because it is less costly to remove and reinstall the same ceiling.

1. Replace acoustical lay-in ceiling tile where damaged or water-stained.

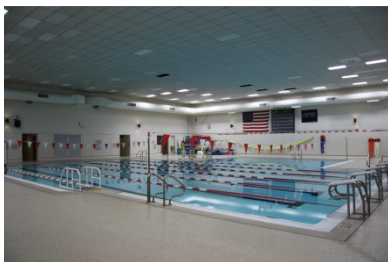
Pool

- Current Condition – fair
  - Flooring – fair condition
    - There are cracked tiles around the pool vessel.
    - Tile patching has been done with mismatched tiles.
  - Ceiling – fair condition
    - There were missing ceiling tiles.
    - The tiles are a mismatched of new and old, newer tiles are white older tiles are stained.
  - Bleachers – poor condition
    - Bleachers are aged and at the end of their life expectancy.

1. Consider replacing ceiling tiles.
2. Repair cracked floor tiles.
3. Consider retiling pool room floor.
4. Replace bleachers.
5. See Section 3 – Educational Adequacy Assessment for additional recommendations.

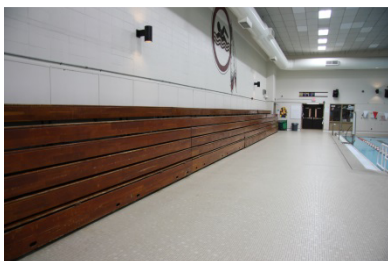
Pool bleachers

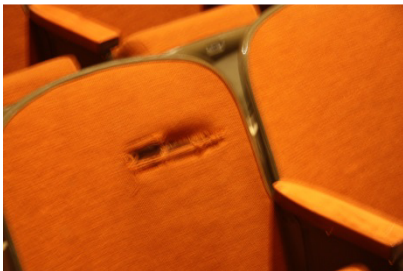
- Current Condition – fair to poor
- Flooring – fair condition
  - The carpet is worn and outdated.
- Ceiling – good
- Seating – poor
  - The fabric on some chairs is worn or torn.
  - The fabric is outdated.

Auditorium seating

1. Consider replacing carpet.
2. Replace or refinish auditorium seating.
3. See Section 3 – Educational Adequacy Assessment for additional recommendations.

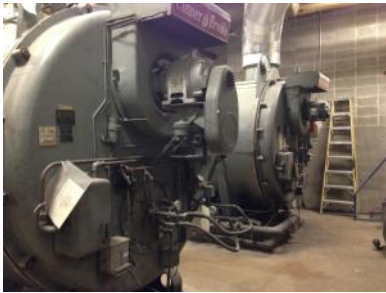
*Hot Water Boilers*

- The boiler plants are in good condition. With recommended maintenance, the 2007 boilers should continue to serve the facility for approximately 15 more years. However, the 1969 boiler plant has well exceeded its ASHRAE service life expectancy of 25-30 years.
- Boiler water chemical systems are in place and are reported to be maintained.
- The hot water piping serving the original boiler system is approximately 44 years old. Typical service life of steel piping is approximately 50 years.
- Insulation at most piping is of adequate thickness.

1. Continue preventative maintenance on the systems.
2. Replace the 1969 boiler plant. The boilers are 44 years old and have exceeded their expected service life. Install new high efficiency boilers with a primary-secondary variable flow pumping system to optimize system efficiency.

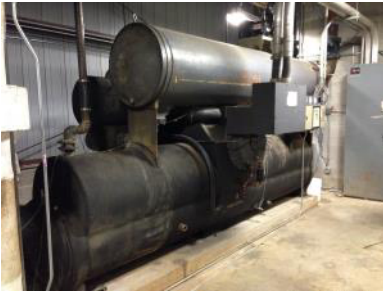
*Centrifugal chiller*

1. Replace the existing 1969 water-cooled chiller with a new high efficiency variable speed type unit. The existing chiller operates on an obsolete refrigerant and at much lower efficiencies than newer equipment with advanced technology.
2. The air handling equipment from 1969 has exceeded expected service life. Plans should be made for replacement within the next 3 years. When this equipment is replaced, additional attention should be given to the use of multiple smaller air handling systems to accommodate areas that are utilized at night.
3. Continue with the current maintenance program on the 2007 equipment.
