Menomonee Falls School District
Thomas Jefferson - Facility Study
Historical Plan

EUA No. 313258-01

BUILDING INSPECTION REPORT

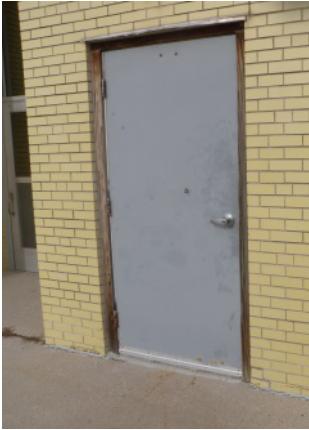
Rusted hollow metal door
frame

- Expected life span 20 years for steel, 30 years for aluminum/ FRP systems
- Current Condition - fair
- Steel doors have areas of rusting on the interior and exterior.
 - The lower portion of exterior steel door and frames are prone to rust and deterioration faster than aluminum is. Steel systems are not thermally broken causing condensation to form on the interior which results in steel corrosion.
 - Exterior hinges and locksets are prone to fail most and are the most costly to replace. Screw holes may strip out losing holding power, doors may drop and no longer align between lockset and frame latch, closers will fail due to over burden, and surface applied weather-stripping fails.
- A single set of FRP doors are in good condition.
- Aluminum doors are in good condition.
 - One of the doors was recently broken into and has been boarded up.

1. Replace all exterior steel doors and frames with new FRP (fiber reinforced plastic) doors in aluminum frames. Include replacement of all exterior door hardware.

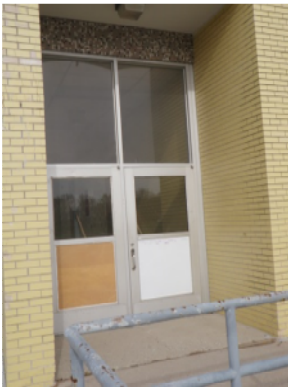
Broken glass in aluminum
frame

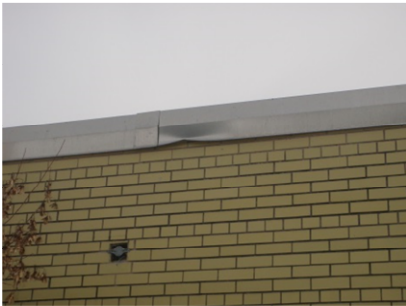
Dented fascia

- Life Expectancy – same as building
- Current Condition – good to fair
- There are areas of chipped painting on the building's entry soffits.
- A metal fascia is provided around the building. This is generally in good condition. There are a few areas of dented fascia.
- Mechanical louvers below windows are dented and damaged in areas.

1. Replace/repair any damaged mechanical louvers.
2. Repaint entrance soffits.
3. As roof replacements are required, replace metal fascia.
4. Repaint all concrete retaining walls at lower level exits.

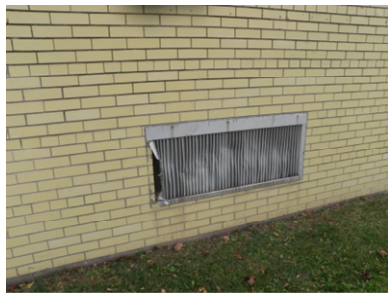
Damaged mechanical louver

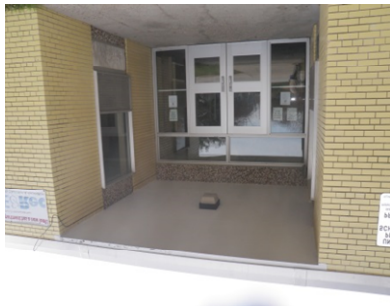
Entry soffit

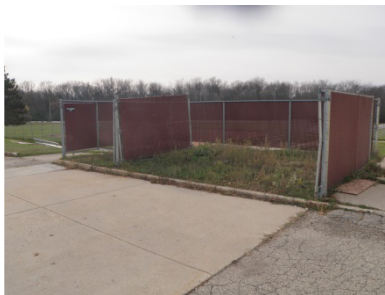
Trash enclosure

- Concrete and asphalt were reviewed independently. See appendix for reference reports.
- Grounds are well maintained.
- Trash enclosure is old and failing.
- Playground spaces appear to be in good condition, despite the lack of use the past few years.
- Playing fields for soccer, athletics and phy ed appear to be in good condition.
- There is no outside storage for lawn or grounds equipment.

1. Replace/repair trash enclosure doors.
2. Repaint all exterior metal (stair handrails).
 - a. Consider replacing any non-code complaint exterior railings.

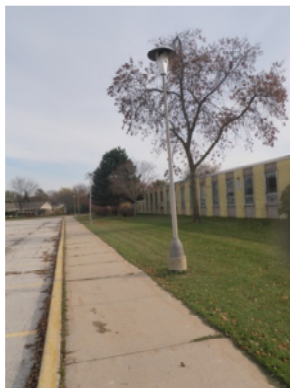
Damaged light pole

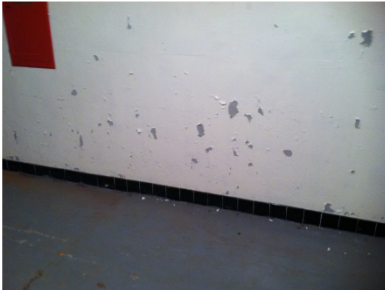
Wall in need of painting

- Expected life span - 50 -100 years with periodic maintenance
- Current Condition - Good
- Most interior walls are concrete block and show no signs of cracks, fractures or failure.
- Paint is in fair condition.

1. If Thomas Jefferson becomes fully operational again, consider painting the entire building.

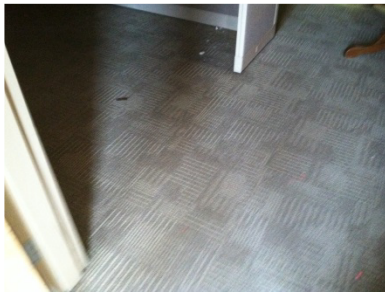
Carpet at office area

- Expected life span 20 years
- Current Condition - good
- Carpet – There are limited amounts of carpet in the building; primarily in offices.
 - Office carpet is in poor condition.
- VCT (Vinyl Composition Tile) – is in good to fair condition.
 - There are minimal areas of VCT used in the building.
- VAT (Vinyl Asbestos Tile) – is original to the building and in fair condition.
- Wall base is in fair condition.

1. Continue annual maintenance for small areas of VCT flooring.
2. Consider replacing all VAT with alternative material.
3. Replace all carpeting.

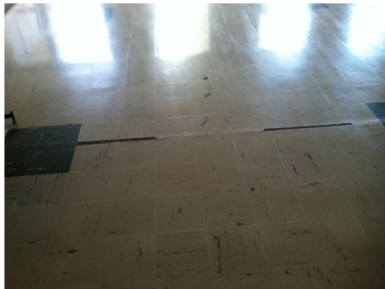
VAT (Vinyl asbestos tile)

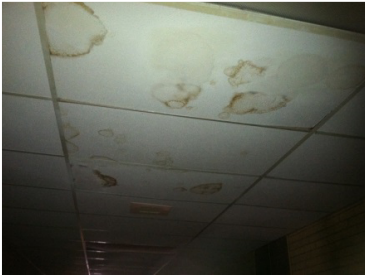
Stained / damaged ceiling tile

- Expected life span 15 years
- Current Condition – poor
- Acoustical ceilings are generally in poor shape with several areas of water-damaged and discolored tile and grid. There are areas of sagging tiles.
- Typical classrooms have adhered ceiling tiles. There are areas where the glue has failed and tiles have dropped. Tiles are also discolored.

1. Replace all acoustical lay-in ceiling tile and grid.
2. In rooms with adhered tiles, add dropped lay-in ceilings.

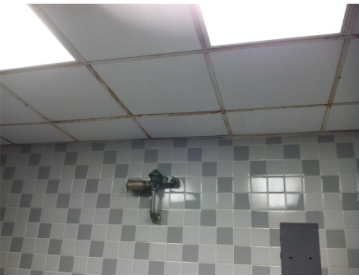
Rusted ceiling grid

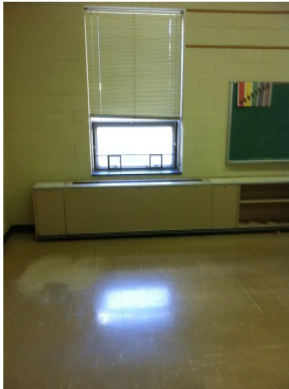
Typical classroom metal shelving

- Expected life span 20-25 years
- Current Condition - poor
- Typical classroom casework is limited to metal shelving that is integral with the room's unit ventilator.
- Science and Art areas include additional casework.
 - Some cabinets do not remain closed.
 - Plastic laminate is prone to chips, dents, and delamination. In wet areas, the backing plywood swells and causes adhesive to let go.
 - Steel drawer slides experience ball bearing slide failures, friction and worn surfaces. Hinges lose their loading ability over time due to door weight, pressure applied when opened by hanging on them, frequent open /close and poor adjustment.
- Sink / faucet – see plumbing report.
- Corridor lockers are in good to fair condition.

1. Replace casework in typical classrooms.
2. Replace Art casework with more durable countertops and cabinets.
3. Paint corridor lockers.
4. Replace blinds/roller shades in building.

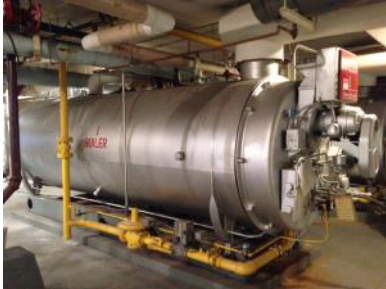
- The boiler plant is in relatively good condition but the boilers have exceeded their expected service life of approximately 30 years.
- Only one system pump remains operational. The stand-by pump currently has a cracked volute. The motor has been saved as a backup in case the main pump motor fails.
- Boiler water chemical systems are in place and are reported to be maintained.
- Insulation at most piping is of adequate thickness.
- Thermometers and gauges are present and appear to be working at all locations.
- Piping is adequately supported where observed.

Hot Water Boilers

1. If the building is to put back on line in the school system, the boiler plant should be replaced with a high efficiency boiler plant with primary-secondary variable flow pumping.

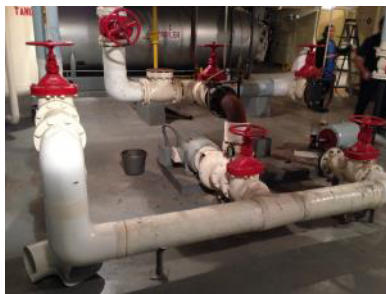
Hot Water Pumps

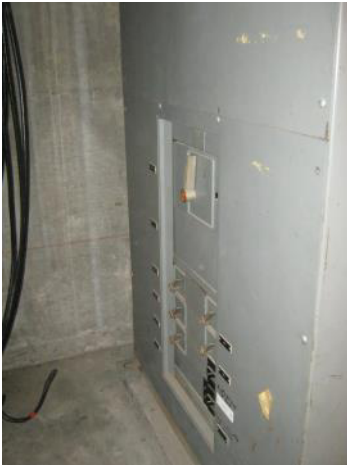
Service Panel

- The facility is fed with two (2) 12 kV unit substations, each with a 300 kVA transformer. Each substation has a 1,000 amp 208Y/120 volt 3 phase, 4 wire distribution panel. One distribution panel is a Federal Pacific the other is a newer Square D. The service age is dated to the original construction of the 1961 building.
- No surge suppression device was present on the main service gear.

1. The unit sub-stations are approximately 50 years old and are nearing the end of their useful lifespans. The unit sub-stations should be considered for a maintenance upgrade/replacement. The unit substation should be replaced with a new electric service with a utility owned transformer. A new service distribution panel should be installed at that time also as part of the service upgrade.
2. We do recommend all electric services be provided with surge devices.
3. Add phase monitoring relays to service for electrical system protection.

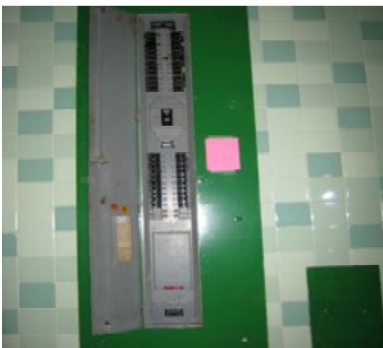
Branch Panel

- Most of the branch panels in the facility are old Federal Pacific type.
- There are approximately 20 existing panels that are over 50 years old and should be scheduled for replacement. Replace feeder wires also.
- There are newer Square D NQ type panels for computer circuits.

1. Keep existing new QO panels in place and add additional circuits if required.
2. Replace existing Federal Pacific panels.
3. Replace all old feeder wires.

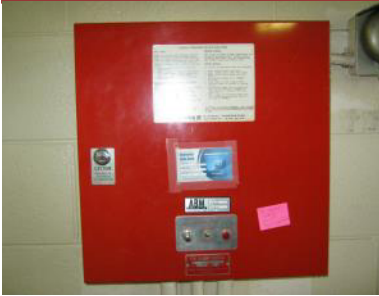
Fire Alarm Control Panel

- The fire alarm system is an old 120 volt Simplex system that is original to the building. There are horns in the corridors and manual pull stations near the exit doors. The fire alarm system 50 years old and is obsolete.

1. Provide new Simplex addressable fire alarm system.

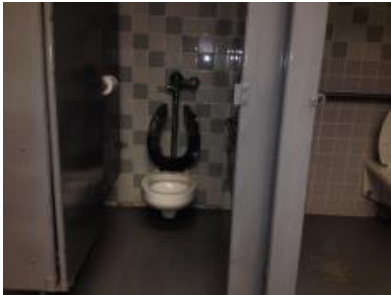
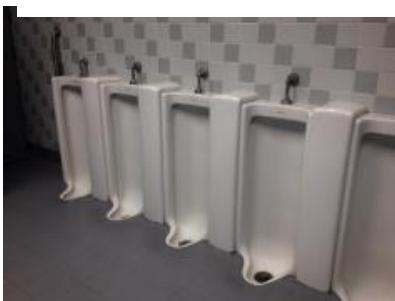
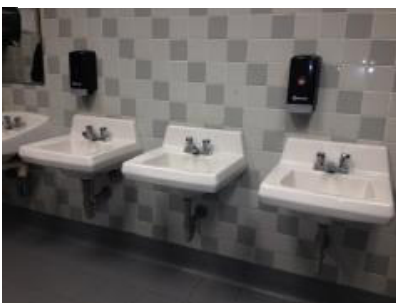
Typical Water Closet

Typical Floor-Mount Urinal

Typical Wall-Hung Lavatory

- Toilet rooms located in the lower level are in poor condition. These fixtures are original to the building and have not been maintained or used since the building was closed to students in 2008.
- Toilet rooms located in the lower level are in poor condition. Fixtures appear to be original to the building.
- Toilet rooms located on the first floor are in poor condition. Water closets and urinals are original to the building. Lavatories appear to have been replaced at some time but are at best in fair condition.

1. All toilet room fixtures would need to be replaced and the rooms would need to be renovated to comply with current ADA requirements.

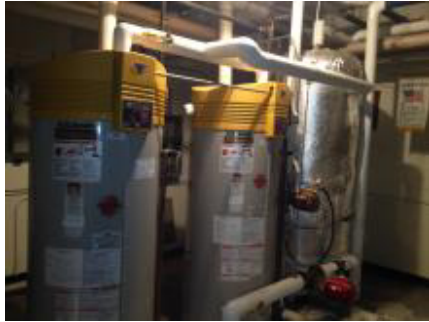
Domestic Water Heater

- The existing domestic water heating system consists of two (2) sealed combustion domestic water heaters and a storage tank. The system appears to be significantly over sized for the actual building demand. The water heater has approximately 8 years of useful life left.
- The water heaters and storage tank are in fair condition.
- An 80 gallon gravity-vented, gas-fired water heater was provided to supply domestic hot water during the summer months. This heater is no longer in use.
- New duplex sewage ejector pumps were installed recently. The pumps discharge the majority of the sanitary for the building. The pumps are in excellent condition.
- Water softening equipment is located in the lower level boiler room. The equipment appears to be in good condition however is no longer required because the school is now on city water.

1. Schedule the water heating system for replacement. The water heaters should be resized to accommodate the actual hot water demand for the building.
2. Provide continual maintenance on the existing sewage ejector.
3. Remove the existing 80 gallon water heater.
4. Remove obsolete water softening equipment.

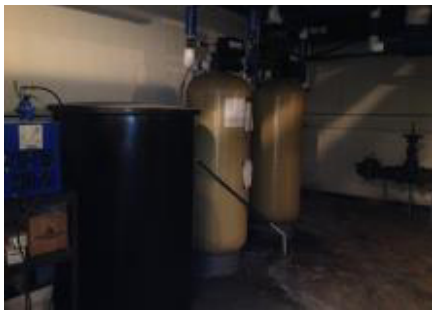
Water Softening Equipment

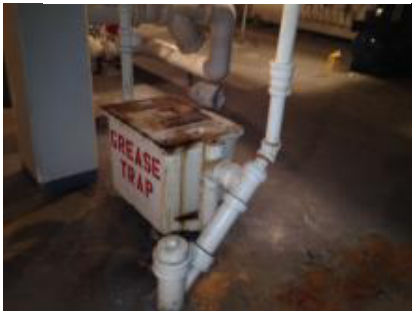
Grease Trap 1

- The sanitary waste and vent piping is a mixture of cast-iron, galvanized and schedule 40 PVC. Schedule 40 PVC waste and vent piping was used to repair piping failures.
- The primary piping system is original and is in poor condition.
- Two (2) interior grease interceptors are located in the lower level below the kitchen. Both interceptors are old and appear to be in poor condition.

1. Replace the existing grease interceptors.
2. Replace all interior sanitary waste and vent piping.
3. We recommend that a building of this age video inspect the interior sewers below the floor to determine the internal condition of the piping.

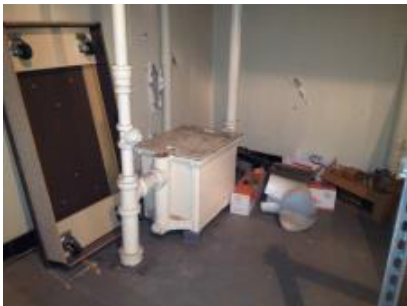
Grease Trap 2

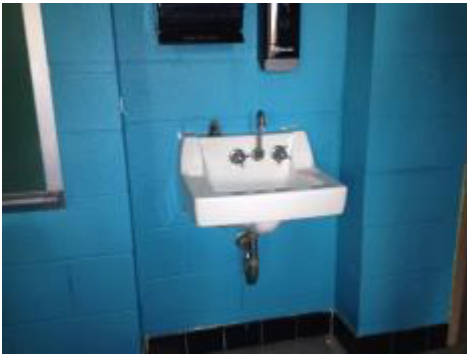
Typical Classroom Sink

- Classroom fixtures are original to the building and are in poor condition. None of the fixtures are ADA compliant per today's requirements.

1. All classroom fixtures should be replaced.

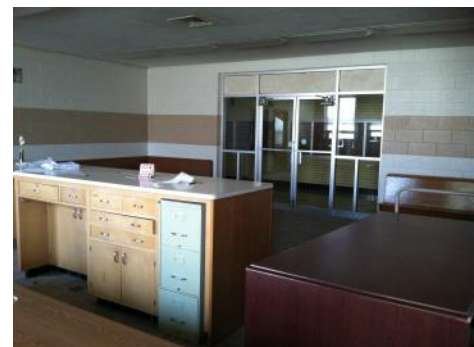
ITEM	ADA REFERENCE
1.	Main Entrance is accessible.	402, 404
2.	Classroom doors are typically accessible. Doors in the administrative suite are generally not accessible.	404
3.	Main Office reception desk does not meet the requirements for accessibility.	308
RECOMMENDATION:		
1. A service counter, maximum 34” above the floor is required for accessibility. Modify the existing reception desk. 2. Provide accessible door hardware.

Main office service counter is not ADA accessible

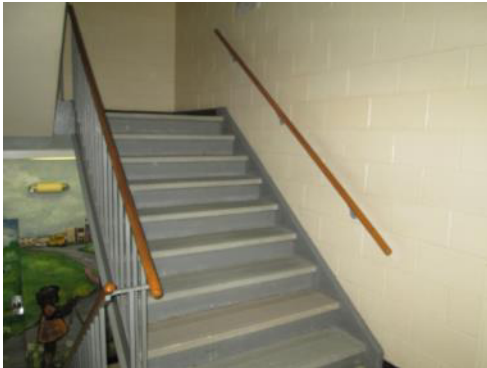
ITEM	ADA REFERENCE
1.	Stair handrails do not have compliant extensions.	505
RECOMMENDATION: 1. None.

Handrail extensions

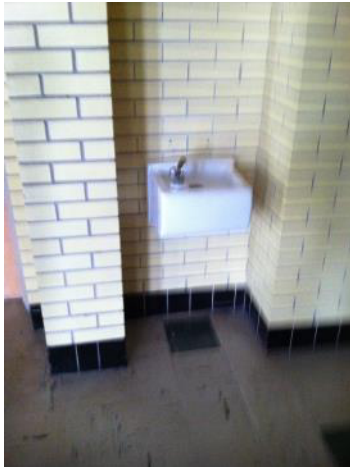
ITEM	ADA REFERENCE
1.	Drinking fountains are not accessible.	602
RECOMMENDATION: 1. Replace drinking fountains with ADA-compliant models.

Drinking fountain
