HISTORIC PLAN, FLOOR PLANS, AERIAL PHOTOS

Menomonee Falls School District Community Center - Facility Study

BUILDING INSPECTION REPORT

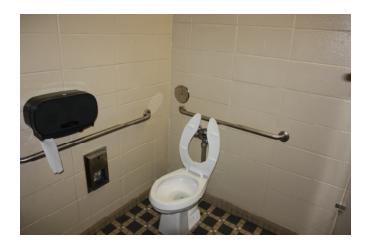
ITEM	ADA
		REFERENCE
1.	All toilet facilities appear to meet accessibility requirements	603
REC	OMMENDATION:	
1.	None.
