eppstein uhen : architects
EUA No. 313258-01

BUILDING INSPECTION REPORT

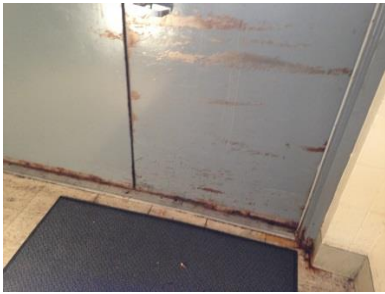
Dented and rusted steel door

- Expected life span 20 years for steel, 30 years for aluminum/ FRP systems
- Current Condition –Good to poor
- Around half of the exterior doors and frames are aluminum and in good condition.
 - The aluminum doors to the restrooms on the first floor and the door into the cafeteria in the basement are in poor condition.
 - The glass has been broken and the doors have been boarded up.
- There are steel doors and frames in poor condition.
- All Steel exterior doors showed signs of damage. Dings, scratches and dents in steel will allow rust to begin faster and corrode easier than aluminum.
- Some steel doors have areas of rusting on the interior and exterior. The lower portion of exterior steel door and frames are prone to rust and deterioration faster than aluminum is. Steel systems are not thermally broken causing condensation to form on the interior which results in steel corrosion.

1. Replace all exterior steel doors and frames with new FRP (fiber reinforced plastic) doors in aluminum frames.
 - Aluminum door and frame systems have internal gasketing less prone to abuse, will not rust or corrode, have improved screw holding power, can be welded to keep doors straight and will not require painting.
2. Replace all broken and boarded up aluminum doors.

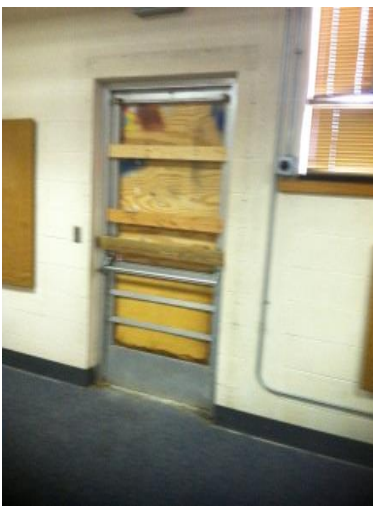
Boarded up aluminum door

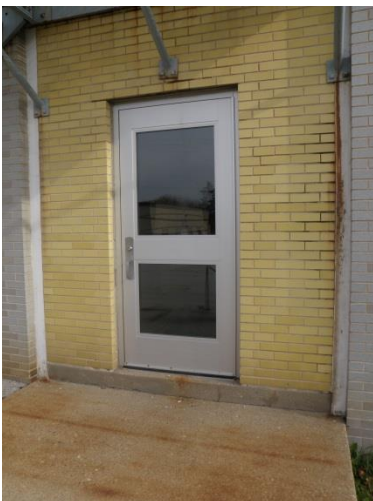
Typical aluminum door and frame

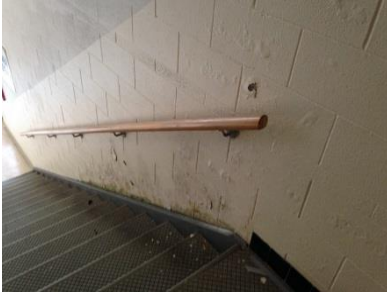
Southeast stairwell water damage

- The Southeast stairwell has signs of water infiltration causing rust damage to stair stringer.
- Paint is in poor condition.
- Drywall walls shown signs of heavy abuse.

1. Investigate cause of water infiltration at Southeast stairwell.

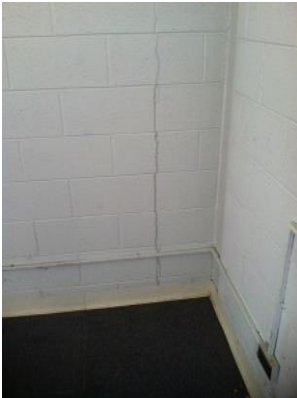
Crack in concrete blocks

- Expected life span - 50 -100 years with periodic maintenance
- Current Condition - Fair
- Most interior walls are concrete block and there are areas of damaged and or cracked blocks.

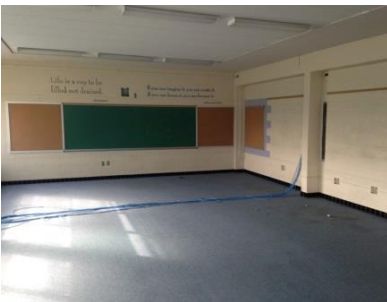
Typical classroom walls

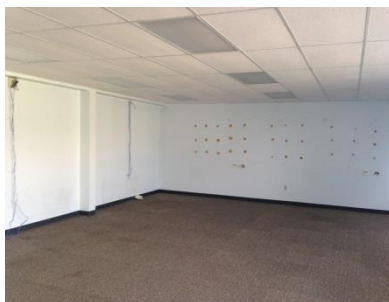
Typical drywall walls

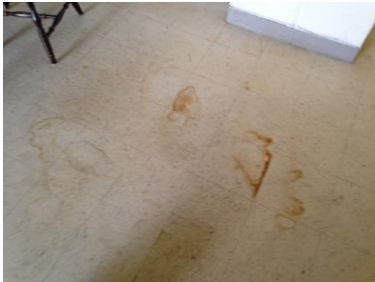
Stained VCT

- Expected life span 20 years
- Current Condition – Poor.
- Carpet – Many of the areas used when the building was a district office.
 - The carpet is in poor condition.
 - The carpet has areas of staining and tears, and in general is worn.
- VCT (Vinyl Composition Tile) –The VCT is in poor condition.
 - The majority of Classrooms have 9"x9" vct tiles, which are original to the building and, in poor condition.
 - 9"x9" tile have been known to contain asbestos.
 - There were many areas where the tiles were worn on the edges.
 - Damaged tiles have been repaired with non-matching tiles
- Wall base tile is in Poor condition.
 - There are areas of chipped and damaged tiles
 - There are also rooms where the tile base was completely removed.

1. Replace all carpet with either new carpet or VCT depending on function of room.
2. Replacing 9"x9" VCT thought the school.
3. Replacing wall base tile with rubber wall base.

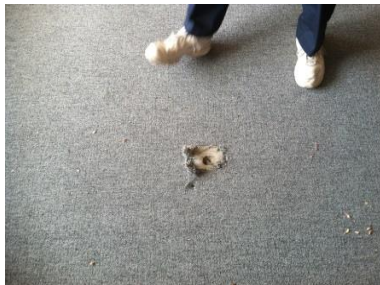
Hole in carpet

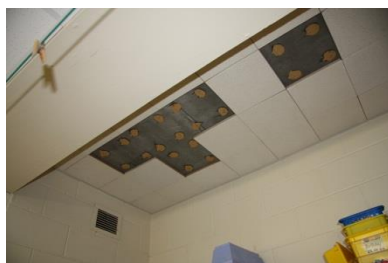
Acoustical ceiling tile

- Expected life span 15 years
- Current Condition – poor
- The majority of classrooms have adhered ceiling tiles in poor condition.
 - There are a few areas where the glue has failed and tiles have dropped.
 - Because of the age of the adhesives used they may contain asbestos.
- Some areas used when the building was the district office have 2'x4' Acoustical lay in ceilings that are in good condition.
 - Acoustical lay in ceilings have tendency to sag over time and discolor.
 - Ceiling grid discolors as well.
- The majority of hallways have 2'X4' Acoustical lay in ceiling tile in poor condition.

1. As adhered tiles fail, consider adding dropped lay-in ceilings.
2. Replace acoustical lay-in ceiling tile where damaged or water-stained.

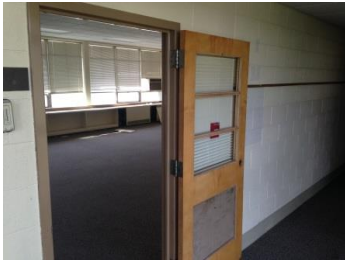
Typical classroom door

- Expected life span 40 years with periodic maintenance
- Current Condition – poor
- The majority of doors are in Poor condition
 - Many of the doors facing veneers have tears and chips.
 - Grilles in typical classroom doors are dented and damaged.
- most door knobs are original to the building and do not meet the accessibility requirements.
- Intruder lock function is not provided.
- Metal door frames can be repaired and painted. Door chips and scratches can be sanded, filled and restrained to revive an old door. Depending on severity of door or frame damage, it may be cost effective to replace the entire door and frame.

1. Replace or refinish doors in poor condition.
2. Paint all door frames.
3. Replace door hardware to be ADA compliant.

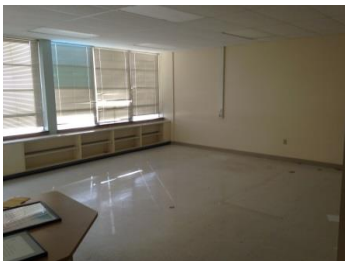
Typical classroom cubbies

- Expected life span 20-25 years
- Current Condition – poor
- Typical classroom casework is in poor condition
 - Casework limited to storage shelves at windows.
 - The metal shelves have areas of rust because of water infiltration from window system.
- Corridor/classroom cubbies not present within the classroom or hallways.

1. Provide student cubbies for storage either in the classrooms or hallway.
2. Replace metal storage shelving at windows.
3. Consider adding more casework to classrooms for teacher and student storage.

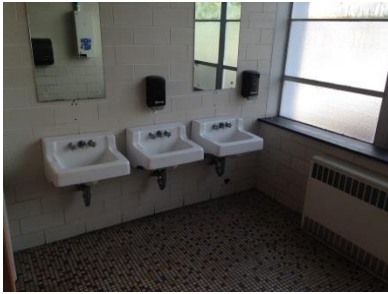
Restroom fixtures

- Current Condition - Poor
- Refer to ADA report for accessibility recommendations
- Finishes are worn and dated and in poor condition
 - Ceramic Floor and Wall Tile (expected life span 40 years) – poor, older grout holds bacteria.
 - Areas of tile have been repaired with mismatching tiles.
- Ceiling- (expected life span 15 years)
 - The restrooms have exposed structure ceilings.
- Toilet Partitions -(expected life span 15 years) poor
 - Rust is present at the base of many partition walls.
- Accessories – (expected life span 8-10 years) fair
- The central restrooms on the first floor has been stripped of all fixtures and converted into a storage room

1. All restrooms: Remove and replace all finishes: ceilings and wall and floor tile. Replace toilet partitions with anti-graffiti plastic type. Paint all walls that are not tiled. Some restrooms may need to be reconfigured due to accessibility requirements.
2. Restrooms converted to storage would need to be returned to a functional restroom if building was to be operational again.
3. Refer to MEP reports for fixture, ventilation and lighting recommendations.

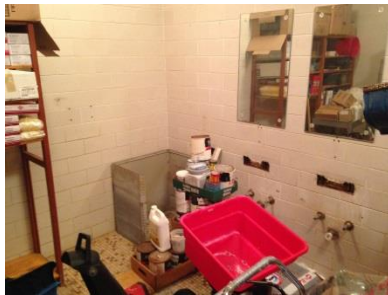
Restroom used for storage

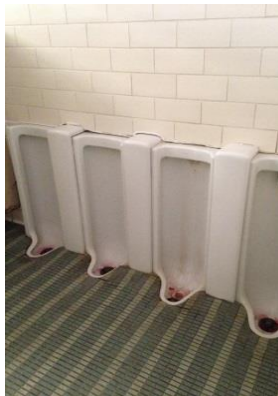
Urinals in boy's restroom

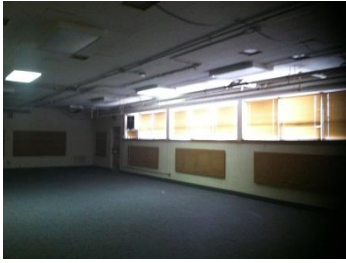
Cafeteria

- Current Condition – poor condition
- Flooring – poor condition.
 - The flooring in the cafeteria is carpet in poor condition.
- Ceiling Tile – Poor condition.
 - The ceiling is adhered ceiling tiles, and many tiles have fallen.
 - Mold was present on the surface of some tiles.
- Wall Base – Poor condition
- Cafeteria in not furnished.
- Kitchen equipment has been removed from the site.

1. Provide Cafeteria furniture if the building is to be used for a school use.
2. Provide appropriate serving/cooking kitchen equipment.
3. Update wall base.
4. Paint walls.
5. Remove carpet and update flooring.
6. Remove mold on ceiling tiles.
7. Add lay-in ceiling.

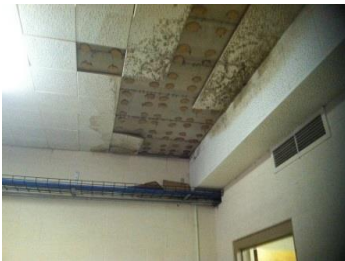
Missing ceiling tiles and Mold

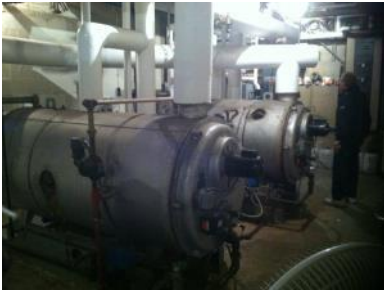
Steam Boilers

- The boiler plant is in satisfactory condition but the boilers have exceeded their expected service life of approximately 30 years.
- Insulation at most piping is of adequate thickness.
- Thermometers and gauges are present and appear to be working at all locations.
- Piping is reportedly in poor condition.

1. If the building is to put back on line in the school system, the boiler plant should be replaced with a high efficiency hot water boiler plant with primary-secondary variable flow pumping.

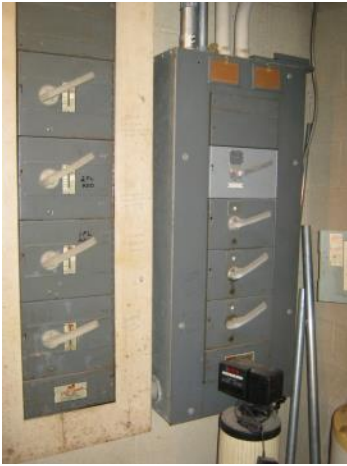
Service Panel

- The facility is fed with a 600 amp 120/240 volt single phase, 3 wire electric service. The main fused disconnect switch, CT cabinet and fused distribution panels are located in the basement mechanical room. The service age is dated to the original construction of the 1957 building.
- No surge suppression device was present on the main service gear.

1. The main distribution panels are approximately 55 years old and are at **the end of their useful lifespan. Provide new 208Y/120V three phase electric service. Provide new main electrical panel.**
2. We do recommend all electric services be provided with surge devices.
3. Add phase monitoring relays to service for electrical system protection.

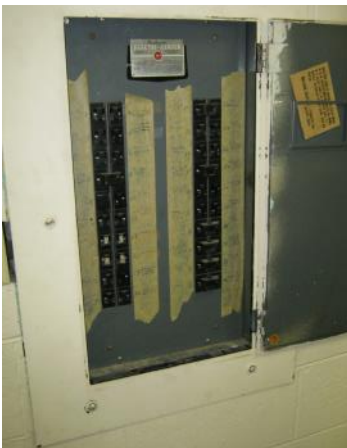
Branch Panel

- Most of the branch panels in the facility are old Pushmatic or ITE type.
- All the branch panels need to be replaced due to age.

1. Replace all existing branch panels.
2. Replace all old feeder wires.

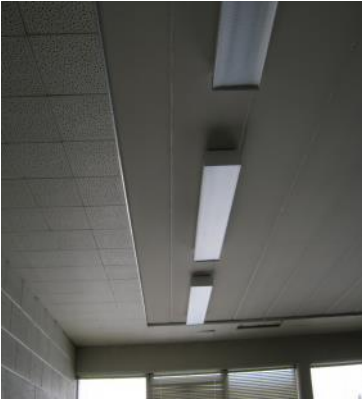
General Lighting

- In the corridors and remodeled offices the original fluorescent fixtures have been replaced with acrylic lens 2x4 fixtures with T8 lamps. Lighting motion sensors were not present in any areas. No day lighting sensors were present.
- The offices that have not been remodeled have surface wrap fixtures with T12 lamps that are controlled by one wall switch.
- The basement has a mix of surface modular and acrylic lens 2x4 fixtures with T12 lamps.

1. Replace all fixtures with T12 lamps with new acrylic lens fixtures that use T8 lamps and electronic ballasts.

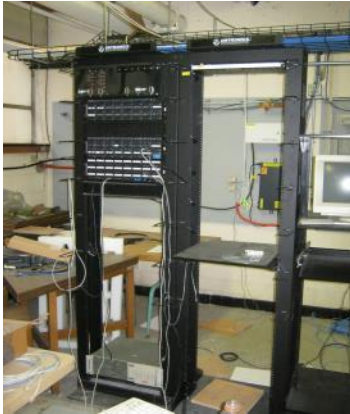
Data Rack

- Data cabling is provided to the office areas.
- Data cabling is CAT6.
- Cabling is routed to a main data rack. The main data rack is located in the basement.
- There is a PBX analog phone system.

1. New data drops can be added at any point. A new data rack may be required to accommodate any new rack mounted equipment.
2. Provide new Cisco VoIP phone system.
3. Provide proper telecom grounding system.

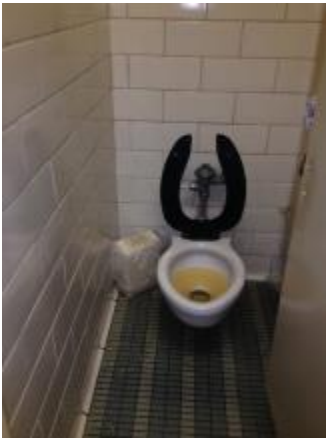
- Water closets, urinals and wall-hung lavatories are in poor condition. The majority of these fixtures are original to the building.
- Water closets and urinals are flush valve style fixtures. Urinals are operated on a timer. This style of fixture wastes a significant amount of water in a years' time.
- Lavatories are wall-hung and appear to be original to the building and are not ADA compliant. Minor modifications would be required to make these fixtures compliant.
- The main toilet room at the front entrance replaced the lavatory with Bradley wash fountain. This fixture is in good condition and appears to be operating well. It is assumed that this fixture was replaced in the last 5-7 years.
- The owner indicated a problem with the Sloan flush diaphragms valves. This may be contributed to the remaining galvanized water piping in the walls.

Water Closet

1. All toilet room fixtures need to be replaced and the rooms would need to be renovated to comply with current ADA requirements.

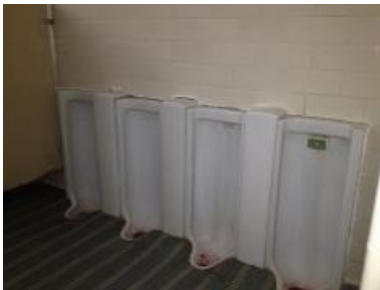
Urinals

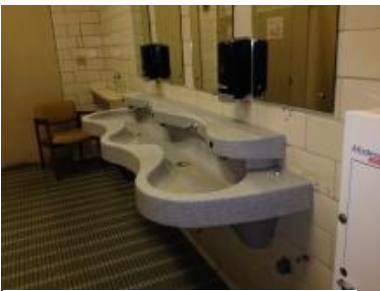
Wash Fountains

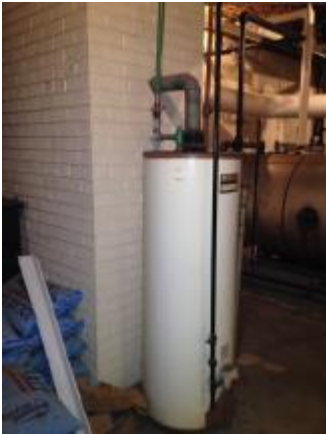
Gas-Fired Water Heater

- A small 40 gallon gas-fired water heater is located in the lower level mechanical room. It is unknown if this heater is operational.
- An electric water heater is located on the main floor adjacent to the toilet rooms. This water heater is in very good condition and is thought to supply hot water to the majority of the plumbing fixtures in the building.
- A small water softener is located in the lower level boiler room. This equipment provides water treatment for the boilers. The softener is in poor condition.

1. Replace both water heaters with one (1) new sealed combustion gas-fired water heater.
2. Replace water softener.

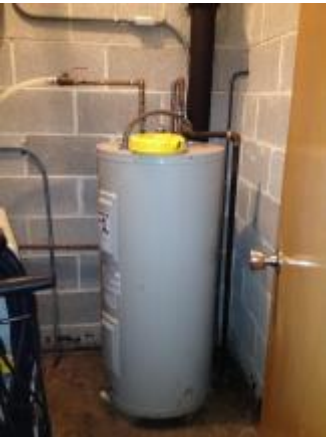
Electric Water Heater

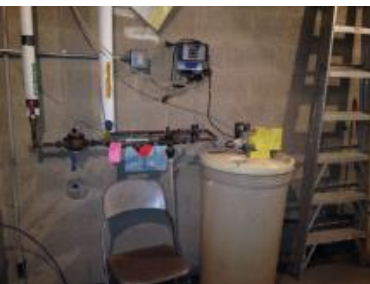
Water Softener

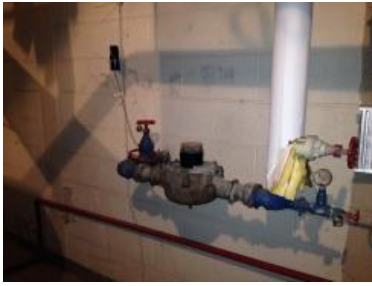
Water Service

- All water supply piping is galvanized piping. Copper piping is located in areas that have been repaired.
- Branch piping to fixtures remains galvanized.
- The building is supported by a 2" water service and 2" water meter. The water service and water meter appear to be properly sized for the building demand.
- Water pressure appears to be adequate throughout the building.

1. Galvanized water piping should be scheduled for replacement.

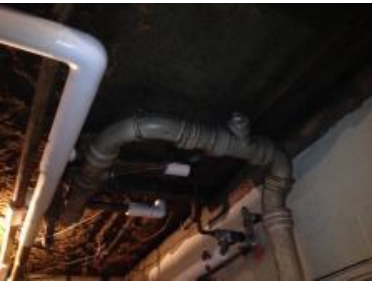
Sanitary Piping

- The existing sanitary waste and vent piping is a mixture of cast-iron, galvanized and schedule 40 PVC. Schedule 40 PVC waste and vent piping was used to repair piping failures.
- The owner indicated that the primary piping system is original and is in fair condition.

1. Continually monitor the existing sanitary sewers for problems.

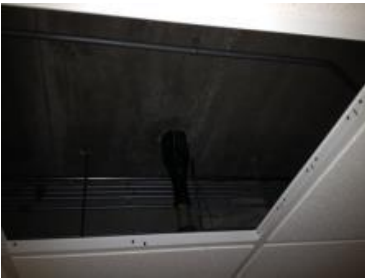
Vent

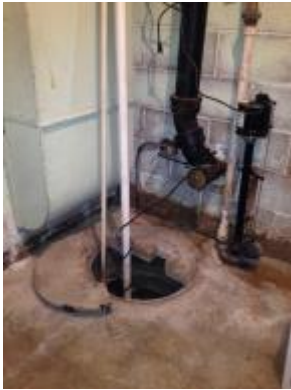
Clearwater Sump

- Piping materials for the storm system is cast iron. This piping system was also inspected and appeared to be in good condition.
- The lower level is provided with a drain tile system and Clearwater sumps. A sump pump is installed in the lower lever to discharge this storm water. The sump pumps do not have alarms or controls.
- Ceiling tiles throughout the building indicate roof leakage. It is unclear if this is the result of roof failure or piping failure. Further investigation is required.

1. Provide controls and alarms on all sump pumps.
2. Investigate roof leakage.

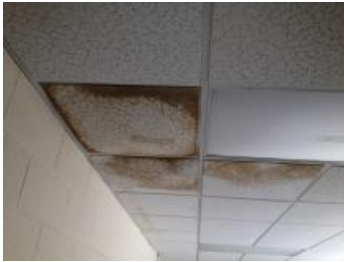
Ceiling tiles indicating water leaks

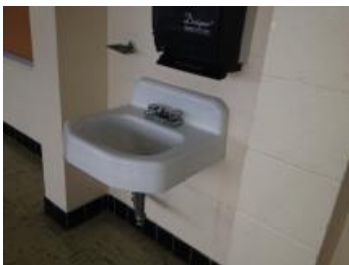
Classroom Sink

- Classroom fixtures are original to the building and are in poor condition. None of the fixtures are ADA compliant per today's requirements.
- Classroom sinks are primarily wall-hung lavatory style fixtures.
- The majority of this building is office space. Only the north wing has classrooms.

1. All classroom fixtures should be scheduled for replacement.
