The building is approximately 6,000 square feet and sits on 1.126 acres of land. The maintenance garage was built as a Village of Menomonee Falls building in 1968, with an addition in 1998.

BUILDING INSPECTION REPORT

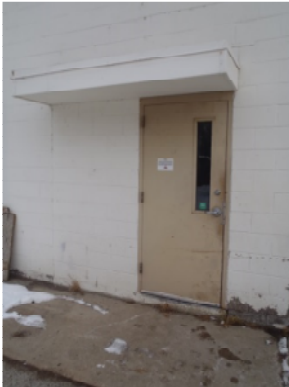
Rusted hollow metal door frame

- Expected life span 20 years for steel, 30 years for aluminum/ FRP systems
- Current Condition - fair
- Steel doors have areas of rusting on the interior and exterior. The lower portion of exterior steel door and frames are prone to rust and deterioration faster than aluminum is. Steel systems are not thermally broken causing condensation to form on the interior which results in steel corrosion.
 - Reports of exterior doors leaking.
 - Exterior hinges and locksets are prone to fail most and are the most costly to replace. Screw holes may strip out losing holding power, doors may drop and no longer align between lockset and frame latch, closers will fail due to over burden, and surface applied weather-stripping fails.
 - There are exterior doors in the gymnasium that do not fully function and open and close. This is a safety concern for emergency egress.

1. Replace all exterior steel doors and frames with new FRP (fiber reinforced plastic) doors in aluminum frames. Include replacement of all exterior door hardware.

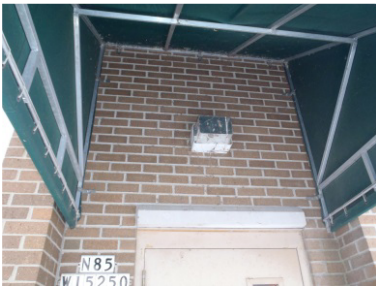
Canopy at main entrance

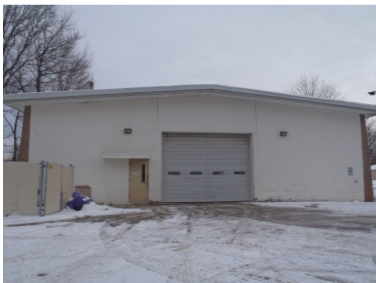
Garage door

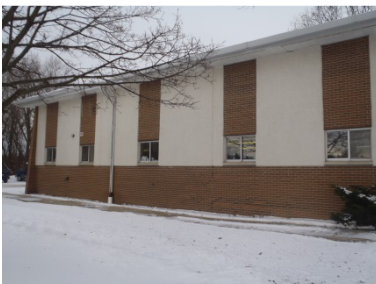
Metal fascia

- Life Expectancy – same as building
- Current Condition – good to fair
- A metal fascia is provided around the building. This is generally in good condition.

1. As roof requires replacing, replace fascia.

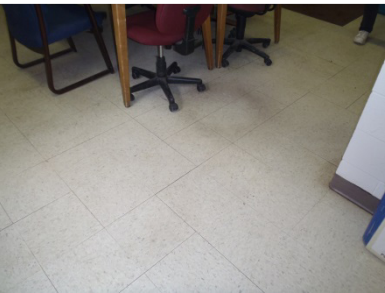
- Expected life span - 20 years
- Current Condition - fair
- VCT (Vinyl Composition Tile) – is dated and in fair condition, which is to be expected for a more industrial-use type of building.
 - There are areas of cracked, failed tile.
- Wall base is in fair condition.

VCT

1. Consider replacing VCT.

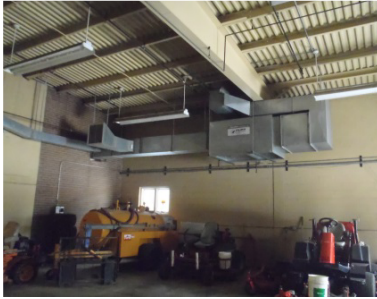
The maintenance building is served by various pieces of gas-fired heating equipment. The garage area is served by a gas-fired makeup air unit and gas-fired unit heaters which appear to be in satisfactory condition. While the exact age of the equipment is not known, the current condition suggests that another 5 years or so should be expected. The garage area also contains ceiling mounted desertification fans to assist with air movement. The office area is served by a Trane high efficiency furnace that is connected to a Trane air-cooled condensing unit for air conditioning and controlled by a digital programmable thermostat. The equipment is in satisfactory condition, but typical service life for this type of equipment is about 15 years.

Mechanical equipment

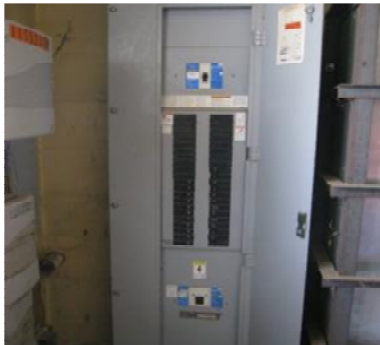
- The facility is fed with a 400 amp 120/240 volt single phase, 3 wire electric service. The main electrical panel has been recently upgraded and is located in the shop.
- No surge suppression device was present on the main service gear.

Service Panel

1. We do recommend all electric services be provided with surge devices.

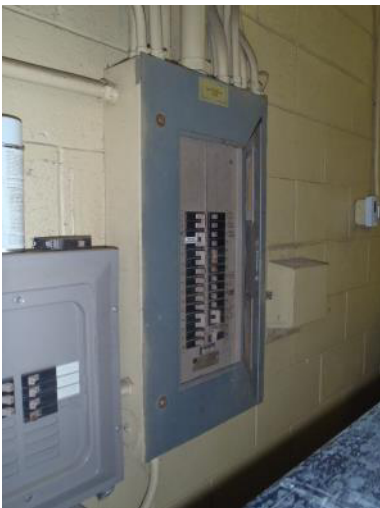
- Most of the branch panels in the facility are Cutler Hammer type.
- There is one existing panels that is over 30 years old and should be scheduled for replacement.

Branch Panel

1. Replace older electrical panel.

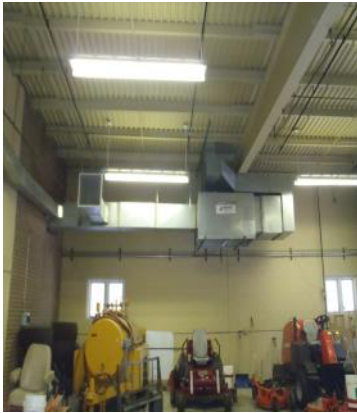
General Lighting

- The shop lighting is 2-lamp T12 industrial fixtures.
- The offices have compact fluorescent recessed downlights. The break room has 2-lamp surface wraps with T12 lamps. Lighting motion sensors were not present.

1. Replace all the T12 industrial fixtures with new T8 industrials that use electronic ballasts.
2. Replace all the T12 surface wrap fixtures with new T8 surface wrap fixtures that use electronic ballasts.

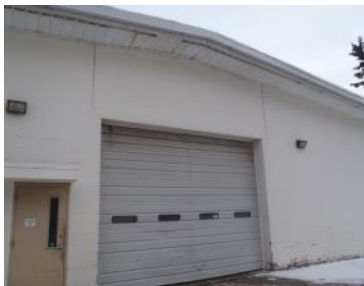
Exterior Lighting

- The majority of the outdoor lighting consists of wall-mounted fixtures with metal halide lamps.

1. We would recommend replacement of the existing exterior fixtures with new LED type to increase efficiency and lower maintenance cost.
2. As increased security is addressed, the district may consider adding security lighting around the perimeter of the facility.

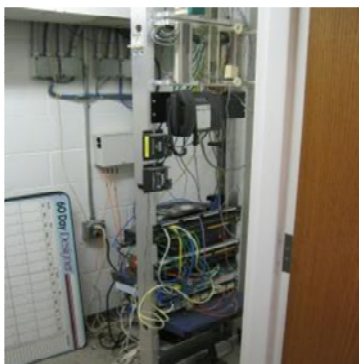
Data Rack

- Data cabling is provided to office areas.
- Data cabling is CAT6.
- Cabling is routed to a main data rack. The main data rack is located in the office.

1. New data drops can be added at any point. Another data patch panel may be required to accommodate any new cabling.
2. Provide upgrade to Cisco VoIP telephone system.
