Roof Survey Data

**Menomonee Falls, School District of
Ben Franklin Elementary School (342)
Roof Area Number: 01**

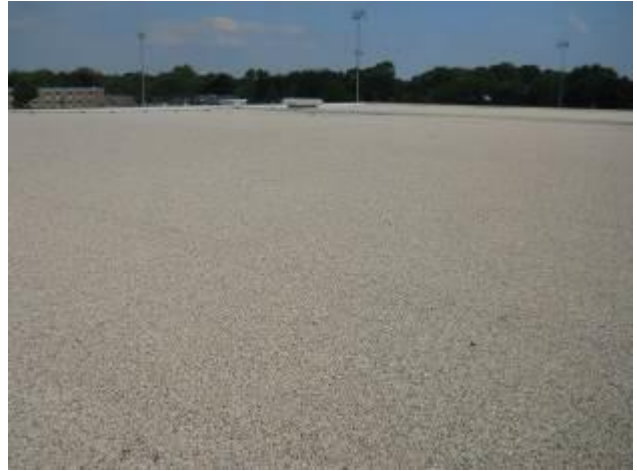
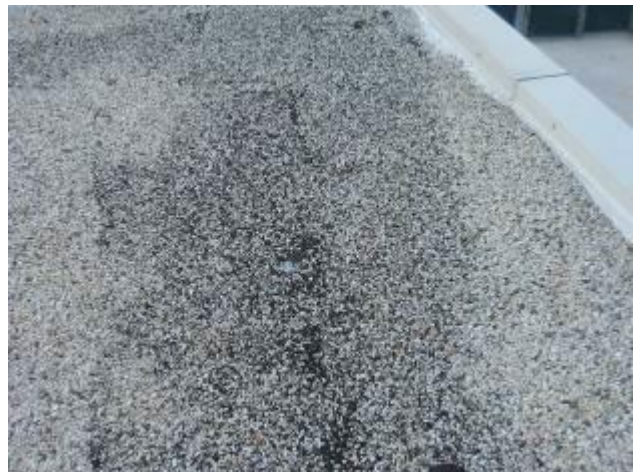
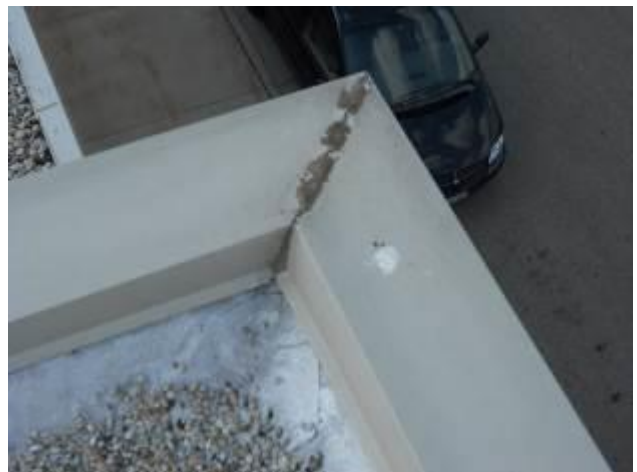
Roof Area 2

The roof membrane is in serviceable condition but we noted wind erosion in the southwest corner, sealant failure in the corners of the prefinished galvanized coping and the 4x4 wood blocks lack slip protection.

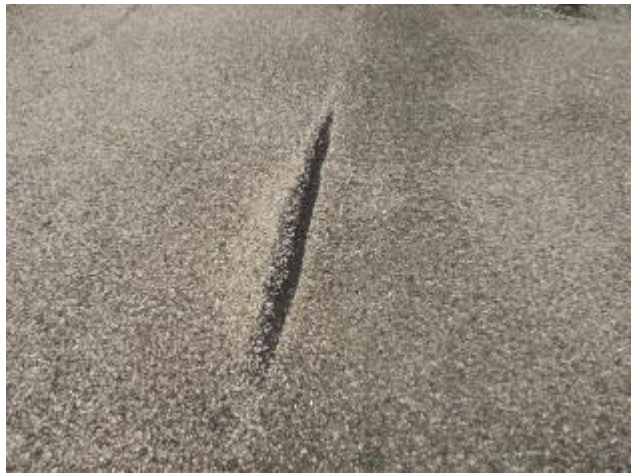
Roof Area 4

The roof membrane is in serviceable condition with failed sealant noted with construction joints along the counter flashing and of the masonry wall, a pipe vent missing a rain cap, blistering in the membrane and debris on the roof surface. Additionally, we noted two locations of spalled concrete in the wall panels and along the ladder rungs penetrating the wall system.

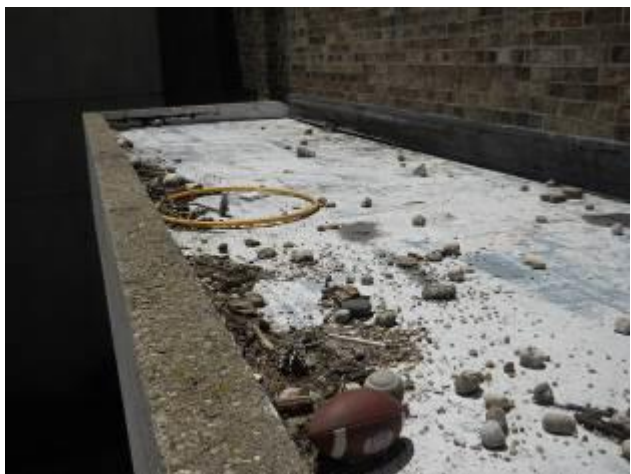
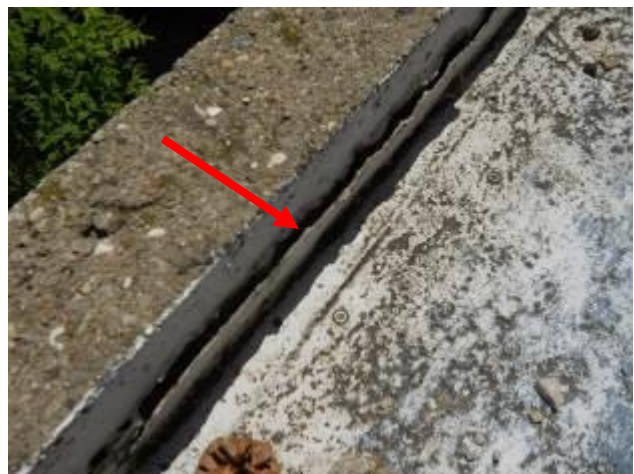
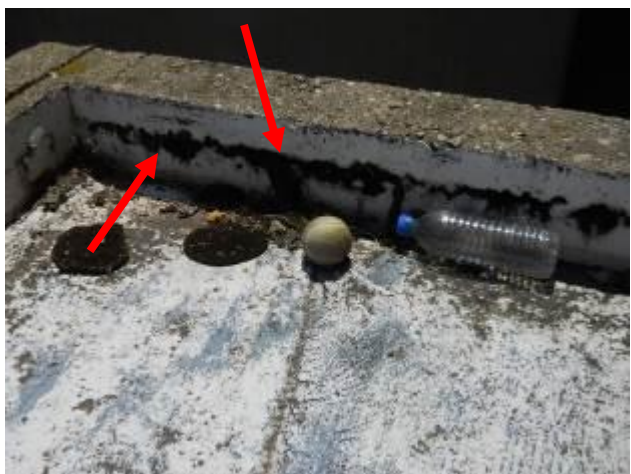
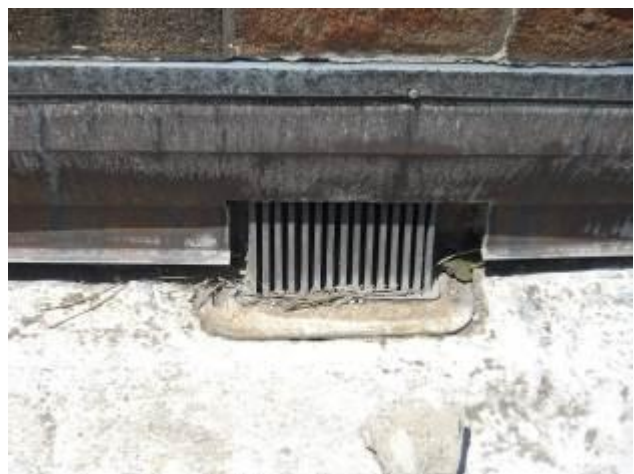
Roof Area 5

The liquid applied coating on top of the roof deck is in poor condition. We noted failed mortar joints within the adjacent masonry walls. Additionally we noted damage to the precast roof deck and debris on the surfacing.

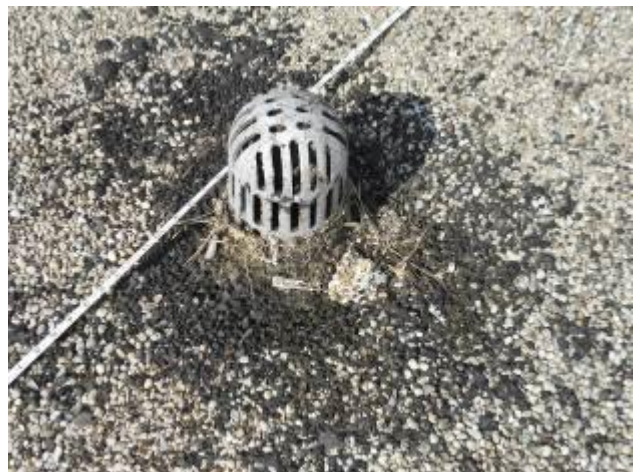
Roof Area 6

The roof membrane is in serviceable condition but we noted several open corner and base flashings along the perimeters of the roof system, failed sealant along the masonry wall, precast concrete walls and counter flashing. Debris was found throughout the surface of the roof and surrounding the drains.

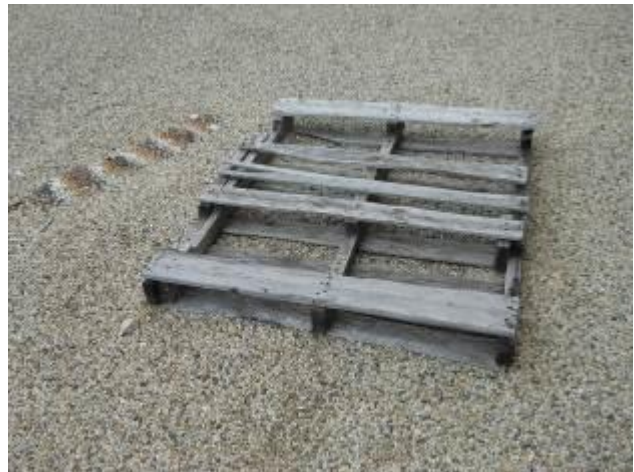
Roof Area 8

The roof membrane is in serviceable condition but we noted failed sealant along the counter flashings, a failed soil stack flashing, a damaged drain bonnet, and debris on the roof and failed mortar within the CMU wall adjacent to the roof area.

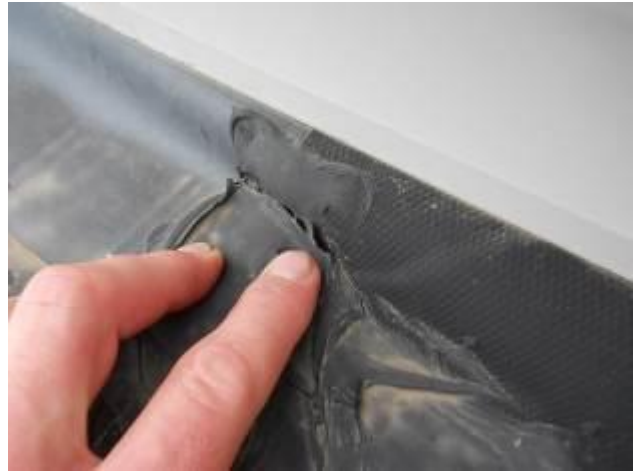
Roof Area 14

The roof membrane is in serviceable condition but we noted failed lap sealant applied along several of the corner flashings potentially allowing water to penetrate the flashings.

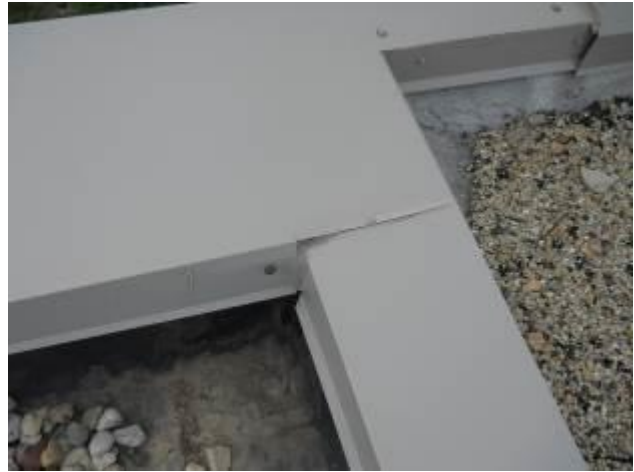
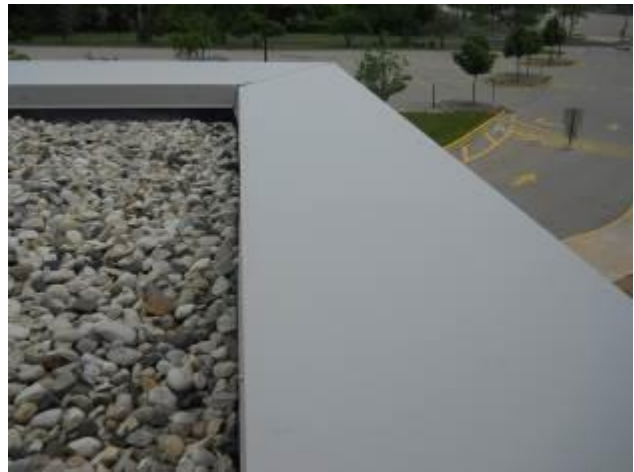
Roof Area 15

The stone ballasted EPDM single-ply roof system is in good condition. We noted a broken strainer on the plastic drain bonnet. No other deficiencies were noted during our survey.

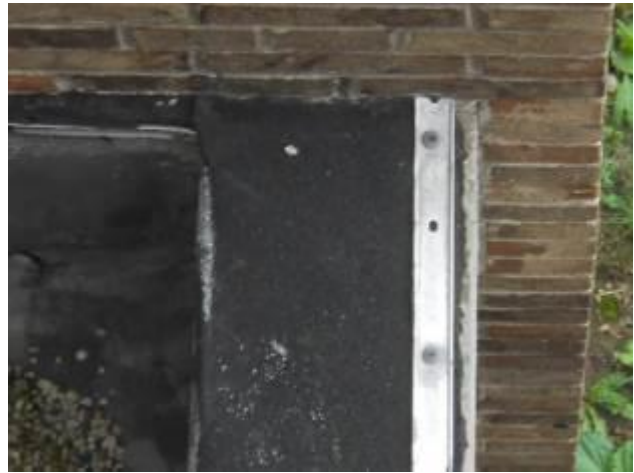
Roof Area 17

The roof system was not safely accessible during the time of our survey but was viewed from the distance of Roof Area 18. The roof membrane appeared to have been previously repaired around the drain and along the perimeter flashings.

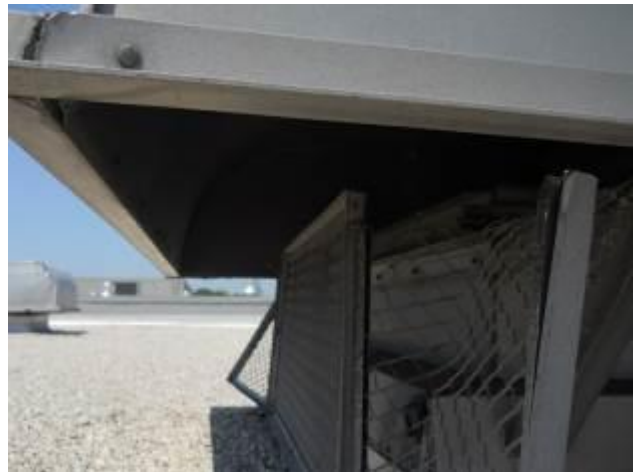
Roof Area 18

The roof membrane is in serviceable condition but we noted failed sealant along the perimeter and several damaged ventilation hoods.

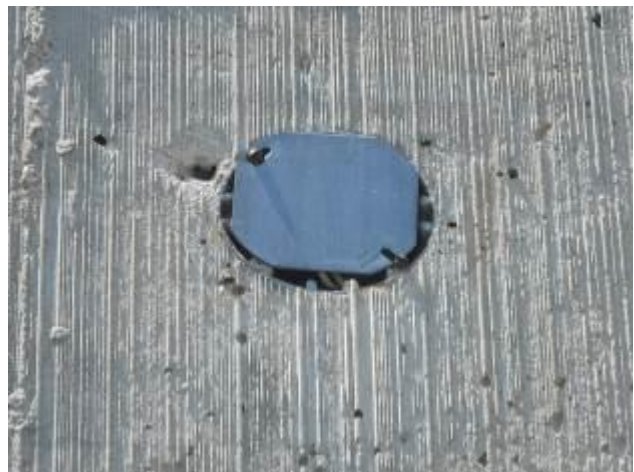
Roof Area 20

The roof membrane is in serviceable condition but we noted failed sealant along the perimeter counter flashings and masonry wall, wind erosion and debris on the roof surface. Additionally, an electrical box has been abandoned but not properly decommissioned, exposing the wires to water.

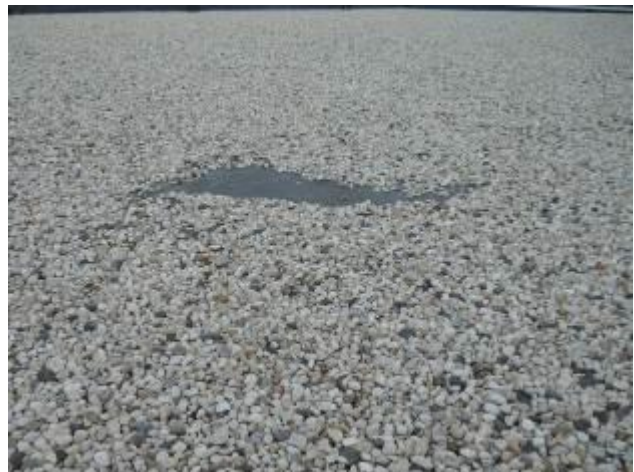
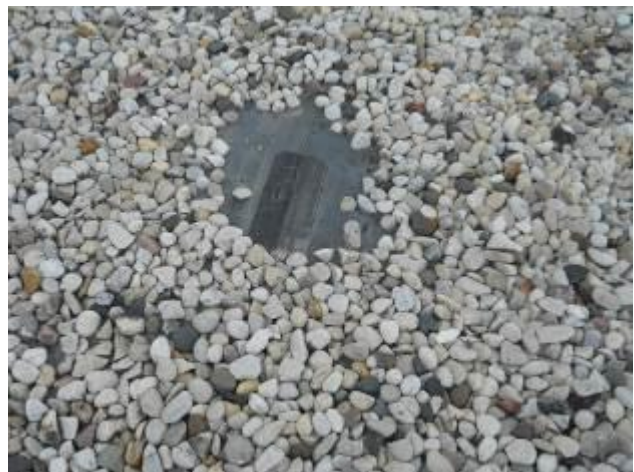
Roof Area 22

The roof membrane is in serviceable condition with minor locations of displaced ballast/windblown corners and debris on the roof membrane. We also noted a location which previously received repairs.

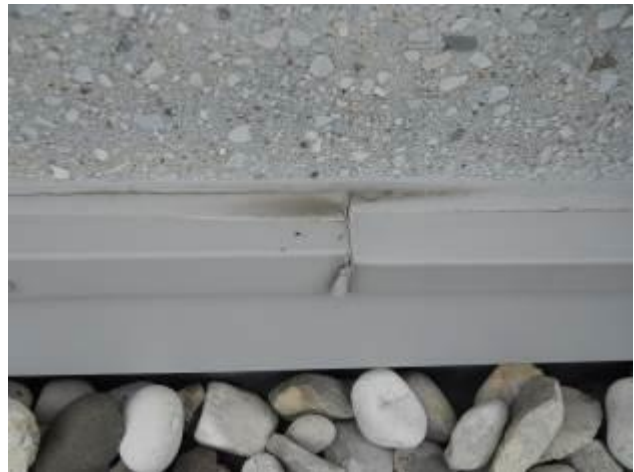
Roof Area 23

The roof membrane is in good condition but we noted failed sealant along the perimeter counter flashing.

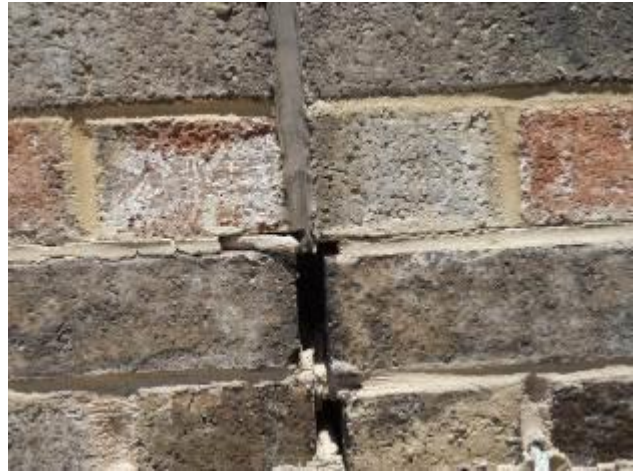
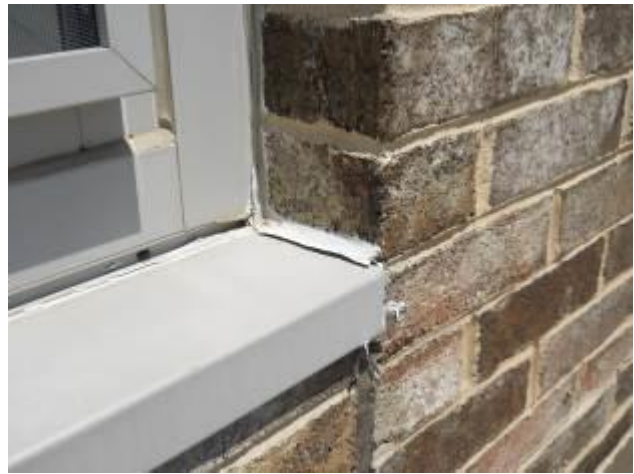
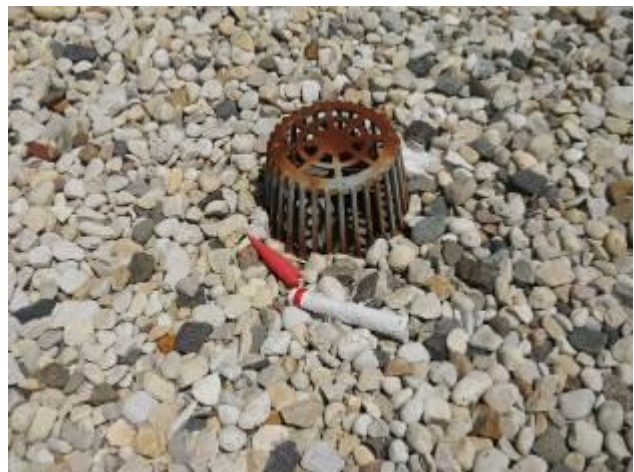
Roof Area 25

The roof membrane is in good condition however we noted failed sealant along the windows within the adjacent masonry wall, failed mortar joints and debris on the roof system.

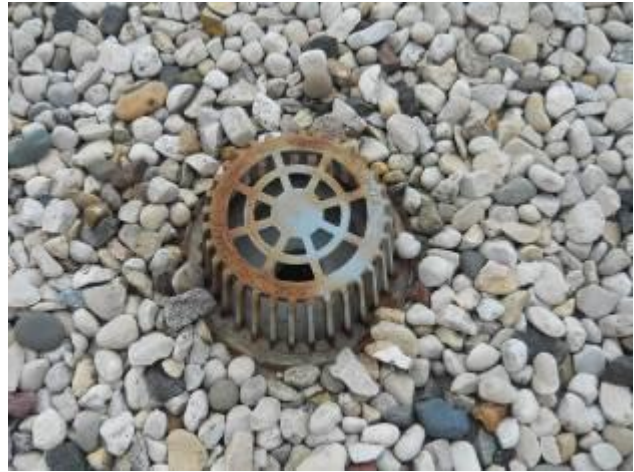
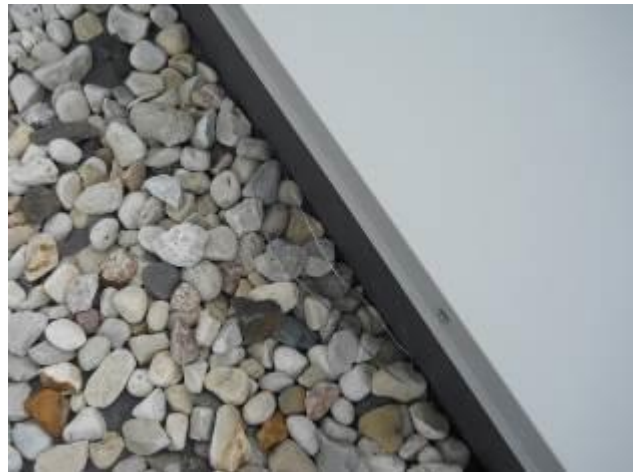
Roof Area 26

The roof membrane is in serviceable condition with isolated locations of debris and glass on the roof surface.

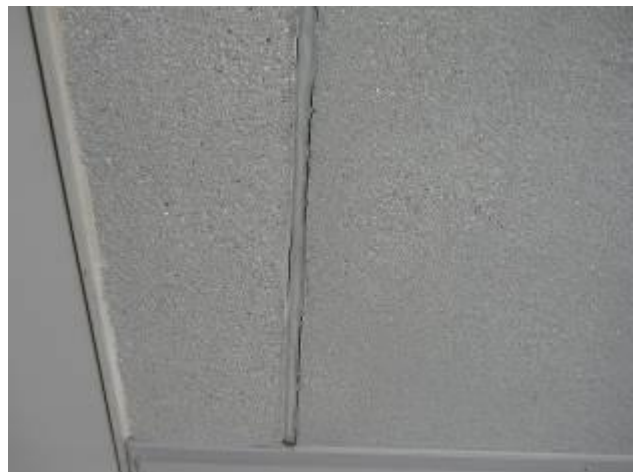
Roof Area 27

The roof membrane is in serviceable condition with areas of debris on the roof surface and displaced ballast. We also noted failed duct wrap around the HVAC duct work, deteriorated pitch pans, conduit pipe supports lack proper membrane protection and failed sealant in the construction joints of the precast wall panels.

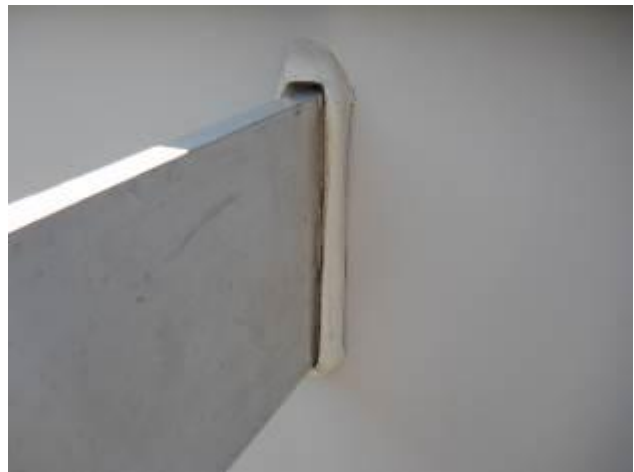
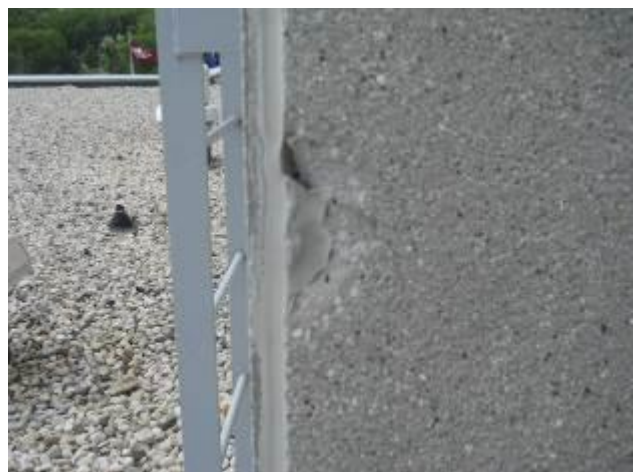
Roof Area 28

The roof membrane is in serviceable condition with minor shrinkage noted along the perimeter flashings and debris accumulation. We also noted failed sealant along the ladder supports, the lack of a rain cap on pipe vent and an area of precast concrete wall panel that is damaged.

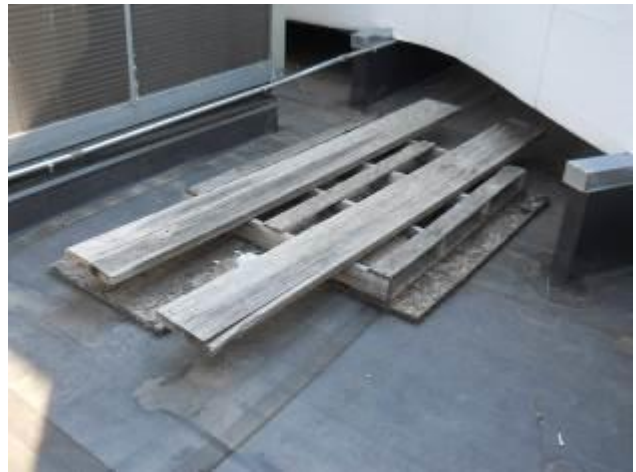
Roof Area 29

The roof membrane is in serviceable condition with several locations of fasteners backing out, membrane shrinkage, open corner flashings, debris on the roof surface and loose duct wrap.

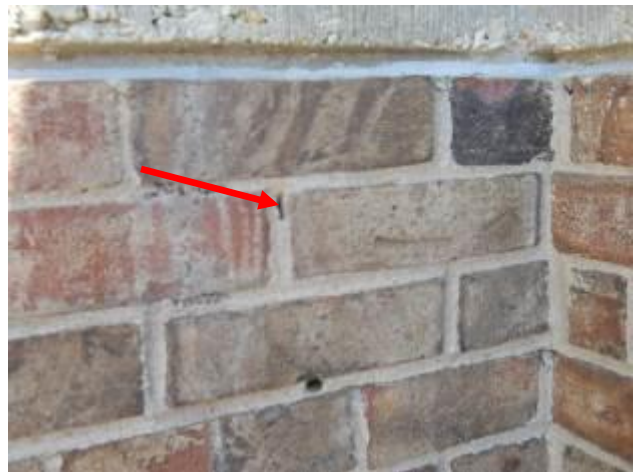
Roof Area 33

The roof membrane is in good condition with only an isolated area of construction debris on the membrane. Additionally, we noted failed sealant applied along the perimeter counter flashings and a failed mortar joint.

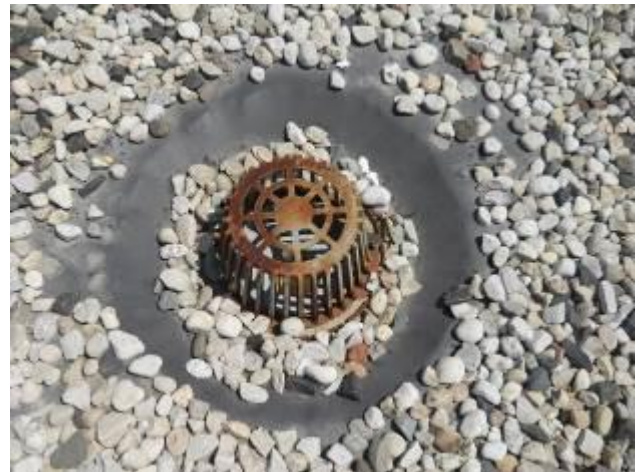
Roof Area 34

The roof system is in good condition with only minor accumulation of stone ballast around the sump pans of the internal roof drains.

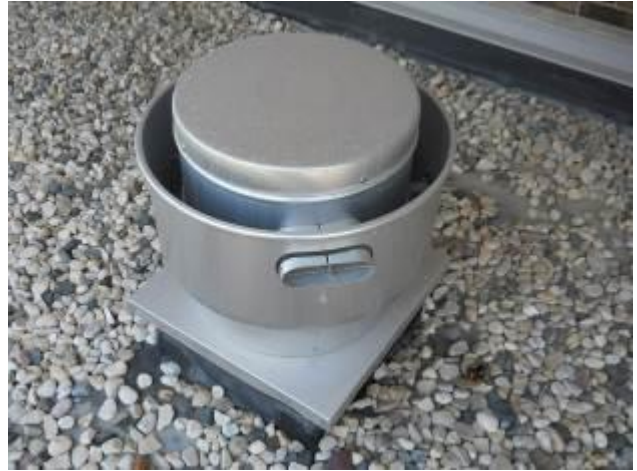
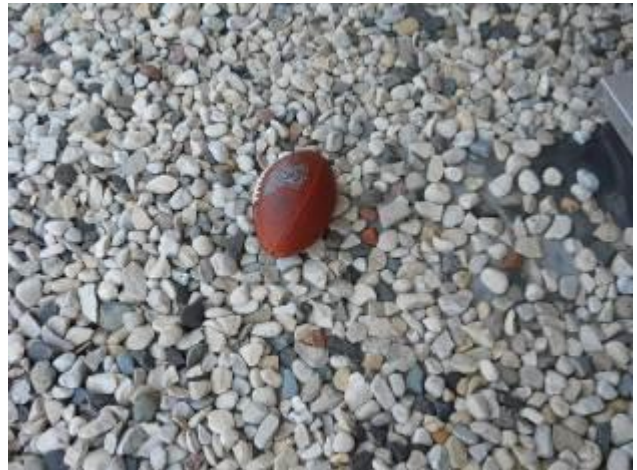
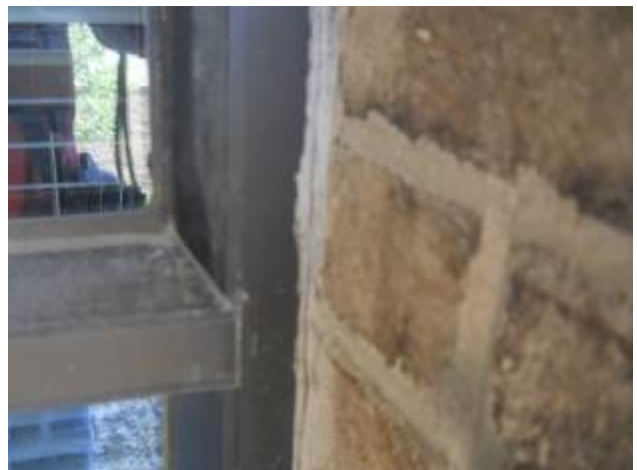
Roof Area 35

The roof system is in good condition with the only deficiencies noted was minor displaced ballasted and debris on the roof system. Additionally, we noted cracking in the concrete sill and failed sealant along the perimeter of a window adjacent to the roof system.
