EDUCATIONAL ADEQUACY ASSESSMENT

School: North Middle School

Date of Assessment: October 28th, 2013

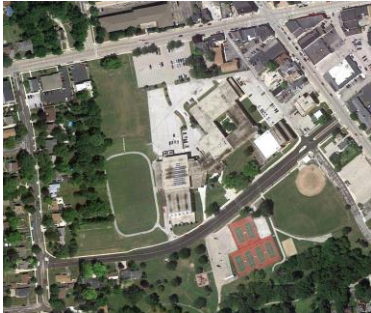
North Middle School site

- Size of site
 - The size of the current site is 12.8 acres (google earth). While the acreage is less than recommended by national guidelines (refer to Section 2) all necessary academic and athletic functions are housed on site but with the use of additional municipal play fields located to the south of the Middle School campus, across the street.

- There is a sufficient amount of parking provided on the site.
- Grounds, Parking Lot and athletic areas
 - The grounds are in good condition and well maintained. Much of the surrounding green area slopes, limiting the amount of flat, usable area.

- Available parking directly adjacent to school is limited and located on the north side of the school, on the other side of the original traditional entrance.

- The parking lot appears to have been maintained, and is in relatively good condition, except that a retaining wall is in need of repair.
 - Drive aisle is primarily restricted to the north side of the school, requiring a vehicle to enter and exit the site to the north. During peak times, traffic is heavily congested, and during public market hours traffic can become congested.

- Tennis courts are part of the municipal facilities to the south.
 - The south side of the school includes a green space with an elevation which rises towards the school to the north from the street.

1. Consider having a traffic study to see if a circle drive could be designed at the south side to make this the primary vehicular access and move Administration to the south side of the building.
2. Consider alternative parking solutions to better alleviate flow and congestion and provide additional capacity closer to building entrance.
3. Review possible vehicular connection between the north and south sides of the school.

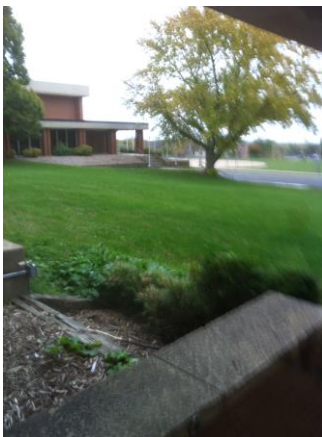
Potential south main entrance and drive/drop off location

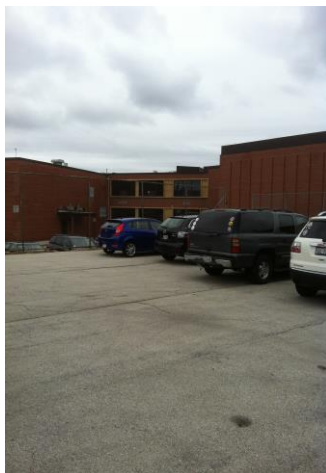
“Current Main Entrance” competes with back of house kitchen service delivery

- Main Entry Sequence.
 - Main entry is located in the vicinity of the staff/visitor parking lot.
 - Main entrance is open before school and is locked once school day begins.

- Visitors to the school after the day begins are greeted by a combined buzzer with camera. Visitors are allowed to enter the exterior doors by magnetic device but the view from the main office to the exterior doors is only marginally supervised.

1. Consider adding electronically controlled locks and video surveillance at all entries so that entries can be monitored and controlled from a central location.
2. Explore methods of controlling student and visitor access to the school once inside.

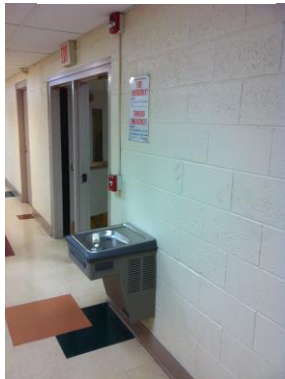
Accessible Drinking Fountain and Visual Fire Alarm Strobe above.

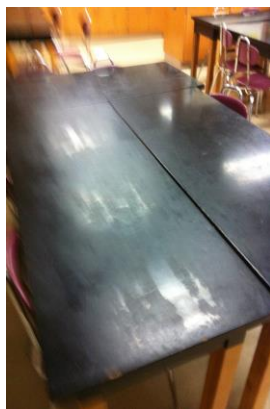
- Science peninsulas have epoxy tops.
 - Casework is in very poor condition.
 - Science-type epoxy tables are provided in both rooms.
 - Tables and chairs are large and heavy and do not allow for flexibility.

Mobile tables should be replaced as a high priority

1. Consider furniture systems that would allow for increased classroom flexibility.
2. Science rooms 126,128,130,202, 204 and 212 need eyewash stations installed.
3. All Science classrooms are missing safety showers.
4. There are no separate lockable chemical storage units and need to be provided.
5. Chemical storage rooms need to be ventilated and are not at present.
6. Shelving used for chemicals should have spill proof lips on the ends.

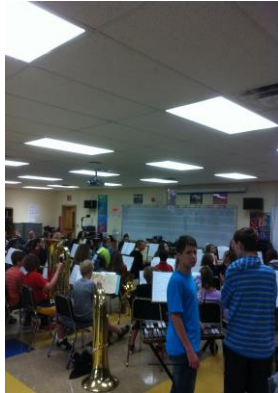
- Practice rooms next to room 86 have been turned into storage rooms. The doors need windows so as to convert these rooms for practice uses.
 - Instrument locker space is not sufficient and the current instrument lockers are in poor shape. Instruments are often stored on the floor and may be easily damaged as a result.

- Size of space.
 - Band Room 86 is 1,683 square feet and is smaller than the recommended size for the student population it serves. Band Room 103 is larger and more adequate at 2,273 square feet, however, it is still smaller than the recommended size for the student population it serves.

- Architecture of existing building does not allow for easy relocation of space without major renovation.
 - Band Room 86 exit door should be converted to a solid opaque door instead of the full glass door currently in place.

1. Consider relocating Band and Orchestra to create a Music area within the building adjacent to the Auditorium.
2. Consider new instrument storage purchase.
3. Consider providing flexible furniture and storage systems.

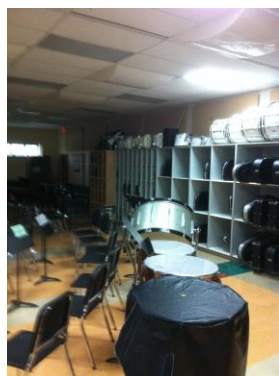
Instrument Storage

- Storage.
 - Instrument storage is not adequate.
- Additional comments.
 - Spaces on lower level of school are not convenient due to lack of proximity to other programs.

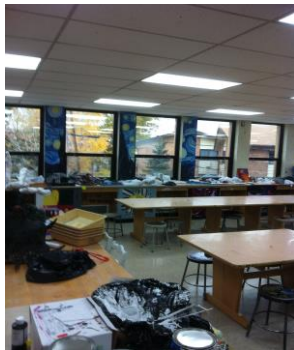
Art room: inflexible furniture

- Furniture is old, worn out, large and inflexible.
- Access to water.
 - Two large stainless steel sinks are provided. Art rooms typically provide 4-6 clean-up stations to minimize clean-up time waiting.

- Additional comments.
 - Typical classroom furniture does not lend itself readily to room reconfiguration or flexibility.
 - Outlets in room 227 are taped down.

- Chalkboards which are desirable in art rooms have been converted to dry erase boards.
 - Student desk bolts in room 229 are stripped and very unstable. New furniture is needed.

1. Consider new furniture systems that would allow for increased classroom flexibility for both rooms 227 and 229.
2. Move sink in room 227.
3. Provide 4-6 clean up sinks per room.

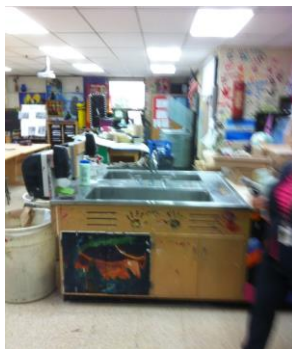
Sink area

- Sink locations need to be reviewed as one may need to be moved.
- Kiln location.
 - The kiln is located between the two classrooms.
- Storage.
 - Art storage is handled in the room with perimeter casework as well as the storage areas in between the two Art classrooms.

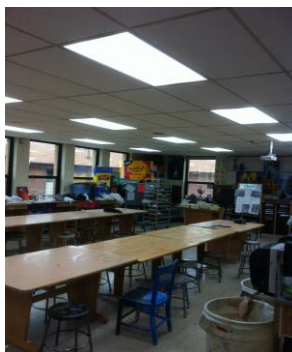
Heavy furniture limits flexibility
