EDUCATIONAL ADEQUACY ASSESSMENT

School: High School

Date of Assessment: October 28th, 2013

Evaluator(s): Abie Khatchadourian (EUA)

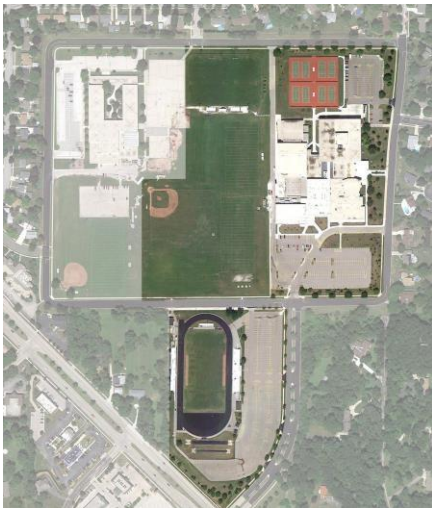
The High School Site

- Size of campus.
 - The size of the current campus is 50 acres (google earth). The acreage is roughly the same as recommended by national guidelines (refer to Section 2) and all necessary academic and athletic functions are housed on site.

- Grounds, Parking Lot and athletic areas.
 - Site access is fair, though there are challenges for site circulation/traffic flow.
 - There is a sufficient amount of parking provided on the site for a typical school day and events.

- The grounds are in good condition and well maintained.
 - Parking and driving lanes are in good condition.
 - Vehicular circulation is via Appleton Avenue to the south then to Woosencraft Drive northward along the stadium and parking area. This drive terminates in the east/west Titan Drive; along the east side of the site Titan Drive becomes Merrimac Drive northbound and connects with Franklin Drive (east/west) along the north side of the site. Ben Franklin Elementary School is to the west of the High School across practice athletic fields.

1. Consider site directional signage for way finding.

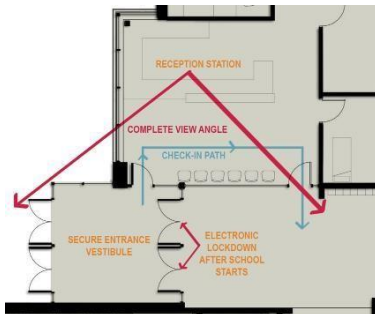
Recommended secure entry sequence.

1. Consider adding electronically controlled locks so that entries can be monitored and controlled from a central location.

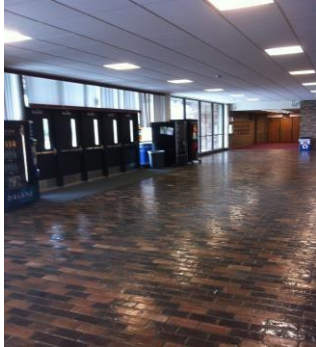
Wide pre function lobby

- Corridor circulation is a series of “racetrack” sections.
 - Corridor width varies. Typical width is approximately 12-14’.
 - Current locker count: 1,665/ 1,455 enrollment.
 - School interior is fully handicapped accessible.
- Common areas for student socialization.
 - The cafeteria provides space and areas to sit when not acting as a dining area.
- Lobbies/commons large enough to support groups.
 - The cafeteria serves as a student commons space.
 - The corridors do not accommodate areas for breakout space, and visibility from classroom is limited.

1. Consider a review of interior design features on commons area blank walls (see photo to left) to add visually stimulating impact.

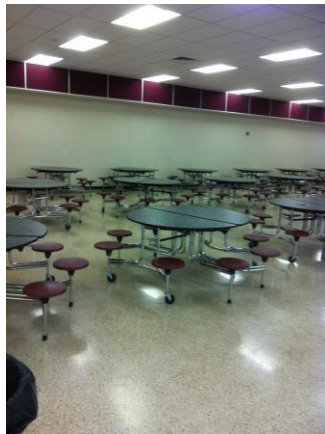
Commons area round table seating

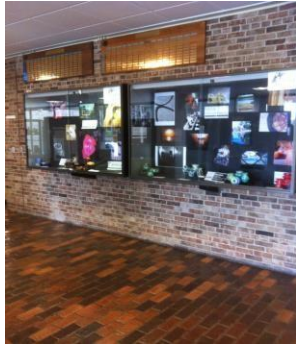
Display Case

- Student Display Opportunities
 - There are multiple areas throughout the school for student display.
 - There are display cabinets located throughout the school.

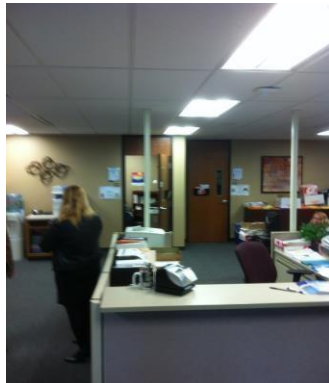
Student Services Reception

- Reception
 - Reception provides a secure entrance to school.
 - A physical line-of-sight to the main entrance is severely limited.
 - Main Door to Administrative area occurs from within school, and provides no control after visitor is admitted.

- Reception counter is not accessible for those in a wheelchair due to the height of the counter being over 30". (It is stand up height at 40").
 - Size of area is adequate.

1. Administration / Student services area is adequate.

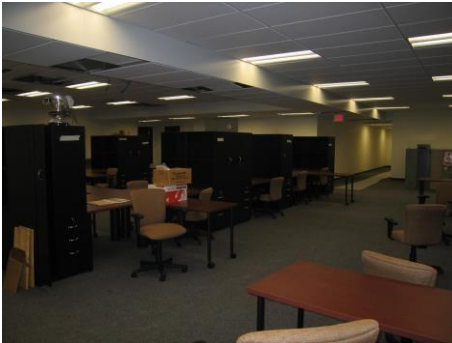
Second floor staff workroom

- Location within building.
 - Staff lounge is located across the hall from the main administration area
 - Staff work room is on the second floor of the building.
 - Administrative workroom is disjointed from the reception area.
- Size and Functionality.
 - There are two staff lounges.
 - Size of staff workroom area is more than adequate. Storage is adequate and workspace is functional. This area should be reviewed for reconfiguration as there is available space for other much needed uses; see recommendations below.

1. Staff lounge and work room are adequate.
2. Consider reconfiguration of the Second Floor large teacher work space to support either large group instruction, full staff work stations for (85), or potential breakout spaces from classrooms as there are no breakout spaces in the school at this time. Review code exiting for the new potential capacity.

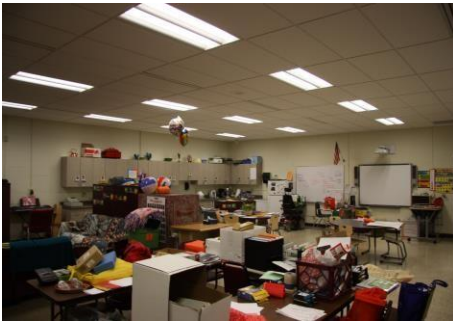
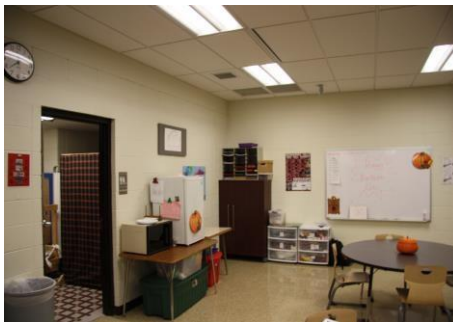
Special Education

- Location within building. This page needs review and input by SDMF.
 - Special Education Room 161 has 1,495 sf.
 - Special Education Room 163 has 1,449 sf.
 - Special Education Room 132 has 736sf.
 - There are no spaces dedicated to PT, OT?
- Size of space
 - Areas for students who have Learning Disabilities are adequate.
 - Area for Emotionally Disturbed students is adequate.
 - Area for students who are Cognitively Disabled is adequate.
 - Psychologist office provides space for one-on-one consultation only. (There is a small group room nearby).
- Adequacy for current educational delivery system.
 - Special Education provides options for one-on-one conferencing and small group activities. If privacy is required, small group spaces are nearby.
 - Heavy furniture does not promote flexibility and reconfiguration.
- Additional comments.
 - All spaces lack daylight or views to the outside.

1. Consider adding spaces to accommodate PT and OT.
2. Consider different furniture that is lightweight and flexible and easy to reconfigure.

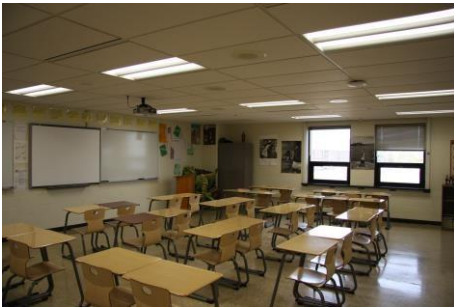
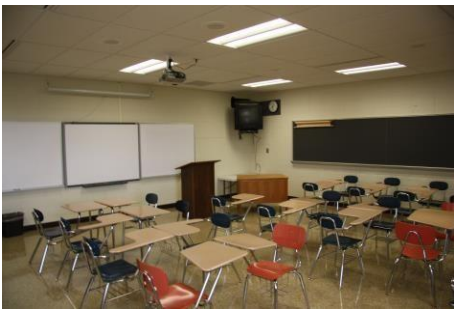
Typical classroom

- Whiteboards and projection screens are typically provided in the classrooms.
 - Smart boards are provided in the general classrooms.
 - Typical classroom furniture is outdated (lecture mode desks only) making it difficult to reconfigure for active learning groupings.

- There are currently few places for collaboration outside classrooms.
 - There is no connectivity between general classrooms, which does not allow larger group configurations or team teaching.

1. Consider furniture systems that would allow for increased classroom flexibility.
2. Consider renovating walls between classrooms to allow for a large group (two class) configuration. Larger spaces can support team teaching and alternative educational delivery methods.
3. Consider increasing transparency between the classrooms and corridors to ensure supervision of breakout areas. This would be possible if the building is fully equipped with an automatic fire sprinkler system, as in the absence of that corridor walls need to be one hour fire rated. (Please note that the newer areas of the building are equipped with fire sprinkler systems.)
4. Consider break out collaboration areas to be created in the large 2nd Floor current teacher work areas which have room to spare. Review code requirements for capacity in that planning.

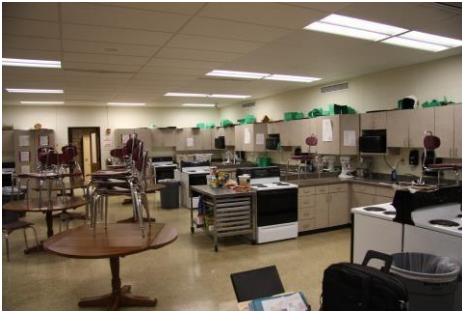
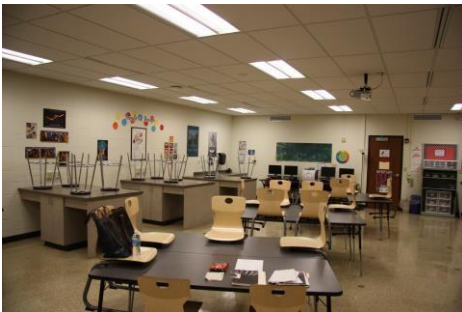
Foods classroom.

F.A.C.E. Classroom

- Location within Building
 - The Family and Consumer Ed spaces are located centrally in the school, just off the Cafeteria and north of Science.
 - FACE areas are relatively close to the school kitchen and pantry which are west across the Cafeteria.
- Size of space
 - Foods Lab 121 (1,330sf)
 - FACE Classroom 125 (1,097sf)
 - FACE Classroom 126 (1,096sf)
- Adequacy for current educational delivery system.
 - Typical classroom furniture is heavy and outdated making it difficult to reconfigure.
 - Foods Lab configuration is a good contemporary layout. Consider use of capture cameras and screens to display instructor cooking.
- Storage
 - There is currently one storage room.

1. Consider furniture systems that would allow for increased classroom flexibility.
2. Consider Foods Lab technology such as a camera and screens to display cooking in real time.

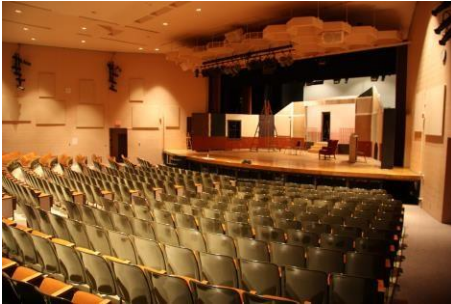
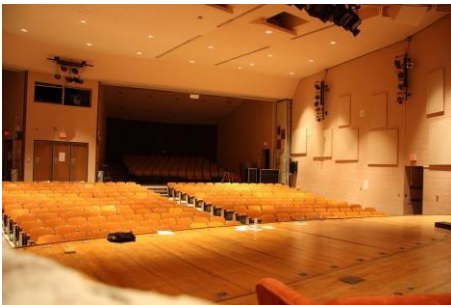
- Location within building.
 - The Auditorium is located to the north of the Band/Music Rooms.
- Size of space.
 - The capacity of the auditorium is 550 and as such provides less than full performing or assembly needs for the high school.
- Adequacy for current educational delivery system.
 - The auditorium is adequate for limited performance and for instructional purposes.
 - Auditorium amenities such as finishes (carpeting, curtains) and systems (lighting and sound) are in need of upgrades.
- Storage.
 - Storage is adequate.

Auditorium: looking at stage

Auditorium: on stage

1. Replace seating.
2. Replace carpeted areas.
3. Replace curtains; add electric operation instead of hand crank for curtains.
4. Provide lighting upgrades and position upgrades.
5. Provide sound system upgrades.

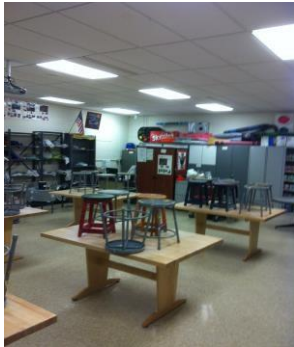
Art room: inflexible furniture

- Location within building.
 - There are (2) Art Rooms located at the Lower Level of the school.
- Size of space.
 - Art Room 28 has 1,562sf. Art Room 30 has 1,510sf.
- Adequacy for current educational delivery system.
 - Furniture is large and inflexible, making room difficult to reconfigure for different types of art and/or presentation/lecture.
- Access to water.
 - One large double-compartment utility sinks is provided for each room. Art rooms typically provide 4-6 clean-up stations to minimize clean-up time waiting.
- Kiln location.
 - There is a dedicated kiln/storage room directly access from and adjacent to room 30. Two electric kilns are provided.
- Storage.
 - Art storage is handled in the room with full-height storage metal shelf units.
- Access to daylight.
 - There a windows to the west side of each of the two rooms. Art is best viewed in natural light from the North.

1. Consider furniture systems that would allow for increased classroom flexibility.
2. Consider more efficient ways of storing items not in use to ease space constraints and reduce clutter.
3. Room 30 has been identified as being humid. Review possible measures to reduce humidity without hurting 3D pottery program.
4. The Ceramics Room (room 30) does not support the desired class sizes. This might be reviewed in conjunction with a major Project Lead the Way renovation of the Lower Level areas.

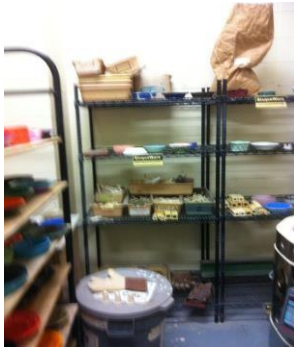
Limited storage

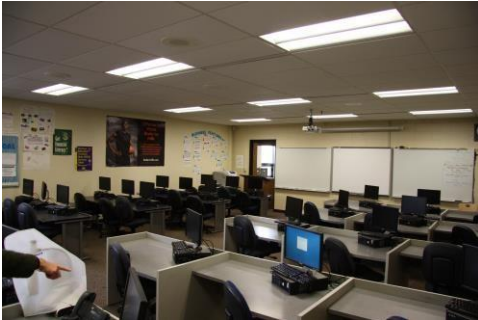
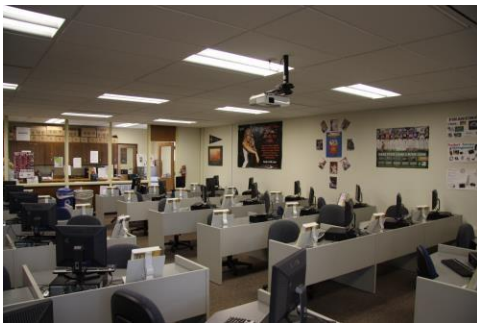
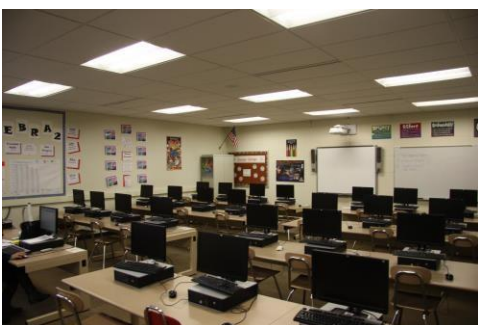
Computer lab.

- All computer spaces are not flexible – hard-wired, desktop technology means the space is permanently fixed and limited to computer related activities only.

- Computer labs with fixed furniture and equipment configuration do not lend itself well to group work and collaboration.
 - As desktop computers are replaced by personal devices, lab space may become obsolete.

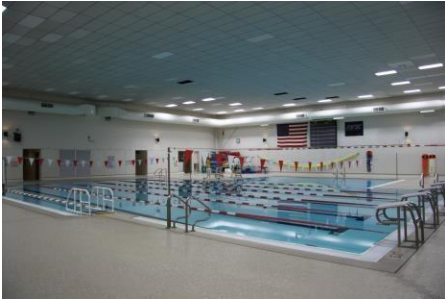
Pool

- Size of space.
 - The Pool room is approximately 10,000 square feet and houses a six lane pool and diving board.
 - There are bleachers on one side; these are in need of replacement due to the corrosive environment in pool rooms.

- Pool room has good acoustics with acoustical tile ceilings. Please note that newer acoustical ceilings have a coating to protect from humidity; these also result in lesser acoustical performance. If the ceiling tile is ever replaced with lower NRC rated tile, then an acoustical analysis is recommended and additional acoustical wall mounted materials need to be considered.

- Replace pool bleachers.
- Provide stanchions to separate spectators from competitors.
- Provide trench grate to separate on deck drainage from spectator area to competitor area.
- Consider replacement of 1" x 1" tiles.
- Replace ceiling tile with new and verify NRC ratings. Provide study for acoustics and consider wall mounted acoustical attenuation.
- Provide doors at the end of the short corridors in the men's and women's locker areas leading up to the pool room. This will provide access to coach/teacher offices without access to pool. Corridors are short enough so as not to constitute a dead end corridor. Access from pool room will be at all times to the corridor via "push panic" hardware typically used in district facilities such as current gyms.
