EDUCATIONAL ADEQUACY ASSESSMENT

School: Valley View Elementary School Capacity of Building:
363 students (based on building sq. ft.)
381 students (functional design capacity)

Configuration: Grades (4K-5th)
Date of Assessment: October 25th, 2013

Evaluator(s): Abie Khatchadourian (EUA)

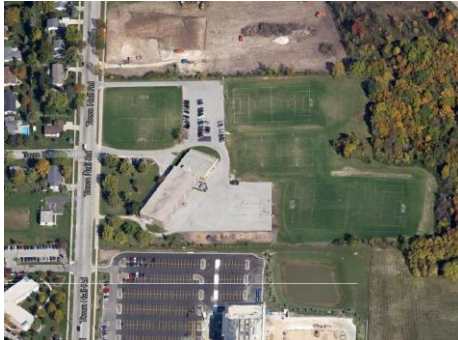
Site aerial

- Size of campus.
 - The size of the current campus is 11.6 acres (google earth). The acreage is less than recommended by national guidelines (refer to Section 2) and all necessary academic and athletic functions are housed on site.

- Grounds, Parking Lot and athletic areas.
 - Though site access to the campus is limited and from the west, there are two egress/ingress curb cuts. There are however challenges for site circulation/ traffic flow.

- The grounds are in good condition and well maintained.
 - Most of the parking and hard playground surfaces are in generally good shape and with few cracks in the asphalt paving. Some cracks however were observed in the concrete sidewalk areas in front of the school to the North West which should be addressed with slab areas being replaced.

1. Consider some re grading and asphalt paving at the east side of the green area as noted above.

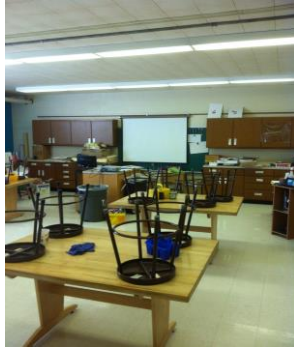
Art room

- Access to daylight.
 - Daylight is inadequate due to only having one window.

1. Consider furniture systems that would allow for increased classroom flexibility.
2. Consider larger, deeper sinks that could potentially be used by 2 students at a time.
3. Consider some modifications to casework to be more art storage appropriate.
4. Consider an option to relocate the Art Room to an upper floor to increase day lighting and to position the function closer to the majority of the upper grades.

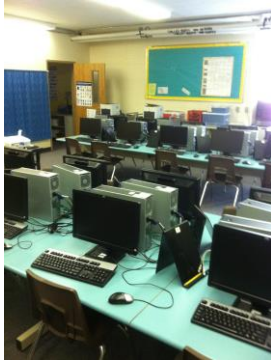
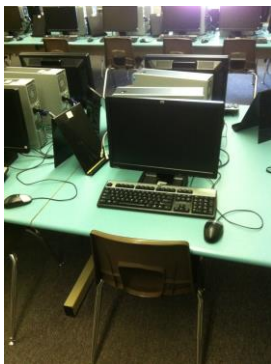
Computer Lab.

- Computer labs with fixed furniture and equipment configuration do not lend itself well to group work and collaboration.
 - As desktop computers are replaced by personal devices, lab space may become obsolete.

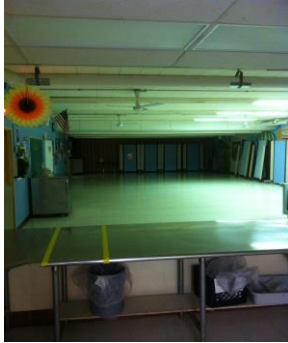
- Kitchen is able to provide lunch warming/serving for the school.
 - Space receives no daylight.
- Furniture.
 - Cafeteria tables are movable, but remain set up at all times.

- Accessible for community use.
 - Location is not well suited for community and after-hour use, without the ability to control access to other parts of the school.
