Menomonee Falls School District
Benjamin Franklin - Facility Study
Historical Plan

eppstein uhen : architects
EUA No. 313258-01

BUILDING INSPECTION REPORT

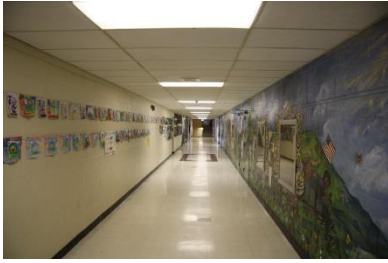
CMU corridor walls / VCT flooring

- Expected life span - 50 -100 years with periodic maintenance
- Current Condition - Good
- Most interior walls are concrete block and show no signs of cracks, fractures or failure.

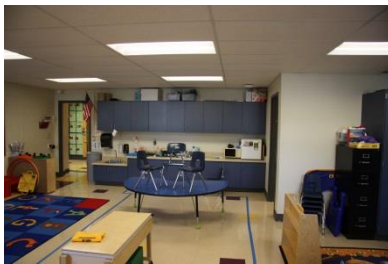
Drywall classroom walls/ VCT flooring

- Paint is in good condition.
- Drywall walls shown signs of light abuse (Drywall walls are mostly found in 2010 renovated portions of the building.)
 - Drywall walls are easier and less messy to demolish, easier to rebuild and are more flexible than concrete block. While the durability of walls are essential inside of schools given the nature of abuse they take, for future flexibility the District should consider the types of walls it plans for future spaces given the flexibility, cost and disruption of drywall versus masonry construction.

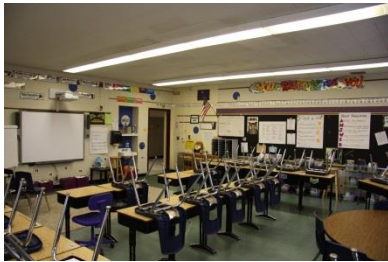
CMU Classroom walls

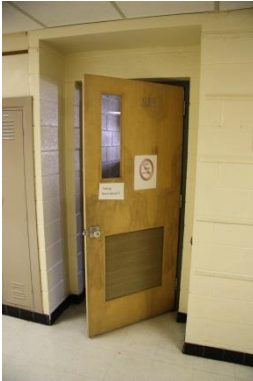
Typical classroom door

- Expected life span 40 years with periodic maintenance
- Current Condition – Good to fair
- The majority of doors are in Fair condition except those in the early childhood area which are in good condition.
 - Many of the doors facing veneers have tears and chips.
 - Grilles in typical classroom doors are dented and damaged.
- Some locksets have been updated to meet accessibility requirements however most door knobs are original to the building.
- Intruder lock function is not provided on original door knobs.
- Metal door frames can be repaired and painted. Door chips and scratches can be sanded, filled and restrained to revive an old door. Depending on severity of door or frame damage, it may be cost effective to replace the entire door and frame.

1. Replace or refinish doors in poor condition.
2. Paint damaged door frames.
3. Replace door hardware to be ADA compliant.

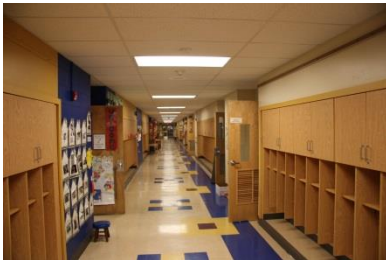
Cubbies in corridor

- Casework in the early childhood classrooms are in good condition.
- Corridor/classroom cubbies are in good to fair condition.
 - Cubbies located in the classrooms at the first grade and kindergarten classrooms are in fair condition.

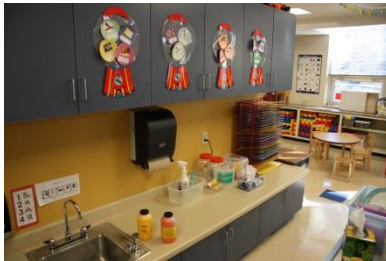
Typical early childhood classroom casework

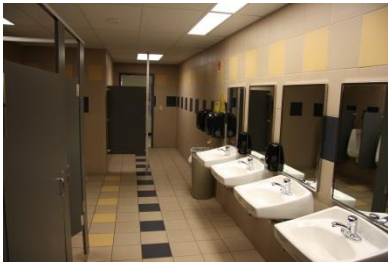
Typical restroom

- Current Condition - Good
- Refer to ADA report for accessibility recommendations
- Majority of finishes are new and in good condition. The only restrooms not renovated were in the basement.
 - Ceramic Floor and Wall Tile (expected life span 40 years) – good
- Ceiling- (expected life span 15 years) good
 - Restrooms have 2'x4' lay in ceiling.
- Toilet Partitions -(expected life span 15 years) good
- Accessories – (expected life span 8-10 years) good
- The single-fixture restrooms between kindergarten classrooms appear to be original to the building. The single fixture restrooms in the early choild development area are new.

1. At non-renovated restrooms: Remove and replace all finishes: ceilings and wall and floor tile. Replace toilet partitions with anti-graffiti plastic type. Paint all walls that are not tiled. Some restrooms may need to be reconfigured due to accessibility requirements.
2. Refer to MEP reports for fixture, ventilation and lighting recommendations.
3. See Section 3 – Educational Adequacy Assessment for additional recommendations.

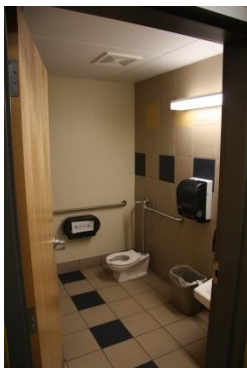
Single-fixture restroom
at early childhood

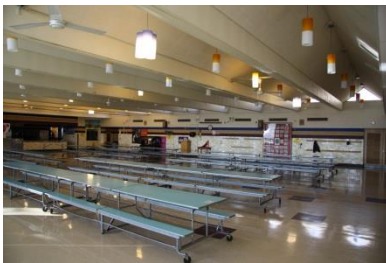
Cafeteria

- Current Condition – fair condition
- Walls – good condition.
 - The CMU walls have tile adhered midway up wall. This tile is in good condition but dated.
- Flooring – good condition.
 - The flooring in the cafeteria is VCT (Vinyl Composition Tile) and in good condition.
 - The flooring in the Kitchen is in Fair condition.
- Ceiling Tile – Poor condition.
 - The cafeteria has adhered ceiling tiles in poor condition.
 - There are a few areas where the glue has failed and tiles have dropped.
 - Because of the age of the adhesives used they may contain asbestos.
- Wall Base – Good condition

1. Consider removing adhered acoustical ceiling tile.
2. See Section 3 – Educational Adequacy Assessment for additional recommendations.

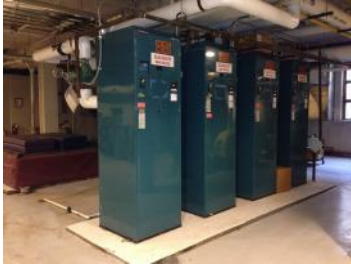
- The boiler plant is in good overall condition. With recommended maintenance, the boilers should continue to serve the facility for approximately 15 more years.
- Boiler water chemical systems are in place and are reported to be maintained.
- Insulation at most piping is of adequate thickness.
- Thermometers and gauges are present and appear to be working at all locations.
- Piping is adequately supported where observed.

Hot Water Boilers

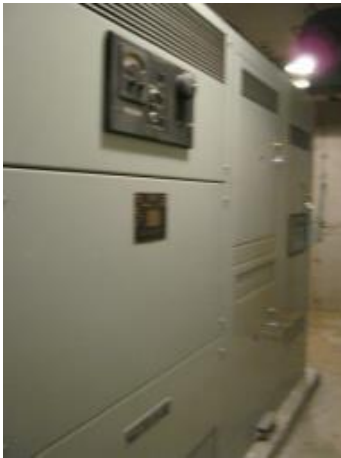
Service Panel

1. Keep existing new QO panels in place; add additional circuits if required.
2. Replace existing Kinney panels.
3. Replace all old feeder wires.

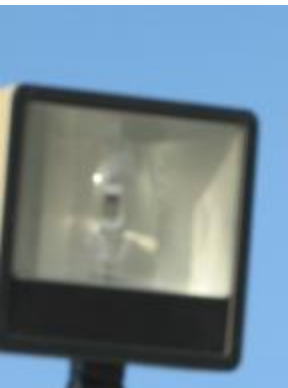
Exterior Parking Lot Pole

1. We would recommend replacement of the existing exterior fixtures with new LED type to increase efficiency and lower maintenance cost.
2. As increased security is addressed, the district may consider adding security lighting around the perimeter of the facility.
3. Provide a new LiteKeeper exterior lighting control panel to improve the exterior lighting control.

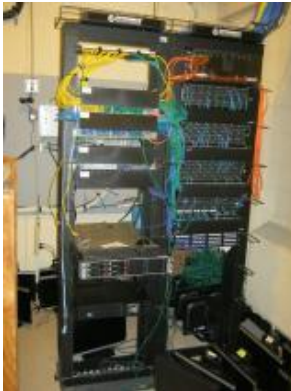
Data Rack

1. New data drops can be added at any point. A possible new data rack may be required to accommodate any new rack mounted equipment.
2. Provide upgrade to Cisco VoIP telephone system.
3. Provide proper telecom grounding system.

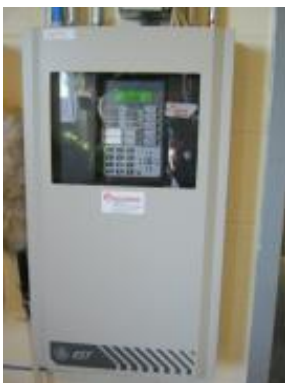
Fire Alarm Control Panel

1. Continue to test the system to ensure proper operation and code compliance.

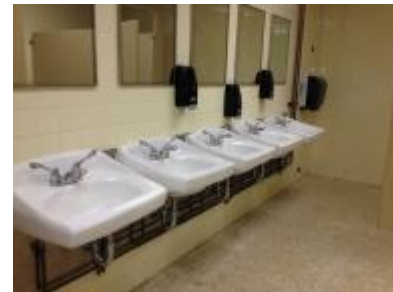
*Lower Level Toilet Room:
New Lavatory Fixtures*

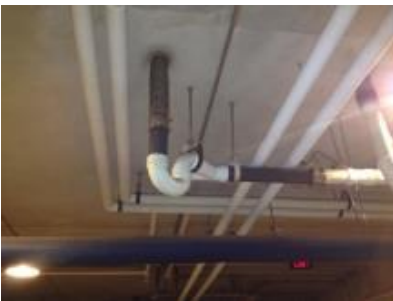
Repaired Sanitary Piping

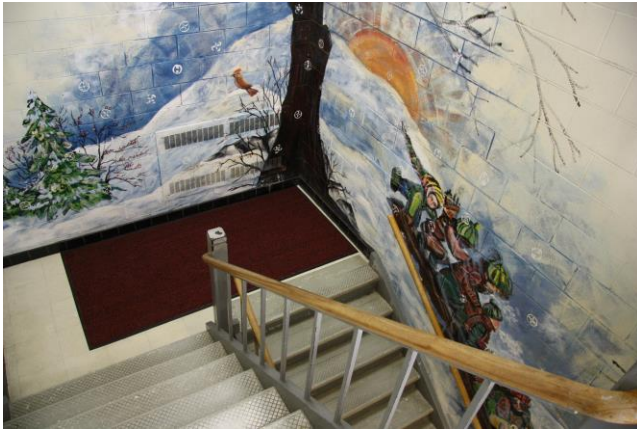
ITEM	ADA REFERENCE
1.	Stairs handrails do not comply with current extension requirements beyond the top and bottom stair risers.	505
RECOMMENDATION: 1. Replace existing handrails with accessible handrails.

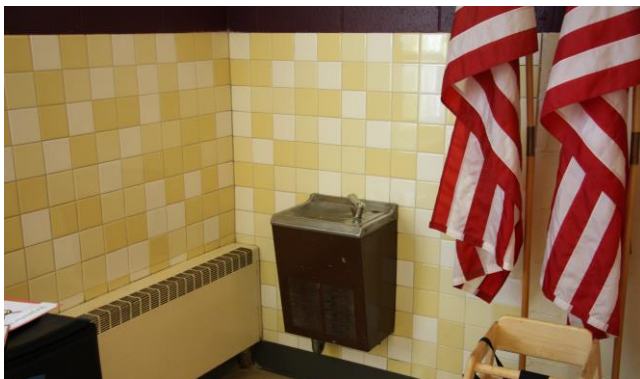
ITEM	ADA REFERENCE
1.	Multiple drinking fountains are not of an accessible design. Some drinking fountains have been replaced with accessible types.	602
RECOMMENDATION: 1. Update all drinking fountains to accessible models.
