Menomonee Falls School District
Riverside - Facility Study
Historical Plan

eppstein uhen : architects
EUA No. 313258-01

BUILDING INSPECTION REPORT

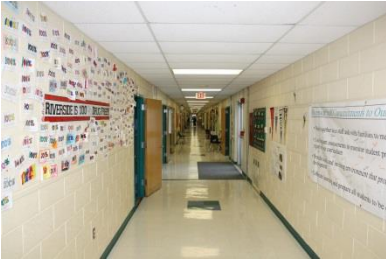
CMU corridor walls / VCT flooring

- Expected life span - 50 -100 years with periodic maintenance
- Current Condition - Good
- Most interior walls are concrete block and show no signs of cracks, fractures or failure.

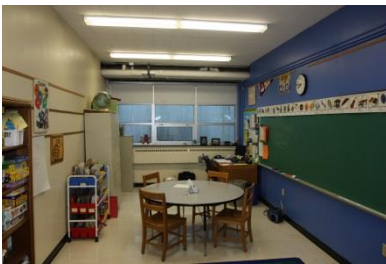
Drywall classroom walls/ VCT flooring

- Paint is in fair condition.
- Drywall walls shown signs of light abuse but have been regularly maintained.
 - Drywall walls are easier and less messy to demolish, easier to rebuild and are more flexible than concrete block. While the durability of walls are essential inside of schools given the nature of abuse they take, for future flexibility the District should consider the types of walls it plans for future spaces given the flexibility, cost and disruption of drywall versus masonry construction.

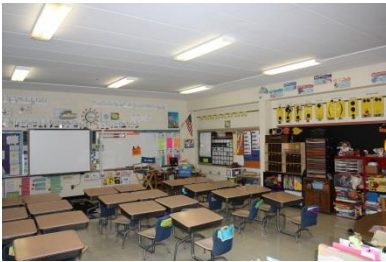
CMU Classroom walls

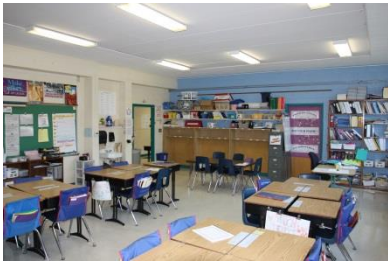
Typical classroom cubbies

- Expected life span 20-25 years
- Current Condition – fair
- Typical classroom casework is in fair condition
 - Casework limited to storage shelves at windows.
- Corridor/classroom cubbies are in similar condition.
 - Cubbies are located in the classrooms.
- Art room casework is in fair condition and well worn.
 - Some cabinets do not remain closed.
 - Plastic laminate is prone to chips, dents, and delamination. In wet areas, the backing plywood swells and causes adhesive to let go.
 - Steel drawer slides experience ball bearing slide failures, friction and worn surfaces. Hinges lose their loading ability over time due to door weight, pressure applied when opened by hanging on them, frequent open /close and poor adjustment.

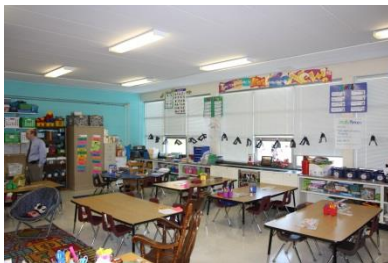
Typical classroom casework

1. Replace Art casework with more durable countertops and casework.

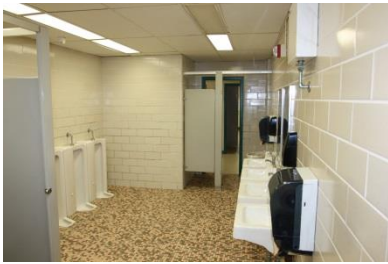
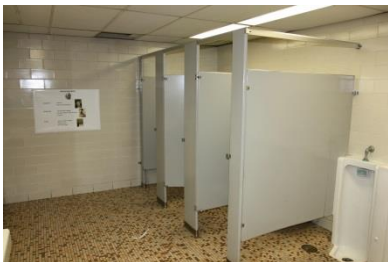
Typical restroom

- Current Condition - fair
- Refer to ADA report for accessibility recommendations
- Finishes are worn and dated but in fair condition
 - Ceramic Floor and Wall Tile (expected life span 40 years) – fair, older grout holds bacteria
- Ceiling- (expected life span 15 years) poor
 - Restrooms have 2'x4' lay in ceiling tile which has staining and rusting of the ceiling grid.
- Toilet Partitions -(expected life span 15 years) fair to poor
 - Rust is present at the base of many partition walls.
- Accessories – (expected life span 8-10 years) good
- The single-hole restrooms between kindergarten classrooms appear to be original to the building.

1. All restrooms: Remove and replace all finishes: ceilings and wall and floor tile. Replace toilet partitions with anti-graffiti plastic type. Paint all walls that are not tiled. Some restrooms may need to be reconfigured due to accessibility requirements.
2. Refer to MEP reports for fixture, ventilation and lighting recommendations.
3. See Section 3 – Educational Adequacy Assessment for additional recommendations.

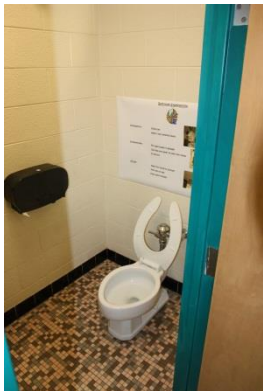
Single-hole restroom at kindergarten

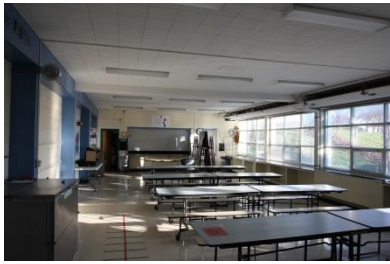
Cafeteria

- Current Condition – fair condition
- Flooring – good condition.
 - The flooring in the cafeteria is VCT (Vinyl Composition Tile) and in good condition.
 - The flooring in the Kitchen is in Fair condition.
- Ceiling Tile – Poor condition.
 - The cafeteria has adhered ceiling tiles in poor condition.
 - There are a few areas where the glue has failed and tiles have dropped.
 - Because of the age of the adhesives used they may contain asbestos.
- Wall Base – Good condition

1. Consider Updating flooring in Kitchen
2. As adhered tiles fail, consider adding dropped lay-in ceilings.
3. See Section 3 – Educational Adequacy Assessment for additional recommendations.

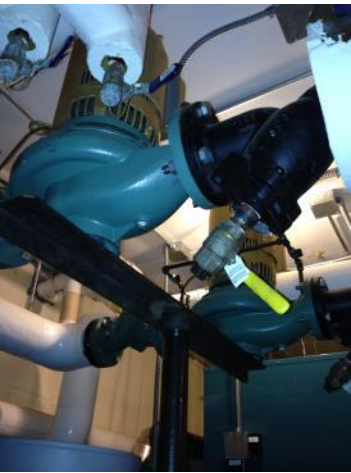
Boiler Pumps

- The boiler plant is in good condition. With recommended maintenance, the boilers should continue to serve the facility for approximately 15-17 more years.
- Boiler water chemical systems are in place and are reported to be maintained.
- Insulation at most piping is of adequate thickness.
- Thermometers and gauges are present and appear to be working at all locations.
- Piping is adequately supported where observed.

1. Continue preventative maintenance on the hot water boilers and pumping system.

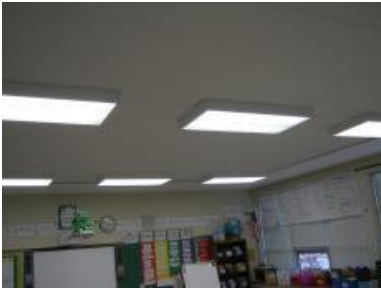
General Lighting

1. Replace all existing fixtures with T12 lamps with new acrylic lens 2x4 fixtures that use T8 lamps and electronic ballasts.
2. Provide dual technology occupancy sensors in all classrooms.

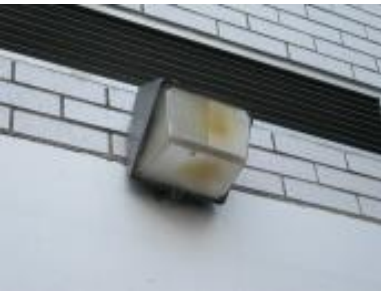
Exterior Lighting

1. We would recommend replacement of the existing exterior fixtures with new LED type to increase efficiency and lower maintenance cost.
2. As increased security is addressed, the district may consider adding security lighting around the perimeter of the facility.
3. Add LED light fixtures at all building entrances for safety and security.
4. Provide new exterior lighting circuits and LiteKeeper lighting control.

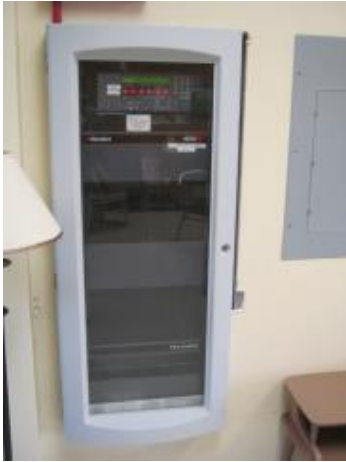
Fire Alarm Control Panel

1. Provide horn strobe devices in all classrooms per code. Provide strobe devices in all offices per code.

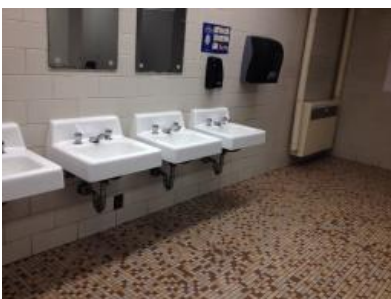
Typical Wall-Hung Lavatory

- Toilet room fixtures are generally in poor condition. The majority of these fixtures are original to the building.
- Water closets and urinals are flush valve style fixtures. Urinals are operated on a timer. This style of fixture wastes a significant amount of water in a years' time.
- Lavatories are wall-hung and appear to be original to the building and are not ADA compliant. Minor modifications would be required to make these fixtures compliant.
- Lavatory faucets have been replaced. The faucets are in fair condition.

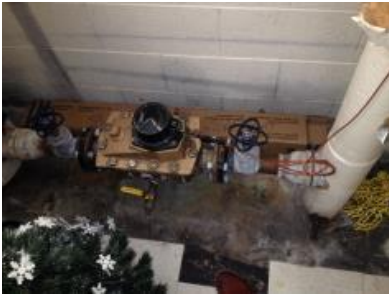
Domestic Water Meter

1. Schedule the remaining galvanized branch piping for replacement.
