Menomonee Falls School District
Shady Lane - Facility Study
Historical Plan

eppstein uhen : architects
EUA No. 313258-01

BUILDING INSPECTION REPORT

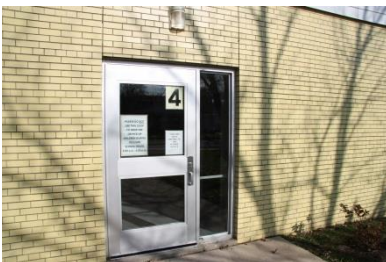
Typical exterior door

- Expected life span 20 years for steel, 30 years for aluminum/ FRP systems
- Current Condition – 90% Good 10% Fair
- The majority of the exterior doors and frames are aluminum and in good condition.
- The aluminum door to the courtyard has a poor seal causing air and weather to enter the building. New weather stripping is required.
- There are steel doors and frames in fair condition.
 - All Steel exterior doors showed signs of damage. Dings, scratches and dents in steel will allow rust to begin faster and corrode easier than aluminum.
 - Some steel doors have areas of rusting on the interior and exterior. The lower portion of exterior steel door and frames are prone to rust and deterioration faster than aluminum is. Steel systems are not thermally broken causing condensation to form on the interior which results in steel corrosion.

1. Replace all exterior steel doors and frames with new FRP (fiber reinforced plastic) doors in aluminum frames.
 - Aluminum door and frame systems have internal gasketing less prone to abuse, will not rust or corrode, have improved screw holding power, can be welded to keep doors straight and will not require painting.

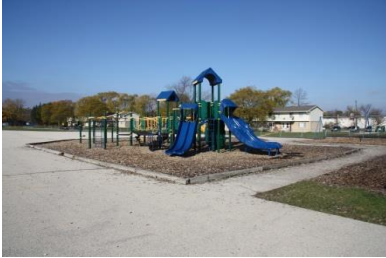
Playground

- Concrete and asphalt were reviewed independently. See appendix for reference reports.
- Playing fields for soccer, athletics and phy ed appear to be in good condition.
 - Standing water was observed on baseball field.
- Portions of the fence around the ball field have significant rust.
- Playground spaces appear to be in good condition.
 - The playground equipment is surrounded by a wood border with no ADA accessible access point.
- There is a drainage issue at the north service drive and sidewalk.

1. Replace rusted sections of fence.
2. Add ADA accessible entrance to playground equipment.
3. Investigate north service drive and sidewalk drainage issue.

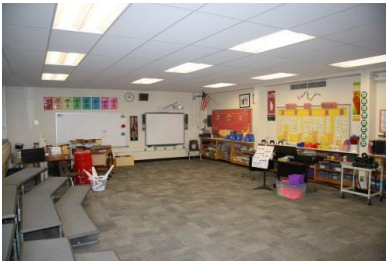
Drywall classroom walls/ carpet flooring

- Paint is in fair condition. Touch-up painting has been done with non-matching paint colors.
- Drywall walls shown signs of light abuse but have been regularly maintained.

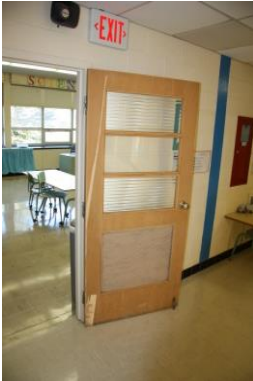
Typical classroom door

- Expected life span 40 years with periodic maintenance
- Current Condition – Fair
- The majority of doors are in Fair condition
 - Many of the doors facing veneers have tears and chips.
 - Grilles in typical classroom doors are dented and damaged.
- Some locksets include an “ADA-attachment” however most door knobs are original to the building.
- Intruder lock function is not provided.
- Metal door frames can be repaired and painted. Door chips and scratches can be sanded, filled and restrained to revive an old door. Depending on severity of door or frame damage, it may be cost effective to replace the entire door and frame.

1. Replace or refinish doors in poor condition.
2. Paint all door frames.
3. Replace door hardware to be ADA compliant.

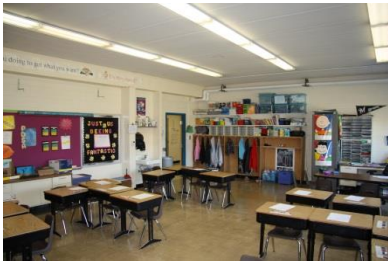
Typical classroom cubbies

- Expected life span 20-25 years
- Current Condition – fair
- Typical classroom casework is in fair condition
 - Casework limited to storage shelves at windows.
- Corridor/classroom cubbies are in similar condition.
 - Cubbies are typically located in the classrooms.

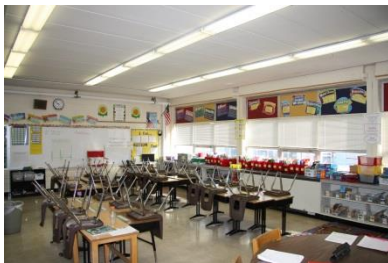
Typical classroom casework

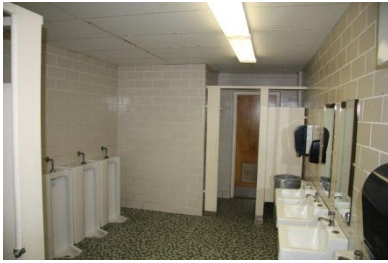
Boys' restroom

- Current Condition – fair
- An accessible single fixture toilet room was added, and is in good condition.
- Refer to ADA report for accessibility recommendations
- Finishes are worn and dated but in fair condition
 - Ceramic Floor and Wall Tile (expected life span 40 years) – fair, older grout holds bacteria
- Ceiling- (expected life span 15 years) poor
 - Restrooms in the original 1960 building have exposed structure ceilings.
 - Restrooms in the 1962 addition have 2'x4' lay in ceiling tile which has staining and rusting of the ceiling grid.
- Toilet Partitions -(expected life span 15 years) fair to poor
 - Rust is present at the base of many partition walls.
 - Staff has complained of partition doors sticking.
- Accessories – (expected life span 8-10 years) good
- The single-hole restrooms between kindergarten classrooms appear to be original to the building.

1. All but the toilet room added in 2005: Remove and replace all finishes: ceilings and wall and floor tile. Replace toilet partitions with anti-graffiti plastic type. Paint all walls that are not tiled. Some restrooms may need to be reconfigured due to accessibility requirements.
2. Refer to MEP reports for fixture, ventilation and lighting recommendations.
3. See Section 3 – Educational Adequacy Assessment for additional recommendations.

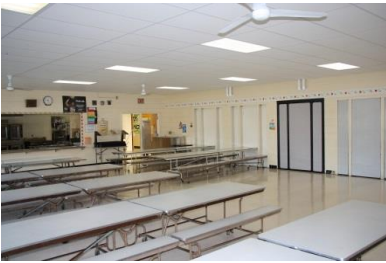
- Current Condition – good condition
- Flooring – Good condition.
 - The VCT flooring in the Kitchen is in Poor condition.
- Ceiling Tile – Good condition.
- Tile Base – Poor condition
 - There are numerous missing and cracked base tiles.
- Half of the existing tables are original and built-in the walls.
 - Very limited flexibility in arranging the space.

1. Update Cafeteria furniture.
2. Update wall tile base.
3. Update flooring in Kitchen
4. See Section 3 – Educational Adequacy Assessment for additional recommendations.

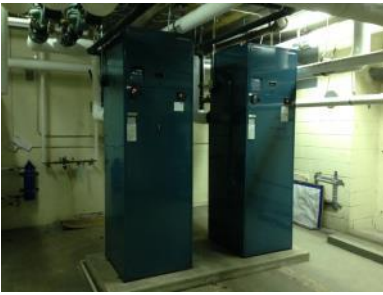
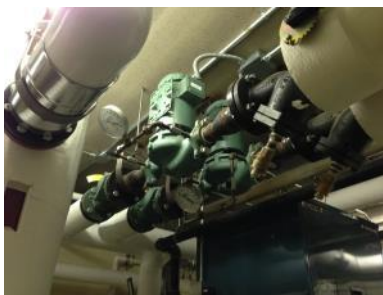
Hot Water Boilers

Boiler Pumps

- The boiler plant is in good condition. With recommended maintenance, the boilers should continue to serve the facility for approximately 15-17 more years.
- Boiler water chemical systems are in place and are reported to be maintained.
- Insulation at most piping is of adequate thickness.
- Thermometers and gauges are present and appear to be working at all locations.
- Piping is adequately supported where observed.

1. Continue preventative maintenance on the hot water boilers and pumping system.

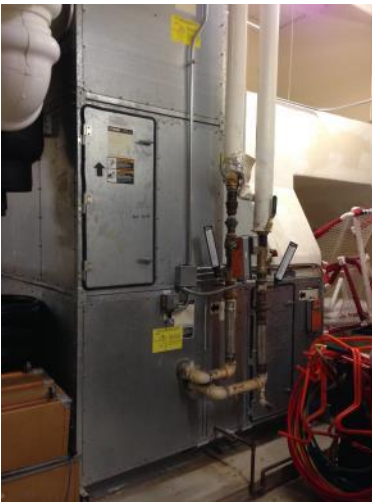
Hot Water Air Handling Unit

- The 1995 and 2009 air handling units have been well maintained and are in good condition.
- The 1960 air handling equipment that continues to serve the music and art rooms and the lower level storage area have been well maintained but have exceeded their expected service life.

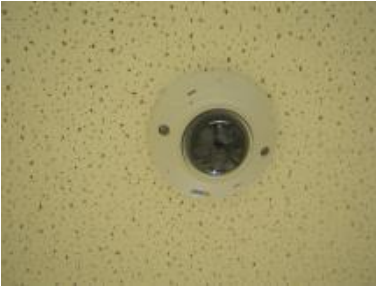
Interior Cameras

- A CCTV system was installed in 2013 and consists of IP based cameras.
- Cameras are located on the interior and exterior of the facility.
- This is a state-of-the-art CCTV system and can be expanded as needed.
- There are select exterior doors with access controls. The system head end is an Open Options Access Technology type. This system is networked and is controlled with FOB's. It appears to be functioning properly and can be expanded.

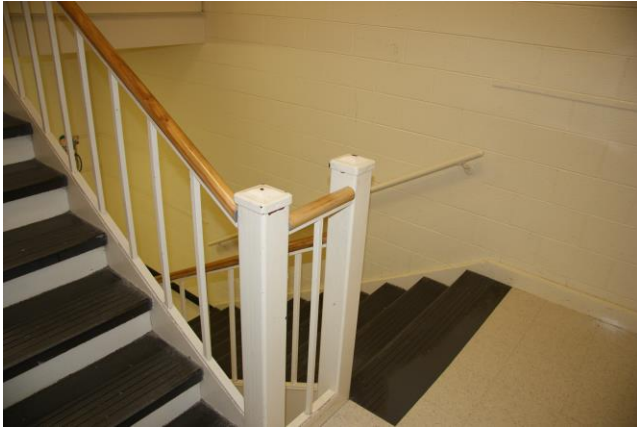
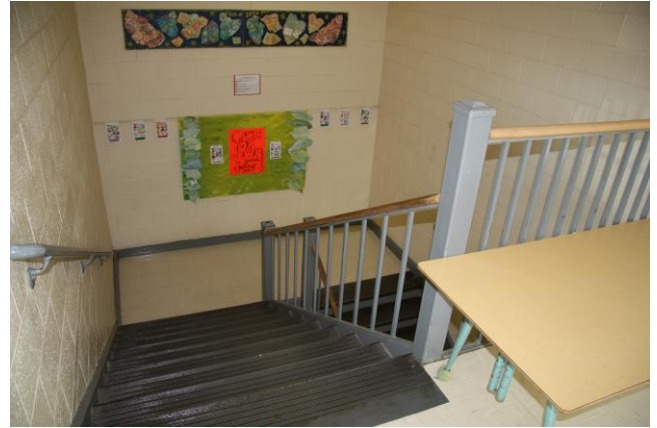
ITEM	ADA REFERENCE
1.	Stairs handrails do not comply with current extension requirements beyond the top and bottom stair risers.	505
RECOMMENDATION: 1. Replace existing handrails with accessible handrails.

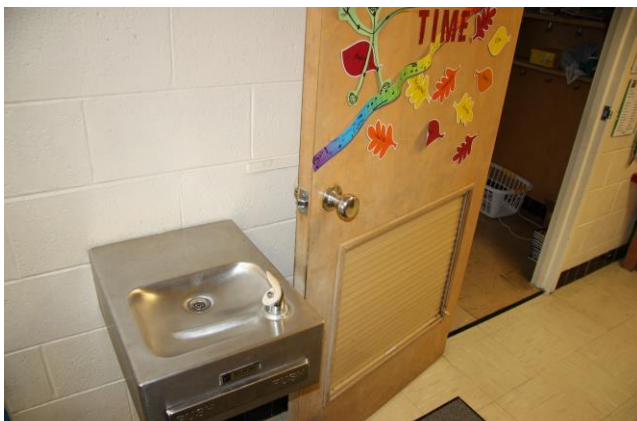
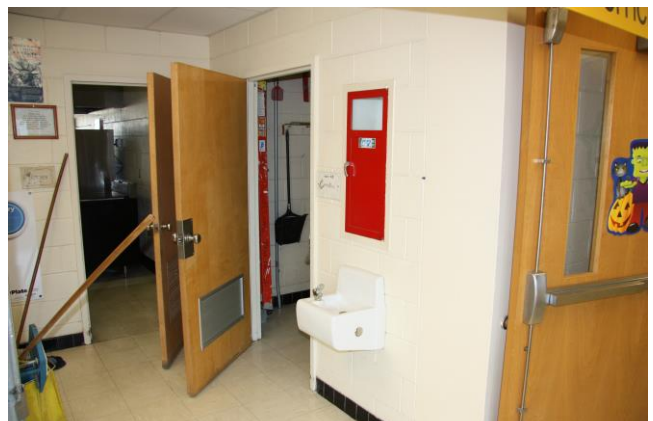
ITEM	ADA REFERENCE
1.	Multiple drinking fountains are not of an accessible design. Some drinking fountains have been replaced with accessible types.	602
RECOMMENDATION: 1. Update all drinking fountains to accessible models.

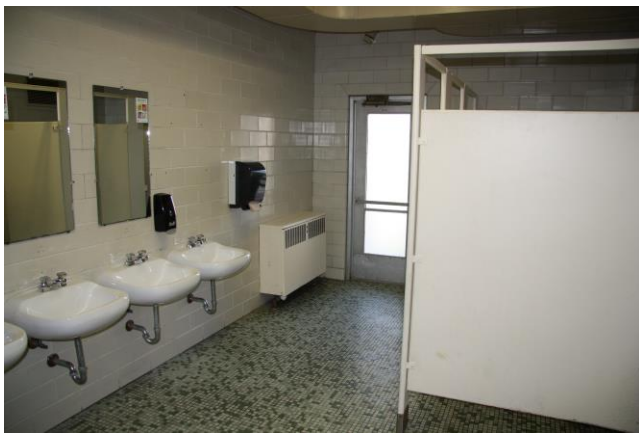
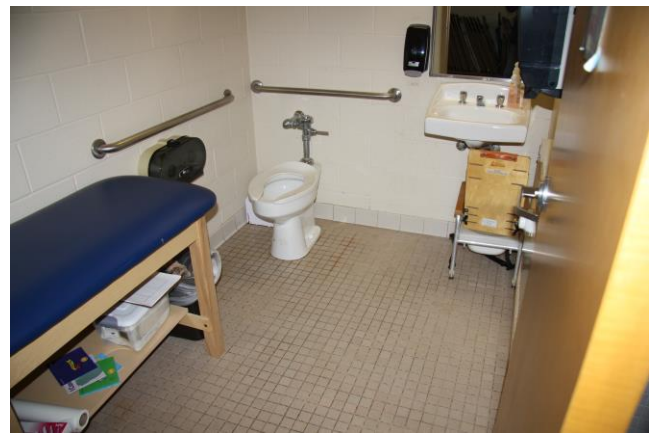
ITEM	ADA REFERENCE
1.	There are two single use toilet room that meets accessibility requirements. This toilet is located on the first floor next to the gymnasium and on the first floor next to the elevator. The rest of the restrooms are not accessible.	603
<p>RECOMMENDATION:</p> <p>1. At a minimum an accessible toilet should be provided in the basement. Preferably all restrooms would be updated to meet accessibility requirements.</p>
