eua eppstein uhen : architects
Menomonee Falls School District
Vally View - Facility Study
Historical Plan

BUILDING INSPECTION REPORT

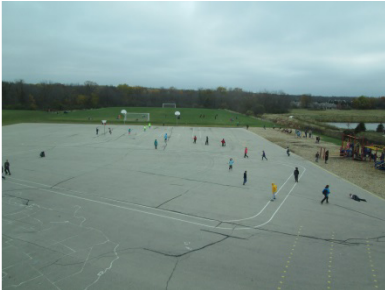
Playground

1. Address drainage at east end of asphalt playground.
2. Replace property fences.
3. Provide outside storage shed.
4. Consider providing additional site lighting.

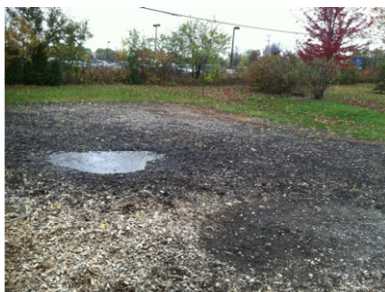
Playground area

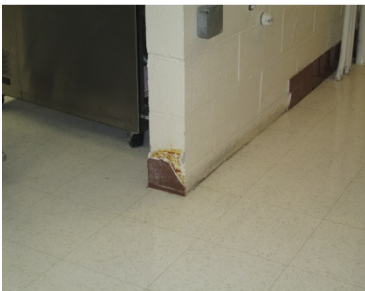
Tile wall base

- Expected life span - 20 years
- Current Condition - good
- Carpet – There are limited amounts of carpet in the building; primarily in offices.
 - Office carpet is in poor condition.
 - Classrooms use large rugs.
- VCT (Vinyl Composition Tile) – is dated, but in good to fair condition.
 - There are areas of cracked, failed tile. (See Specialty Areas in report.)
- Quarry tile in the kitchen is original but holding up well.
- Recessed walk off mats are installed at all of the vestibules. These are original to the building.
- Wall base is in fair condition.

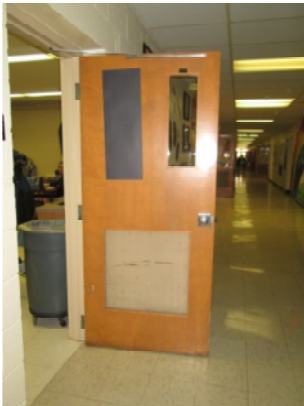
Typical classroom door

- Expected life span 40 years with periodic maintenance
- Current Condition - fair
- A majority of doors appear to be in good-fair condition, however due to the use and continued operation of interior wood doors the facing veneer will chip and tear over time and experience scrapes and dents.
- Doors have settled and do not open and close properly.
- Some locksets include an "ADA-attachment" however most door knobs are original to the 1966 building.
- Intruder lock function is not provided.
- Metal door frames can be repaired and painted. Door chips and scratches can be sanded, filled and restrained to revive an old door. Depending on severity of door or frame damage, it may be cost effective to replace the entire door and frame.
 - Grilles in typical classroom doors are dented and damaged.
- Noted area of broken glass in sidelight.

1. Replace or refinish doors in poor condition.
2. Paint all door frames.
3. Adjust doors so that they latch properly.
4. Replace door hardware to be ADA compliant.

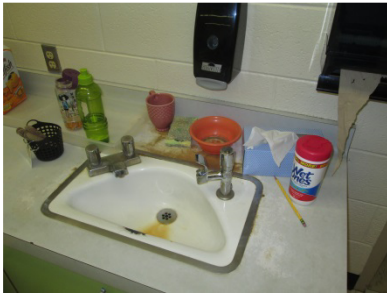
Typical classroom sink

- Expected life span 20-25 years
- Current Condition - fair
- Typical classroom casework is in fair condition and well worn.
 - Some cabinets do not remain closed.
 - Plastic laminate is prone to chips, dents, and delamination. In wet areas, the backing plywood swells and causes adhesive to let go.
 - Steel drawer slides experience ball bearing slide failures, friction and worn surfaces. Hinges lose their loading ability over time due to door weight, pressure applied when opened by hanging on them, frequent open /close and poor adjustment.
- Sink / faucet – see plumbing report.
 - Areas of the countertop at the sink are well worn and deteriorating.
- Corridor/classroom cubbies are in similar condition.
 - Cubbies are typically located in the classrooms. Additional cubbies were placed in the corridors.
- Blinds are worn and damaged.

1. Replace casework in typical classrooms.
2. Replace Art casework with more durable countertops and casework.
3. Consider replacing the blinds at all windows.

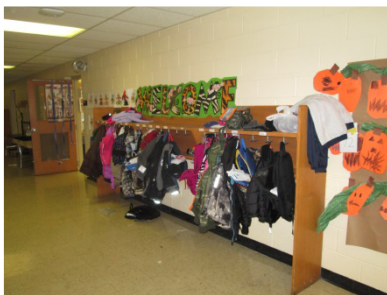
Corridor cubbies

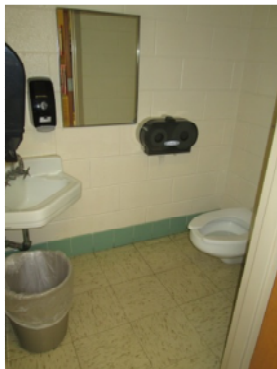
Single-hole restroom at kindergarten

- Current Condition - fair
- Refer to ADA report for accessibility recommendations
- Finishes are worn and dated but in fair condition. They are original to the 1966 building.
 - Ceramic Floor and Wall Tile (expected life span 40 years) – fair, older grout holds bacteria
 - Ceiling- (expected life span 15 years) fair
 - Toilet Partitions -(expected life span 15 years) fair
 - Accessories – (expected life span 8-10 years) good
- Public restrooms on first and second floor are centrally located.
 - A single stall was modified to provide accessibility.
- The single-hole restrooms between classrooms are original to the building.
- An accessible restroom and shower is provided in the 1997 addition with direct access to the gym.

1. All restrooms: Remove and replace all finishes: ceilings and wall and floor tile. Replace toilet partitions with anti-graffiti plastic type. Paint all walls that are not tiled. Some restrooms may need to be reconfigured due to accessibility requirements.
2. Refer to MEP reports for fixture, ventilation and lighting recommendations.

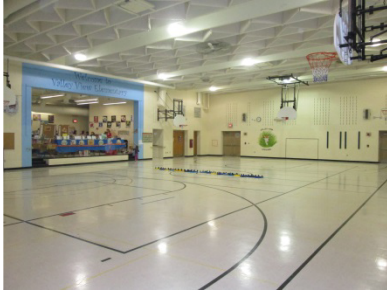
Gym

- Current Condition – good condition
- Areas of flooring along east wall are damaged. The main gym floor appears to be in fair to good condition.
- Southeast corner of gym has hollow sound when ball is bounced.
- Basketball backboards and wall mats are in good condition.
- A stage is provided in the gym. This is accessed by stairs and a ramp.

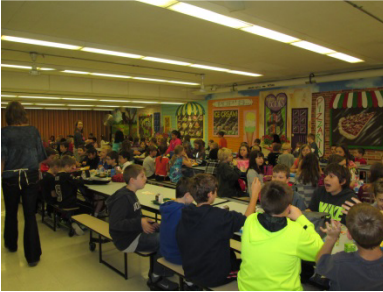
Cafeteria

- Current Condition – good condition
 - Flooring – good condition.
 - Ceiling – fair condition.
- Ceiling fans hang low in cafeteria.
- Operable wall between kitchen and cafeteria is old, worn and does not function well.
- Operable wall between cafeteria and music room remains closed.
 - Operable walls do not provide enough acoustic separation for two high-noise spaces such as a music room and cafeteria.
- Current furniture limits the flexibility for arranging the space.
- There have been reported leaks at the west wall of the kitchen.

1. Provide daylighting.
2. Update Cafeteria furniture.
3. Replace operable wall between kitchen and cafeteria.
4. Replace operable wall between cafeteria and music room with permanent wall.
5. See Section 3 – Educational Adequacy Assessment for additional recommendations.

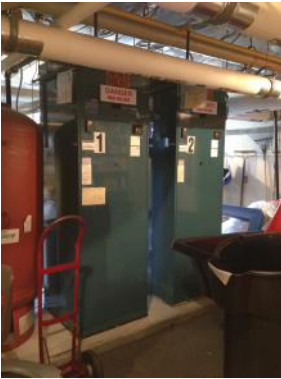
- The boiler plant is in good overall condition. With recommended maintenance, the boilers should continue to serve the facility for approximately 15 more years.
- Boiler water chemical systems are in place and are reported to be maintained.
- Insulation at most piping is of adequate thickness.
- Thermometers and gauges are present and appear to be working at all locations.
- Piping is adequately supported where observed.

Hot Water Boilers

1. Continue preventative maintenance on the hot water boilers and pumping systems.

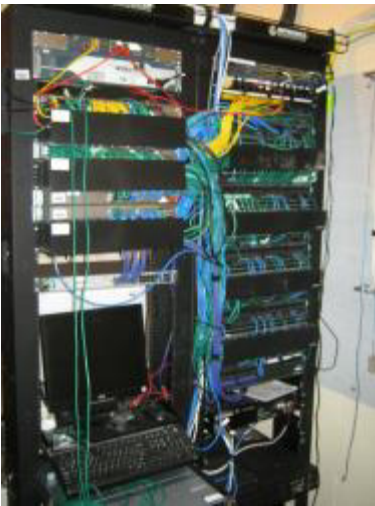
Data Rack

1. New data drops can be added at any point. A possible new data rack may be required to accommodate any new rack-mounted equipment.
2. Provide proper telecom grounding system.

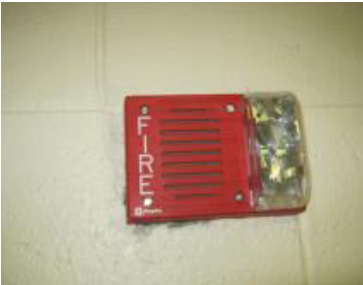
- The fire alarm system is a Simplex 4002 conventional zoned system. The facility does not have smoke detectors in corridors with open cubby areas. There are horn strobe devices in the corridors only. This fire alarm system is not expandable and does not meet current code.

Fire Alarm Notification Appliance

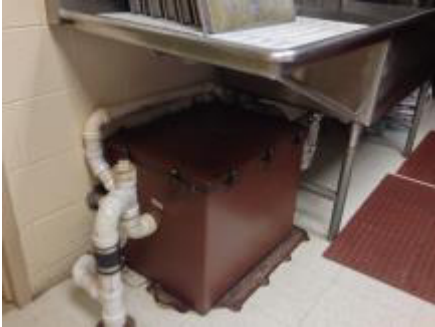
- The existing sanitary waste and vent piping is a mixture of cast-iron, galvanized and schedule 40 PVC. Schedule 40 PVC waste and vent piping was used to repair piping failures.
- The owner indicated that the primary piping system is original and is in good condition. The system was viewed with a camera in 2012 and appeared to be in good condition.
- An interior grease interceptor is located in the kitchen below the three-compartment sink. The grease interceptor is in fair condition and appears to be adequately sized for its usage. Current codes also require the dishwasher to discharge through a grease interceptor.

Grease Trap

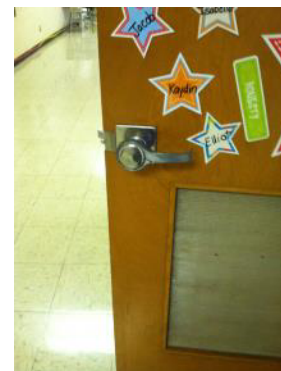
Door hardware attachment

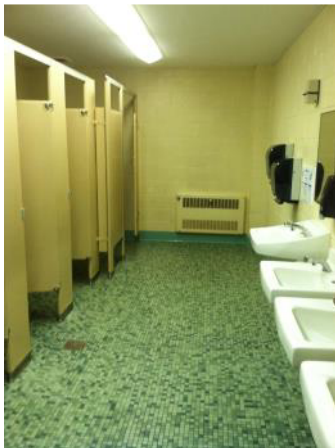
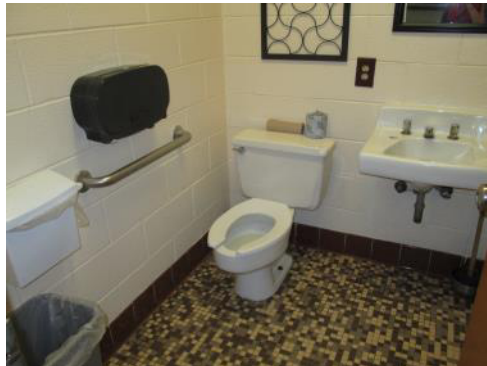
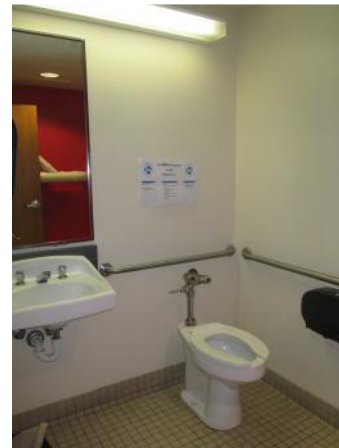
F - TOILET FACILITIES

ITEM	ADA REFERENCE
1.	Toilet facilities on the first and second floors have been update to include accessible stalls and sinks.	603
2.	Three single fixture toilet rooms on the first floor are not accessible.	603
3.	An accessible toilet and shower is provided on the lower level, attached to the gymnasium.	603
RECOMMENDATION: 1. None.
