Menomonee Falls School District  
Menomonee Falls High School - Facility Study  
Historical Plan

eppstein uhen : architects  
EUA No. 313258-01

## BUILDING INSPECTION REPORT

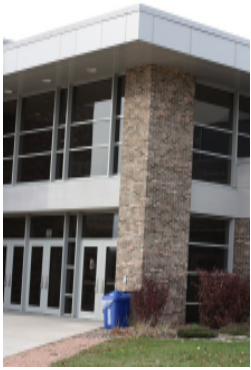
Main entrance

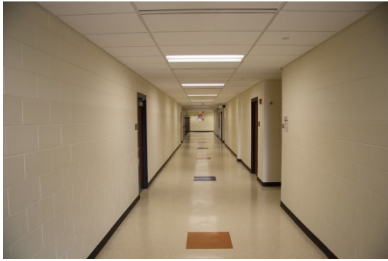
Concrete block corridor wall/ VCT flooring

- Expected life span - 50 -100 years with periodic maintenance
- Current Condition - Good
- Most interior walls are concrete block and show no signs of cracks, fractures or failure.

- Paint is in good condition.
- Drywall walls shown signs of light abuse but have been regularly maintained.
  - Drywall walls are easier and less messy to demolish, easier to rebuild and are more flexible than concrete block. While the durability of walls are essential inside of schools given the nature of abuse they take, for future flexibility the District should consider the types of walls it plans for future spaces given the flexibility, cost and disruption of drywall versus masonry construction.

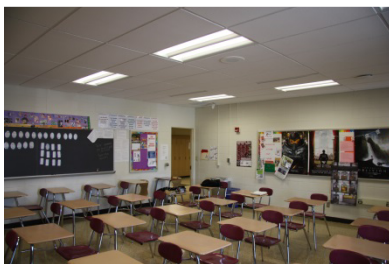
- Expected life span 15 years; replaced in 2007
- Current Condition – good
- Acoustical ceilings are generally in good shape with few areas of water-damaged or discolored tile.
  - Acoustical lay-in ceilings have tendency to sag over time and discolor.
  - Ceiling grid discolors as well.
- There were a few instances where ceiling tiles were removed and never replaced.
- When mechanical systems above ceilings are renovated, it is customary to remove and replace the entire ceiling at that time because it is less costly to remove and reinstall the same ceiling.

Acoustical ceiling tile

1. Replace acoustical lay-in ceiling tile where damaged or water-stained.

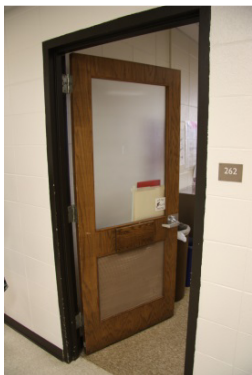
- Expected life span 40 years with periodic maintenance
- Current Condition – 75% fair, 25% good
- A majority of doors are in fair condition, except for those installed during the renovation/addition in 2007, which are in good condition.
- All locksets were replaced and are ADA compliant. These appear to be in good shape.
- Metal door frames can be repaired and painted. Door chips and scratches can be sanded, filled and restrained to revive an old door. Depending on severity of door or frame damage, it may be cost effective to replace the entire door and frame.

Typical classroom door

1. Replace doors in poor condition.
2. Paint all door frames.

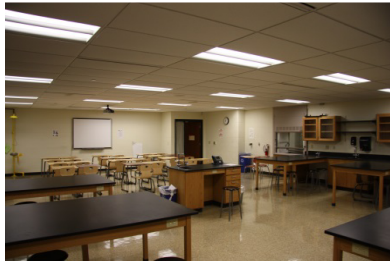
Science Lab cabinetry

- Expected life span 20-25 years
- Current Condition – good to fair
- Plastic laminate is prone to chips, dents, and delamination. In wet areas, the backing plywood swells and causes adhesive to let go.
- Steel drawer slides experience ball bearing slide failures, friction and worn surfaces. Hinges lose their loading ability over time due to door weight, pressure applied when opened by hanging on them, frequent open /close and poor adjustment.
- Sink / faucet – see plumbing report.
- Corridor lockers are in good working condition.

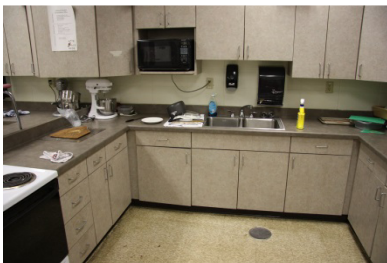
FACE casework

1. Repair damaged cabinet doors in art and FACE rooms.

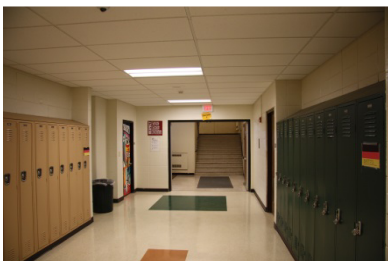
Corridor lockers

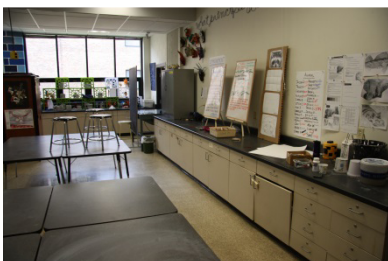
Art room casework

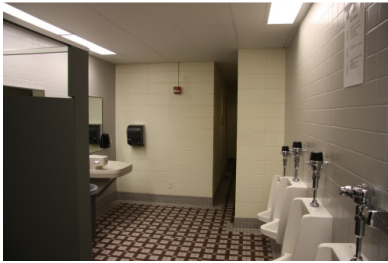
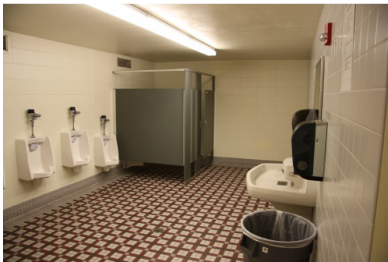
Typical restroom

- Current Condition - Good
- Refer to ADA report for accessibility recommendations
- Finishes are new and in good condition
- Ceramic Floor and Wall Tile (expected life span 40 years) – good
- Ceiling- (expected life span 15 years) good
- Toilet Partitions -(expected life span 15 years) good
- Accessories – (expected life span 8-10 years) good

1. Refer to MEP reports for fixture, ventilation and lighting recommendations.
2. See Section 3 – Educational Adequacy Assessment for additional recommendations.

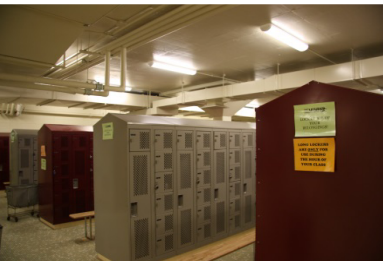
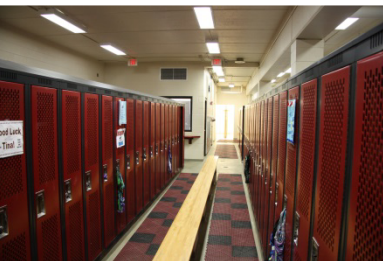
Boys' Locker Room

Girls varsity Locker Room

- Current Condition – good to fair
- Finishes are worn and dated but in fair condition.
  - Ceramic Floor and Wall Tile (expected life span 40 years) – fair, older grout holds bacteria
  - Ceramic tile has been patched with mismatching tile.
- Lockers are in good condition.

1. Consider upgrading finishes.
2. See Section 3 – Educational Adequacy Assessment for additional recommendations.

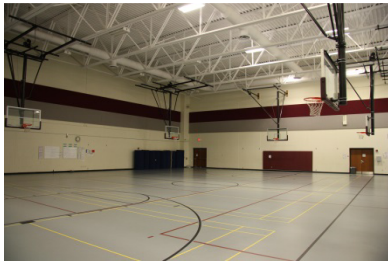
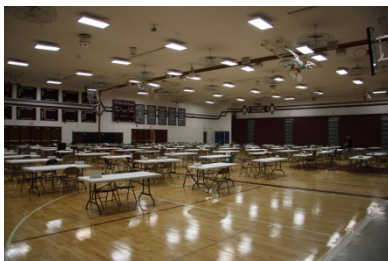
New gymnasium

Main gymnasium

- Current Condition – good to fair
- The school has two gymnasiums:
- The New gymnasium is in good condition.
  - Flooring – good condition
  - Basketball backboards and wall mats are in good condition.
- The Main gymnasium is in fair condition.
  - Ceiling – fair condition, some of the adhered acoustical ceiling tiles are beginning to fall.
  - Flooring – good to fair
    - The wood gym floor is in good condition.
    - The VCT (Vinyl Composition Tile) around the perimeter of the gymnasium is in poor condition.
  - Basketball backboards and wall mats are in good condition.
  - The bleachers are in good condition.

1. Replace ceiling tiles in main gymnasium.
2. Replace VCT flooring around perimeter of main gymnasium.
3. Replace ceiling fans in main gymnasium.
4. Paint auxiliary gym and replace wall padding.
5. Repair motorized partition in auxiliary gym.
6. See Section 3 – Educational Adequacy Assessment for additional recommendations.

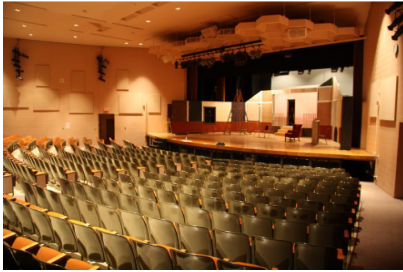
Auditorium

- Current Condition – fair to poor
- Flooring – fair condition
  - The carpet is worn and outdated.
- Ceiling – good
- Seating – poor
  - The fabric on some chairs is worn or torn.
  - The fabric is outdated.

1. Consider replacing carpet.
2. Replace or refinish auditorium seating.
3. See Section 3 – Educational Adequacy Assessment for additional recommendations.

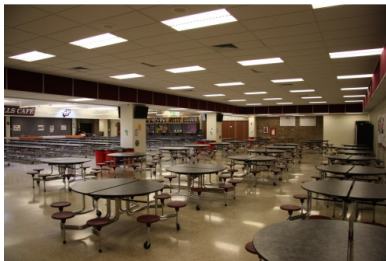
- Current Condition – good
- Flooring – good condition.
- Ceiling – good condition.
- Tables – good condition.

Cafeteria

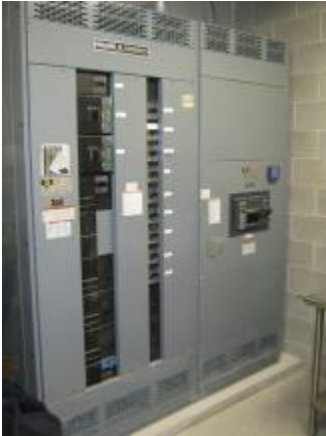
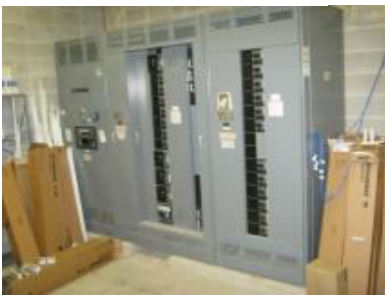
Service Panel 1

Service Panel 2

1. Keep existing Square D panels in place; add additional circuits if required.
2. Replace the old panels.
3. Replace all old feeder wires.

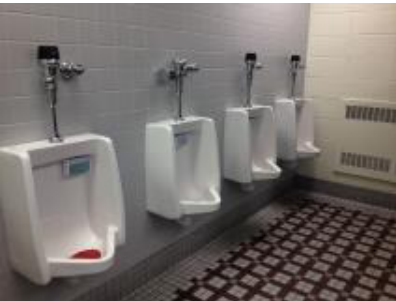
Toilet Room Fixtures in Original School 1

- The main toilet rooms supporting the cafeteria are in very good condition. These rooms were renovated as part of a project in 2007. Toilet rooms are provided with flush valve, wall-hung water closets and urinals. Two (2) three-station Bradley wash fountains are located in each restroom.
- Toilet rooms throughout the building are in fair condition. These fixtures are old however they are not original to the building and have been very well maintained.
- The toilets for the pool are too small for the space.

1. Continually maintain toilet room fixtures.
2. Schedule toilet room fixtures for replacement. These fixtures could be placed on a long term maintenance budget.
3. Modify pool toilet rooms to accommodate more people.

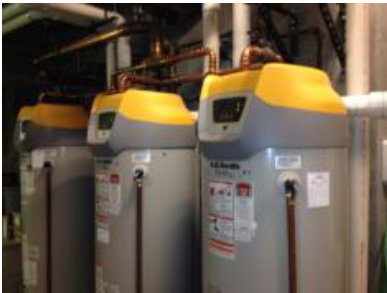
Water Heaters

- The domestic water heating system for the school consists of three (3) A.O. Smith 250,000 BTU, sealed-combustion, gas-fired domestic water heaters. The heaters are in good condition and appear to be accurately sized for the actual building demand. The water heaters life expectancy is approximately another 15 years.
- The domestic water heating system supplies hot water for the kitchen, laundry and all remaining hot water demands for the building. The heaters are set with an outlet temperature of 140 degrees which is designated for the laundry and kitchen. The remaining water is controlled with a mixing valve and routed through the building at 120 degrees.
- The domestic water heating equipment for the pool is in fair condition.

4. Provide continual maintenance on the existing water heating equipment.
5. Provide long-term budgeting for replacement equipment.

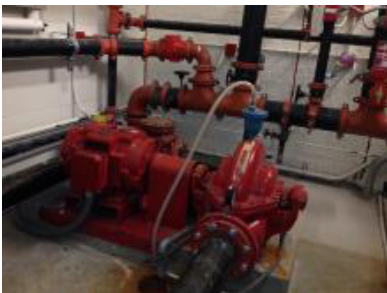
Fire Pump

- The 2007 addition was provided with a new 8" water service and fire pump. This system is in very good condition; however it appears to be oversized for its current demand. This system currently only serves the 2007 addition but it is believed that the system is sized to provide fire protection for the entire building should the school district chose to do so.
- Sprinkler piping materials are schedule 40 and schedule black iron pipe. Piping appears to be in good condition.

3. Provide interior fire sprinkler system for the existing building as required.

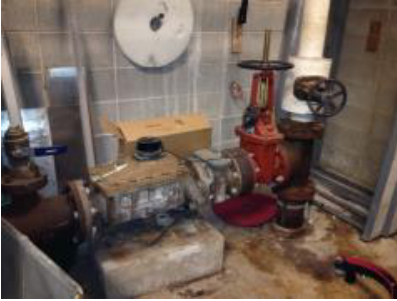
Water Service

- The building is provided with a 6" domestic water service and 6" water meter. This service and meter appear to be oversized for the domestic water demand.
- Domestic water piping in the addition is entirely type "L" copper tube. The domestic water supply mains were replaced in the original building as part of the 2007 addition. Some galvanized branch piping still remains in the walls that serve existing fixtures.
- Water pressure appears to be adequate throughout the building.

1. The remaining galvanized water piping should be scheduled for replacement. This will be difficult because the existing piping is located in the concrete walls. The piping should be replaced on a as- needed basis.

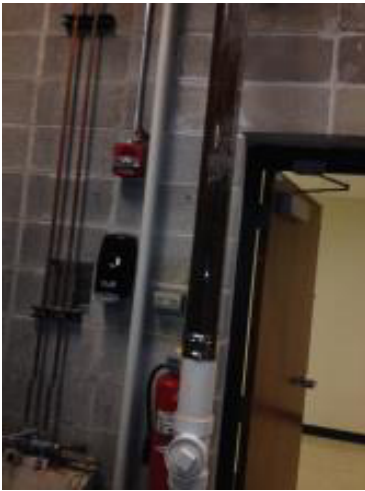
Sanitary Piping

- The existing sanitary waste and vent piping is a mixture of cast-iron, galvanized and schedule 40 PVC. All piping located in the 1969 building is primarily cast iron and galvanized unless the space was renovated.
- Schedule 40 PVC was used in throughout the 2007 addition. This piping is in good condition.
- The owner indicated that the primary piping system is original and is in good condition. The system was viewed with a camera and appeared to be in good condition.
- This facility has an interior grease interceptor. The interceptor appears to be in fair condition and is reported to be maintained on a regular basis
- Art room sinks are provided with plasters traps as required.

1. Original sanitary sewers should be continually monitored and inspected with a camera on a regular basis.
2. Per code, a grease interceptor is not required until modifications are made to the existing kitchen, dishwasher or the original grease interceptor. At that time, a new grease interceptor should be added for dishwasher.
3. Continually maintain the existing grease interceptor.

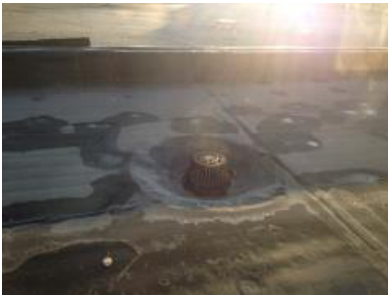
Roof Drains

- The existing storm piping is a mixture of cast-iron, galvanized and schedule 40 PVC. All piping located in the 1969 building is primarily cast iron and galvanized unless the space was renovated.
- Schedule 40 PVC was used throughout the 2007 addition. This piping is in good condition.
- The owner indicated that the primary piping system is original and is in good condition. The system was viewed with a camera and appeared to be in good condition.
- Lower levels are provided with clear water sump pumps for drain tile. None of the pumps witnessed are provided with alarms or controls. A sump pump is installed in the lower level to discharge this storm water.

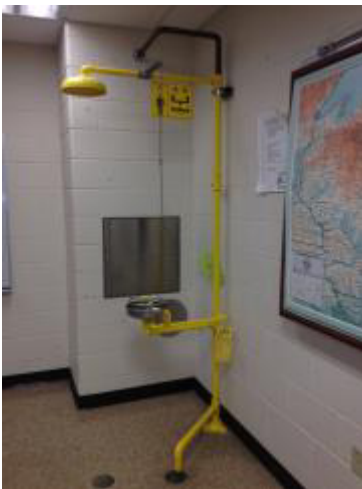
Emergency Eye Wash

- Classroom sinks are generally in good condition. Many of the fixtures are new as part of the 2007 addition. Only a few classrooms have sinks within the room, which is typical of a high school.
- Science rooms are in good condition. All sinks are phenolic type integral bowls with hot and cold water and dual outlet gas controls.
- The science rooms are supported by an emergency eye wash/shower. The fixture is in good working condition; however, it does not have a thermostatic mixing valve to control water temp. This is not a code requirement but is an OSHA recommendation.
- Science rooms also have an emergency shut off valve for the gas system. The main gas control is in a locked wall access panel which is very cumbersome to operate.
- Art room sinks appear to have been updated and are in good condition.

1. Provide a mixing valve for all eye-wash/shower stations.
2. Relocate controls for the main gas shut-offs to each science room.

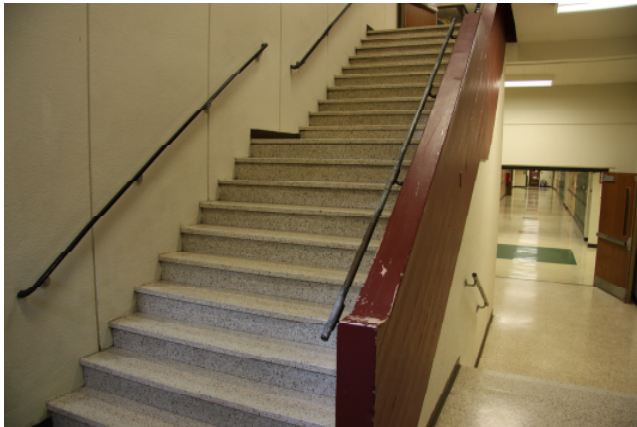
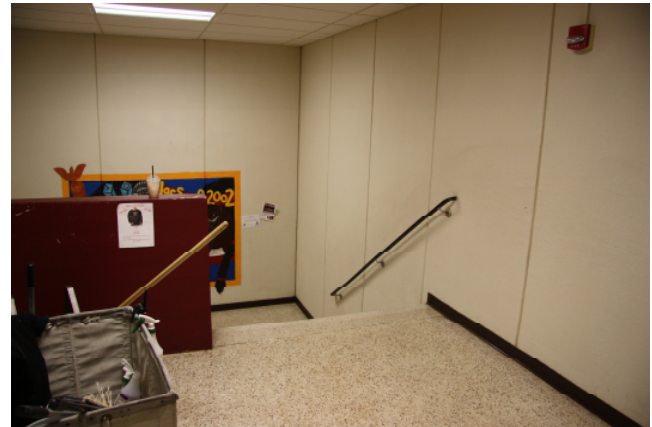
ITEM	ADA REFERENCE
1.	Stairs in the new additions meet accessibility requirements. In the original building many of the Stairs handrails do not comply with current extension requirements beyond the top and bottom stair risers.	505
RECOMMENDATION: 1. Replace existing handrails with accessible handrails at the original building.
