Menomonee Falls School District
Thomas Jefferson - Facility Study
Historical Plan

EUA No. 313258-01

BUILDING INSPECTION REPORT

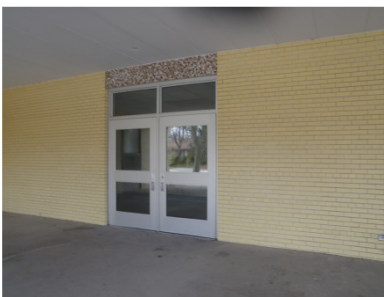
Broken glass in aluminum
frame

- Expected life span 20 years for steel, 30 years for aluminum/ FRP systems
- Current Condition - fair
- Steel doors have areas of rusting on the interior and exterior.
 - The lower portion of exterior steel door and frames are prone to rust and deterioration faster than aluminum is. Steel systems are not thermally broken causing condensation to form on the interior which results in steel corrosion.
 - Exterior hinges and locksets are prone to fail most and are the most costly to replace. Screw holes may strip out losing holding power, doors may drop and no longer align between lockset and frame latch, closers will fail due to over burden, and surface applied weather-stripping fails.
- A single set of FRP doors are in good condition.
- Aluminum doors are in good condition.
 - One of the doors was recently broken into and has been boarded up.

1. Replace all exterior steel doors and frames with new FRP (fiber reinforced plastic) doors in aluminum frames. Include replacement of all exterior door hardware.

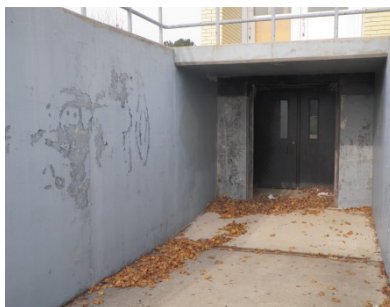
Entry soffit

- Life Expectancy – same as building
- Current Condition – good to fair
- There are areas of chipped painting on the building's entry soffits.
- A metal fascia is provided around the building. This is generally in good condition. There are a few areas of dented fascia.
- Mechanical louvers below windows are dented and damaged in areas.

1. Replace/repair any damaged mechanical louvers.
2. Repaint entrance soffits.
3. As roof replacements are required, replace metal fascia.
4. Repaint all concrete retaining walls at lower level exits.

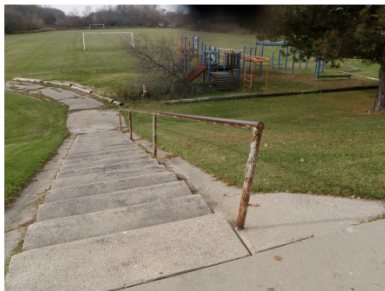
Trash enclosure

- Concrete and asphalt were reviewed independently. See appendix for reference reports.
- Grounds are well maintained.
- Trash enclosure is old and failing.
- Playground spaces appear to be in good condition, despite the lack of use the past few years.
- Playing fields for soccer, athletics and phy ed appear to be in good condition.
- There is no outside storage for lawn or grounds equipment.

1. Replace/repair trash enclosure doors.
2. Repaint all exterior metal (stair handrails).
 - a. Consider replacing any non-code complaint exterior railings.

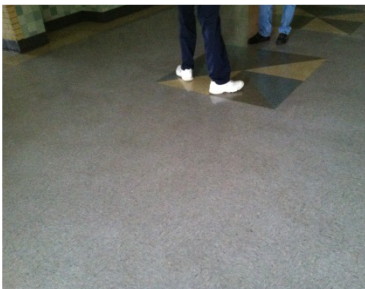
- Expected life span 20 years
- Current Condition - good
- Carpet – There are limited amounts of carpet in the building; primarily in offices.
 - Office carpet is in poor condition.
- VCT (Vinyl Composition Tile) – is in good to fair condition.
 - There are minimal areas of VCT used in the building.
- VAT (Vinyl Asbestos Tile) – is original to the building and in fair condition.
- Wall base is in fair condition.

Corridor VCT

1. Continue annual maintenance for small areas of VCT flooring.
2. Consider replacing all VAT with alternative material.
3. Replace all carpeting.

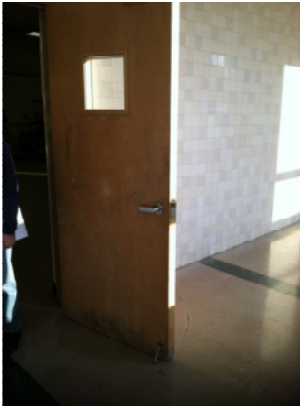
Sound door at Music

- Expected life span 40 years with periodic maintenance
- Current Condition - fair to poor
- A majority of doors appear to be in fair condition, however due to lack of use there are missing vents, door hardware and glass in some doors.
- Continued operation of interior wood doors will cause the facing veneer will chip and tear over time and experience scrapes and dents.
- Metal door frames are in fair condition.

1. Replace or refinish doors in poor condition.
2. Paint all door frames.
3. Replace all door hardware to be ADA compliant.

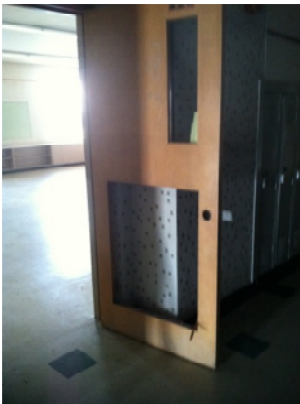
Classroom door

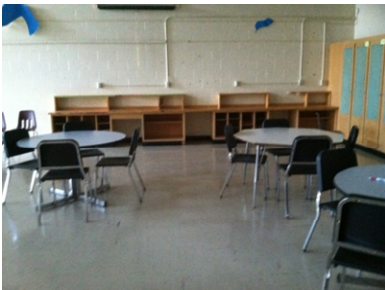
Art casework

- Expected life span 20-25 years
- Current Condition - poor
- Typical classroom casework is limited to metal shelving that is integral with the room's unit ventilator.
- Science and Art areas include additional casework.
 - Some cabinets do not remain closed.
 - Plastic laminate is prone to chips, dents, and delamination. In wet areas, the backing plywood swells and causes adhesive to let go.
 - Steel drawer slides experience ball bearing slide failures, friction and worn surfaces. Hinges lose their loading ability over time due to door weight, pressure applied when opened by hanging on them, frequent open /close and poor adjustment.
- Sink / faucet – see plumbing report.
- Corridor lockers are in good to fair condition.

1. Replace casework in typical classrooms.
2. Replace Art casework with more durable countertops and cabinets.
3. Paint corridor lockers.
4. Replace blinds/roller shades in building.

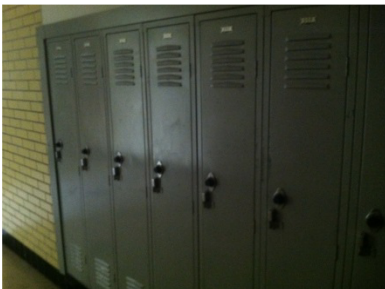
Corridor lockers

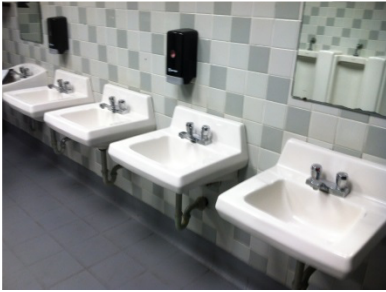
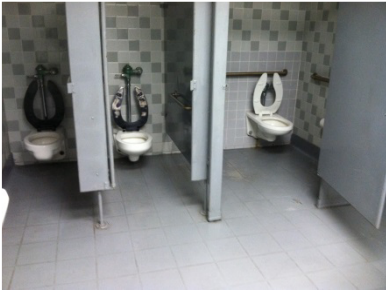
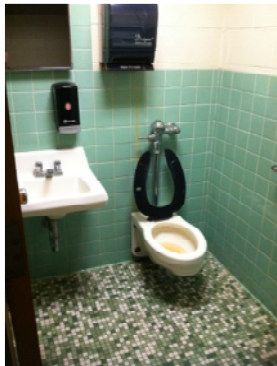
Typical restroom

Single-fixture restroom

- Current Condition - fair
- Refer to ADA report for accessibility recommendations
- Finishes are worn and dated but in fair condition. They are original to the 1961 building.
 - Ceramic Floor and Wall Tile (expected life span 40 years) – fair, older grout holds bacteria
 - Ceiling- (expected life span 15 years) fair
 - Toilet Partitions -(expected life span 15 years) fair
 - Accessories – (expected life span 8-10 years) good
- Public restrooms floor are well-located throughout the building.
- The single-hole restrooms are original to the building. Four have been provided in the administrative suite. Two others are located near the cafeteria.

1. All restrooms: Remove and replace all finishes: ceilings and wall and floor tile. Replace toilet partitions with anti-graffiti plastic type. Paint all walls that are not tiled. Some restrooms may need to be reconfigured due to accessibility requirements.
2. Refer to MEP reports for fixture, ventilation and lighting recommendations.

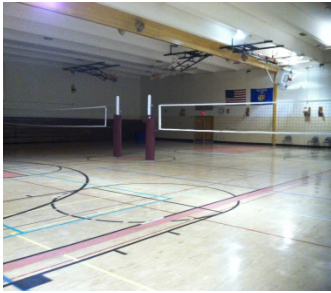
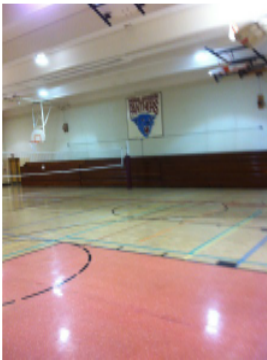
Gym

- Current Condition – good condition
- Basketball backboards and wall mats are in good condition.
- There is an operable partition to allow for two-sections of activity. It functions well, but is damaging the floor.

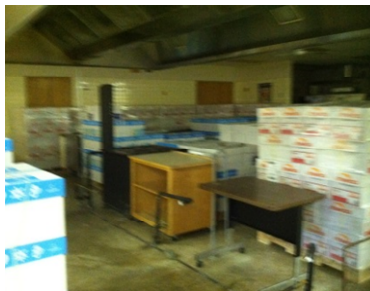
Kitchen

- Current Condition – good to fair condition
 - Flooring – good condition.
 - Ceiling – fair condition.
- Cafeteria is not furnished.
- Kitchen equipment has been removed from the site.
 - Kitchen had been a fully-functioning cook kitchen. Some equipment has been removed from the facility.
 - Currently used as storage.

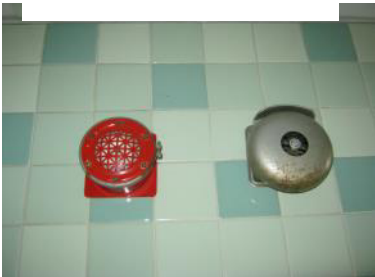
Fire Alarm Notification Appliance

1. Provide new Simplex addressable fire alarm system.

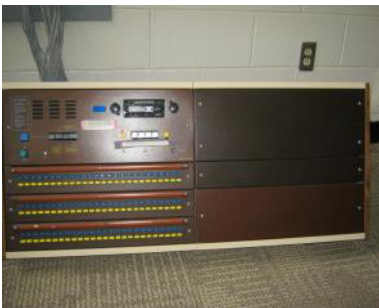
Public Address

1. Provide new public address system with programmed bells.
2. Connect public address system in all buildings for mass notification.
3. Provide new GPS based wireless clock system.

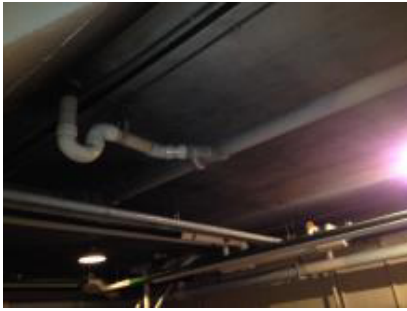
Sanitary Piping

1. Replace the existing grease interceptors.
2. Replace all interior sanitary waste and vent piping.
3. We recommend that a building of this age video inspect the interior sewers below the floor to determine the internal condition of the piping.

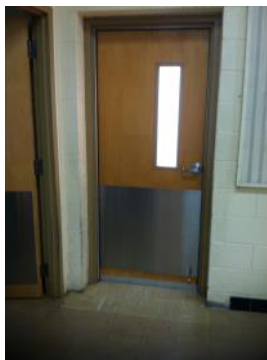
ITEM	ADA REFERENCE
1.	Main Entrance is accessible.	402, 404
2.	Classroom doors are typically accessible. Doors in the administrative suite are generally not accessible.	404
3.	Main Office reception desk does not meet the requirements for accessibility.	308
RECOMMENDATION:		
1. A service counter, maximum 34” above the floor is required for accessibility. Modify the existing reception desk. 2. Provide accessible door hardware.

Accessible door lever
