eppstein uhen : architects
EUA No. 313258-01

BUILDING INSPECTION REPORT

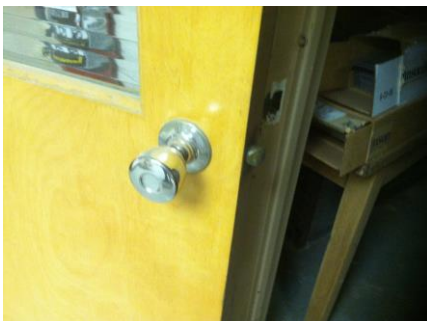
B - INTERIOR ACCOMODATIONS

ITEM	ADA REFERENCE
1.	Main Entrance appears to be accessible. The doors do not have a power handicapped operator. The ‘pull force’ required to open the door should be measured to confirm if it falls within accessibility requirements.	402, 404
2.	Classroom door hardware is not accessible.	404
<p>RECOMMENDATION:</p> <ol style="list-style-type: none"> 1. Provide new classroom door hardware that meets accessibility requirements. 2. Confirm that ‘pull force’ at the entrance door is within accessibility guidelines. Adjust/replace door closer as required to meet ‘pull force’ requirements for accessibility.

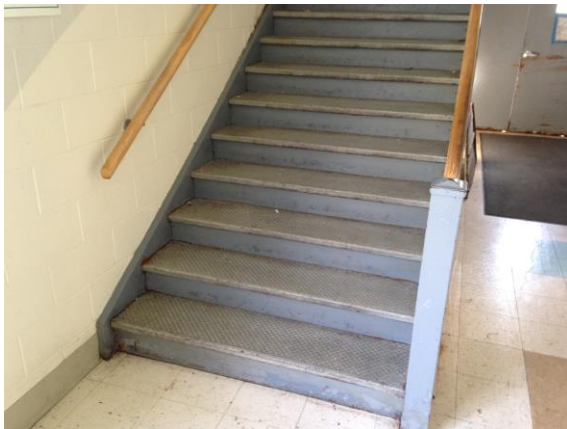
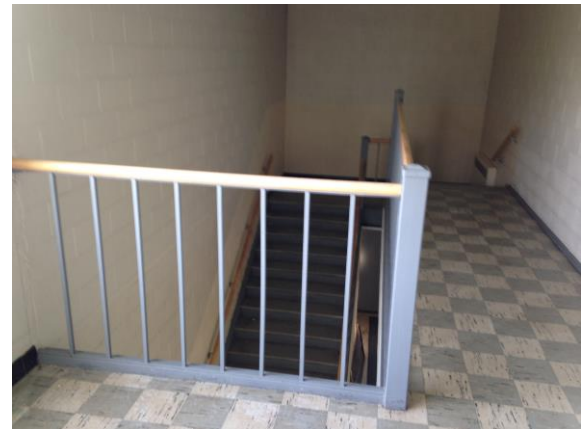
C - INTERIOR STAIRS / RAMPS

ITEM	ADA REFERENCE
1.	Stairs handrails do not comply with current extension requirements beyond the top and bottom stair risers.	505
RECOMMENDATION: 1. Replace existing handrails with accessible handrails.

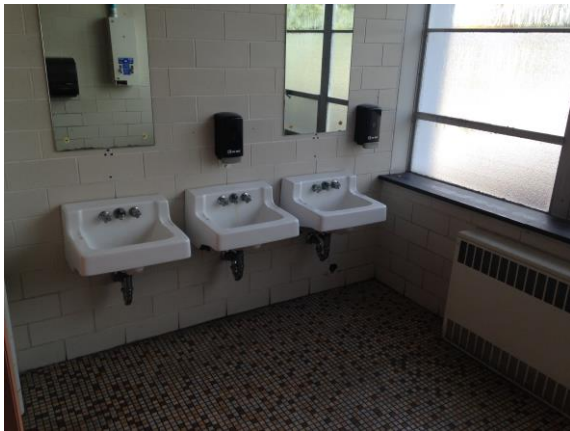
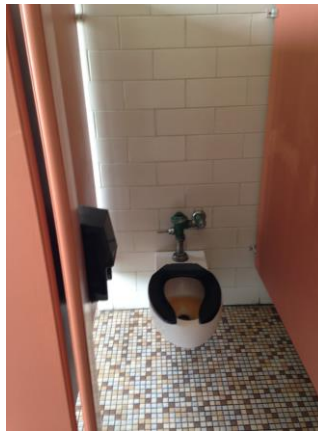
F - TOILET FACILITIES

ITEM	ADA REFERENCE
1.	No toilet rooms meet accessibility requirements.	603
<p>RECOMMENDATION: 2. Upgrade all restrooms to meet accessibility requirements.</p>
