The building is approximately 6,000 square feet and sits on 1.126 acres of land. The maintenance garage was built as a Village of Menomonee Falls building in 1968, with an addition in 1998.

BUILDING INSPECTION REPORT

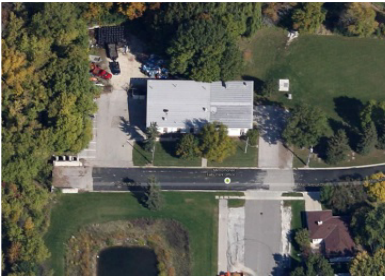
Site

- Observation of the site was limited to snowfall; however the grounds are generally in good condition.
- There is a fenced area for a mulch pile/ material storage.
- Parking appears to be adequate.
- Concrete and asphalt were reviewed independently. See appendix for reference reports.

1. None

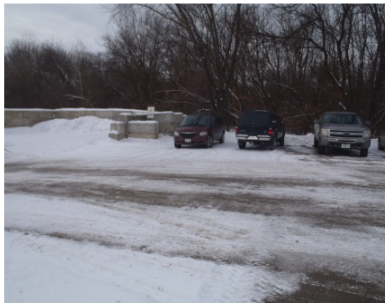
Material storage

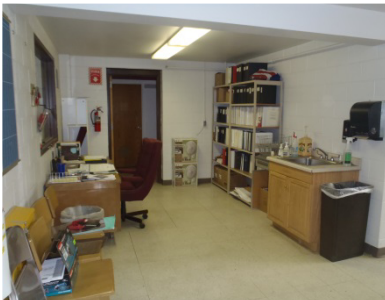
General interior workroom

- Expected life span - 50 -100 years with periodic maintenance
- Current Condition - Good
- Most interior walls are concrete block and show no signs of cracks, fractures or failure.
- Paint is in fair condition.
- Drywall walls shown signs of light abuse. Drywall walls are limited to the offices areas of the building.

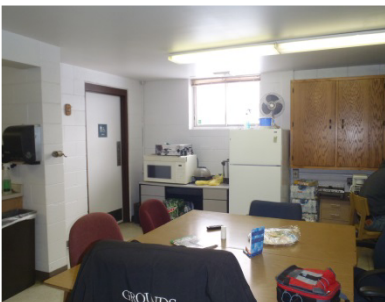
General interior workroom

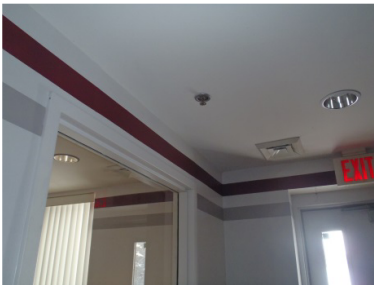
Ceiling

- Expected life span - 15 years
- Current Condition – good
- There are limited amounts of gypsum board ceilings in the office area.

1. None.

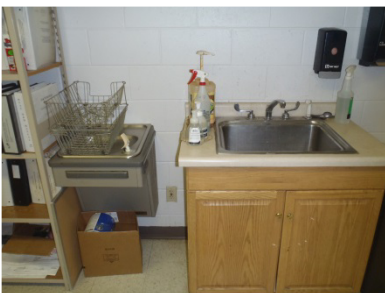
Casework

- Expected life span 20-25 years
- Current Condition - fair
- Typical classroom casework is in fair condition and of residential grade.

1. None.

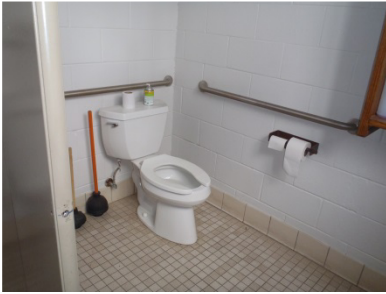
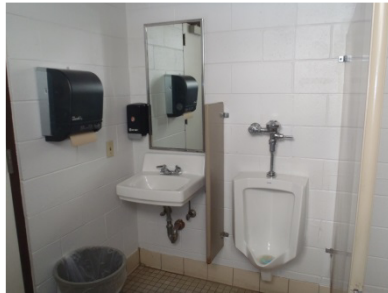
Restroom

- Current Condition - fair
- Finishes are worn but in fair condition.
 - Ceramic Floor and Wall Tile (expected life span 40 years) – fair, older grout holds bacteria
 - Ceiling- (expected life span 15 years) fair
 - Toilet Partitions -(expected life span 15 years) fair
 - Accessories – (expected life span 8-10 years) good

1. None.
2. No ADA accessibility recommendations.
