Roof Survey Data

**Menomonee Falls, School District of
Ben Franklin Elementary School (342)
Roof Area Number: 01**

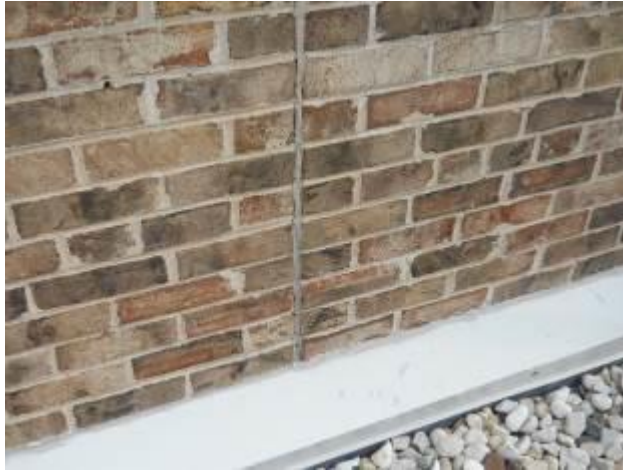
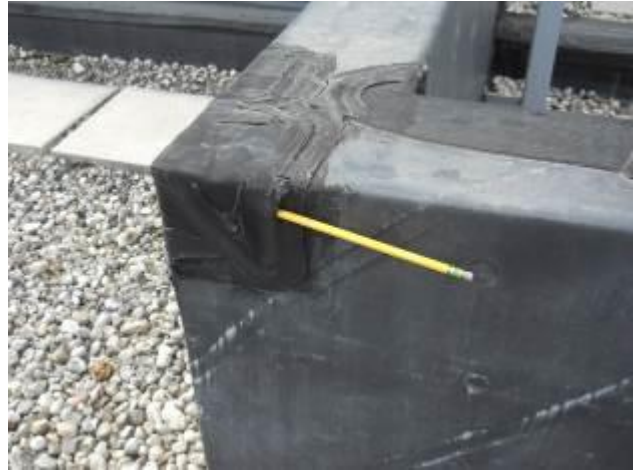
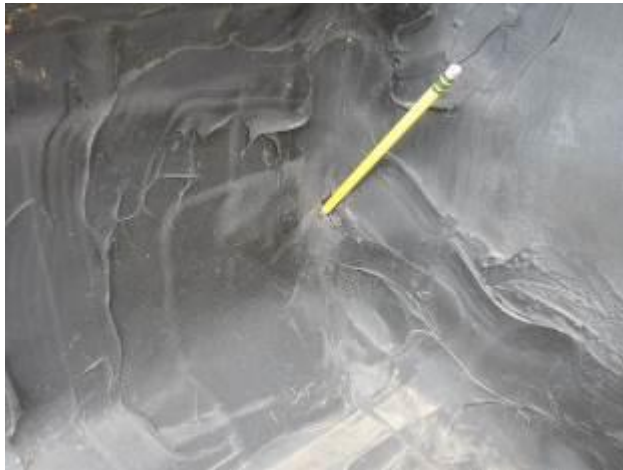
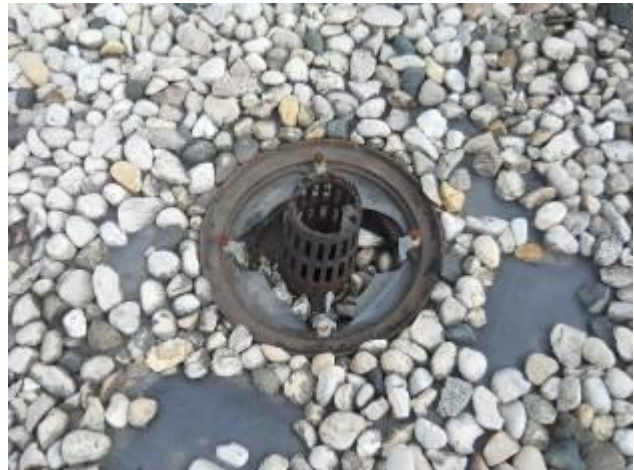
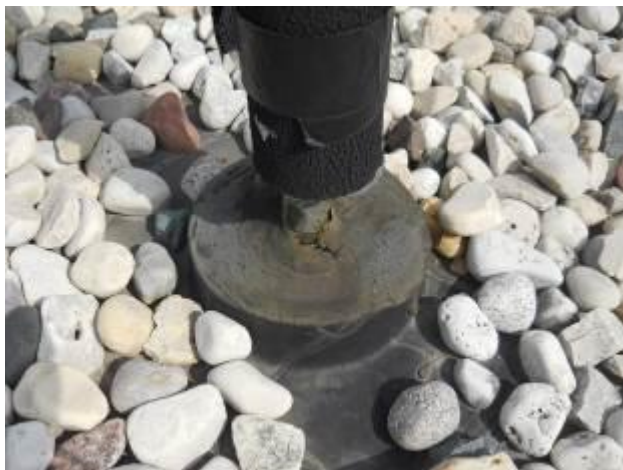
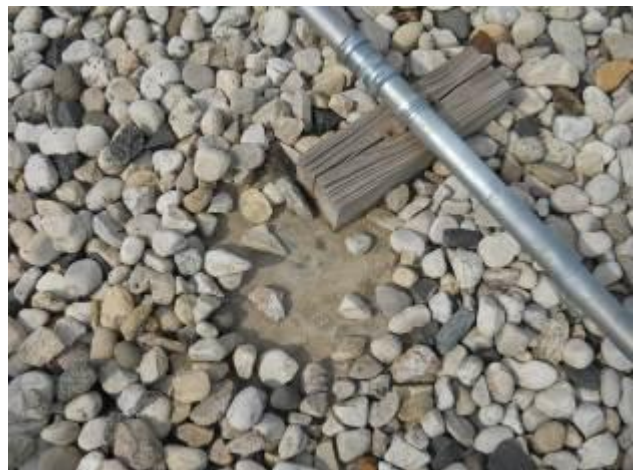
The roof membrane is in serviceable condition but we noted the sealant in the control joints of the wall panels, along the counter flashing, and at the ladder the sealant has failed. Several locations of construction debris were found on the roof membrane. Additionally, we noted open base flashings along the perimeter and curbs, a broken drain strainer a pitch pan which requires refilling and the 4x4 blocking lack slip protection membrane.

Engage IRS to develop an Annual Maintenance and Repair Specifications (AMRS) to address necessary preventative and remedial repairs.

Remedial repairs are necessary, and should be included in a future (AMRS).

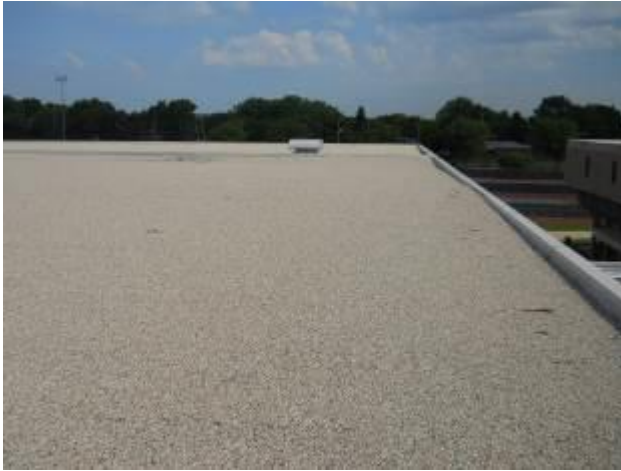
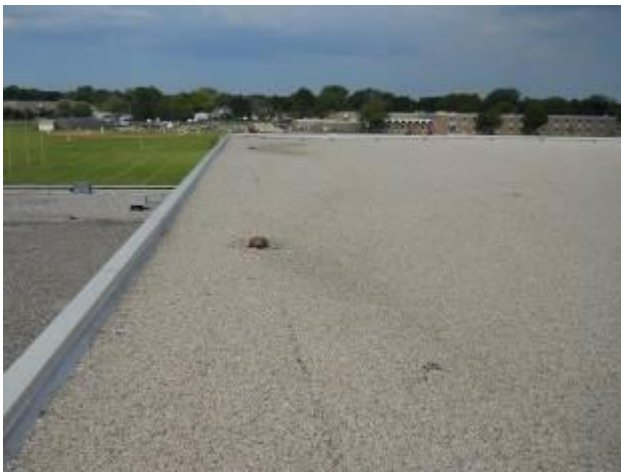
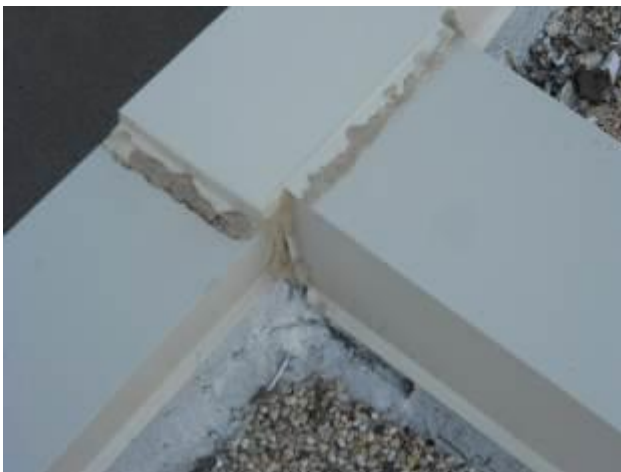
The roof membrane is in serviceable condition but we noted wind erosion in the southwest corner, sealant failure in the corners of the prefinished galvanized coping and the 4x4 wood blocks lack slip protection.

Engage IRS to develop an Annual Maintenance and Repair Specifications (AMRS) to address necessary preventative and remedial repairs.

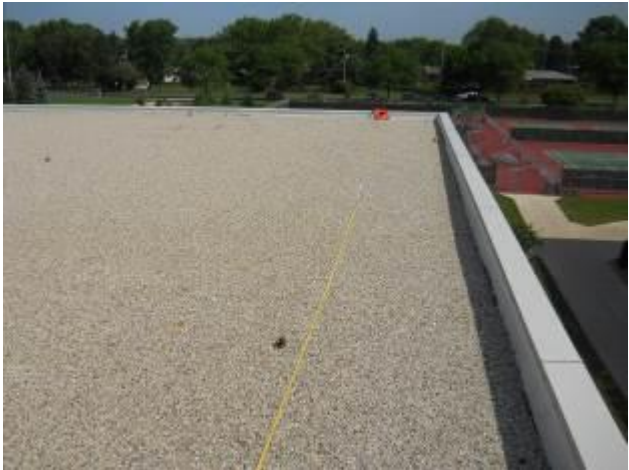
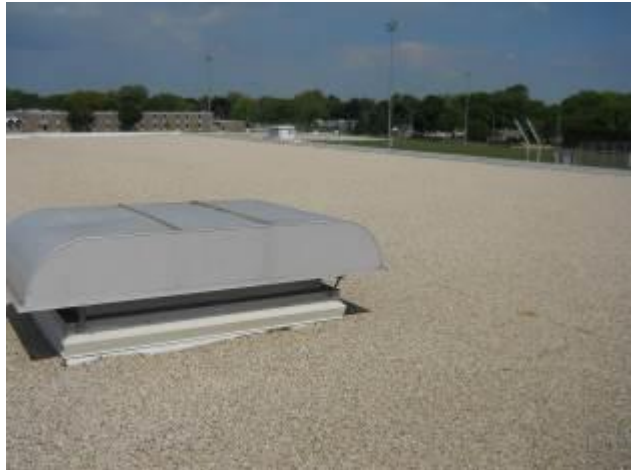
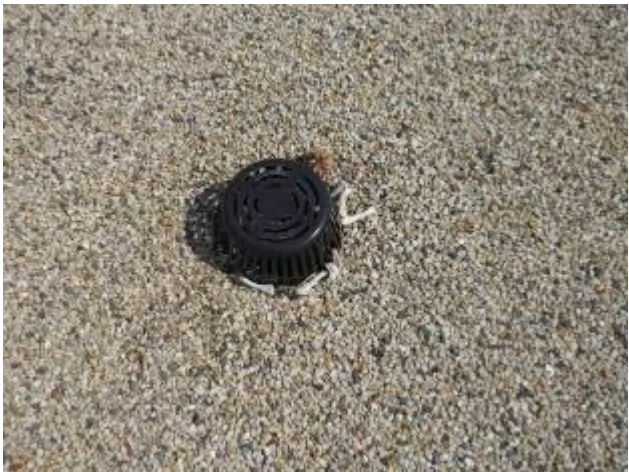
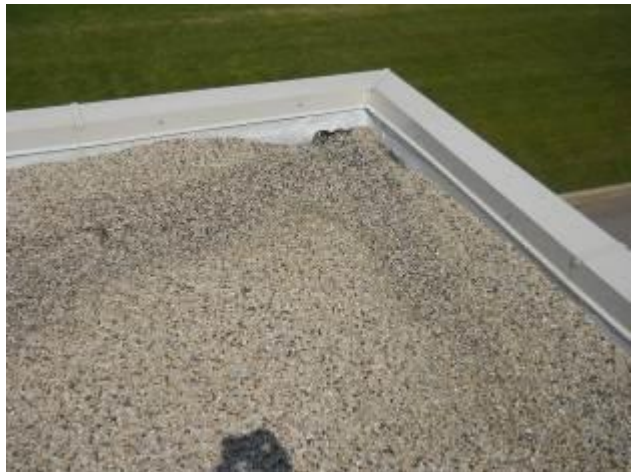
We did not note any deficiencies during our survey beyond the minor wind erosion occurring in the northwest corner and minor accumulation of debris on the roof surface.

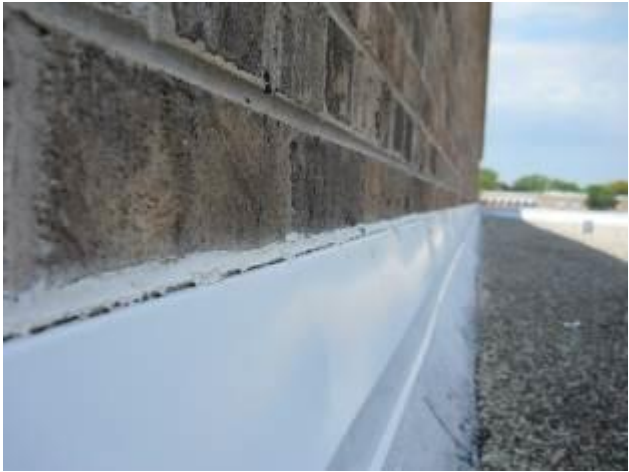
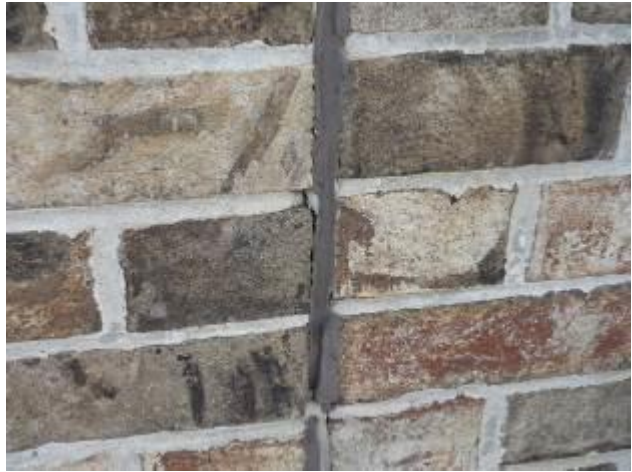
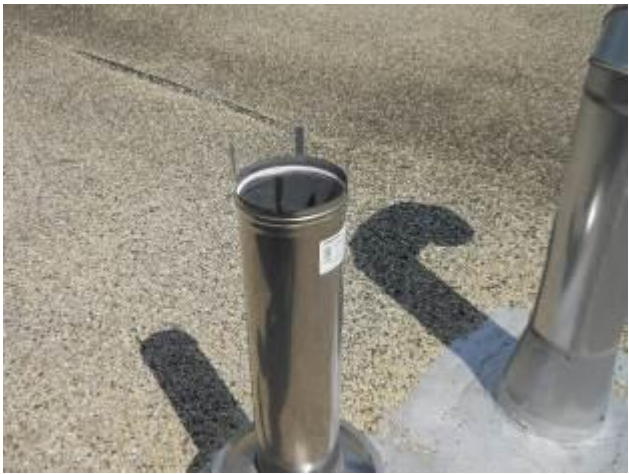
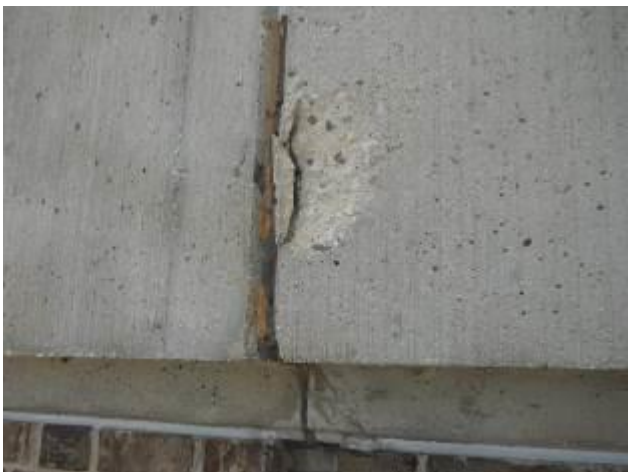
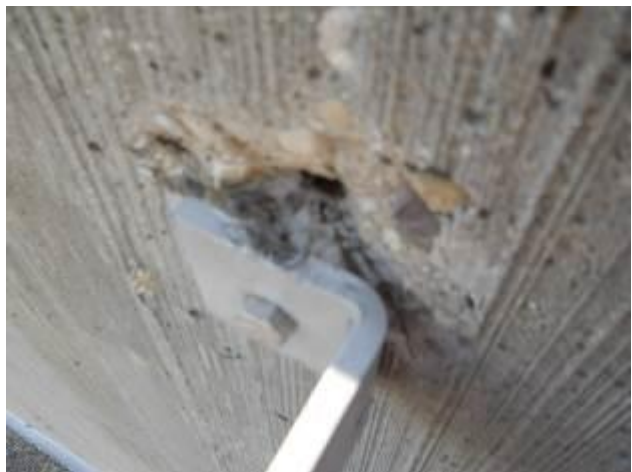
The roof membrane is in serviceable condition with failed sealant noted with construction joints along the counter flashing and of the masonry wall, a pipe vent missing a rain cap, blistering in the membrane and debris on the roof surface. Additionally, we noted two locations of spalled concrete in the wall panels and along the ladder rungs penetrating the wall system.

The 23 year old 2-ply & SBS modified bitumen built-up roof system is in serviceable condition but requires preventative & remedial maintenance at this time to facilitate its proper performance throughout the duration of its 25 year designed service life and extend its useful service life.

Engage IRS to develop an Annual Maintenance and Repair Specifications (AMRS) to address necessary preventative and remedial repairs.

Remedial repairs are necessary, and should be included in a future (AMRS).

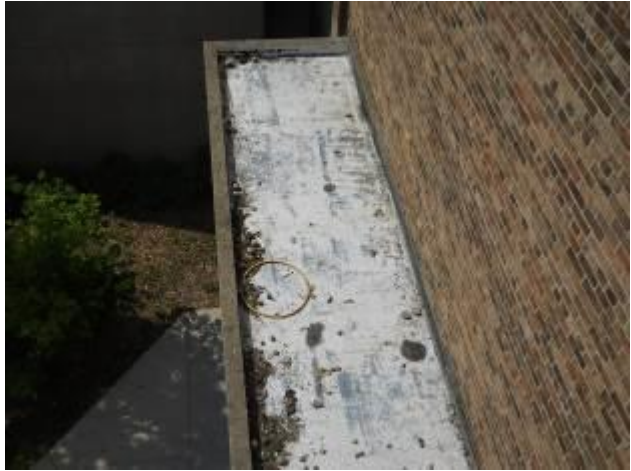
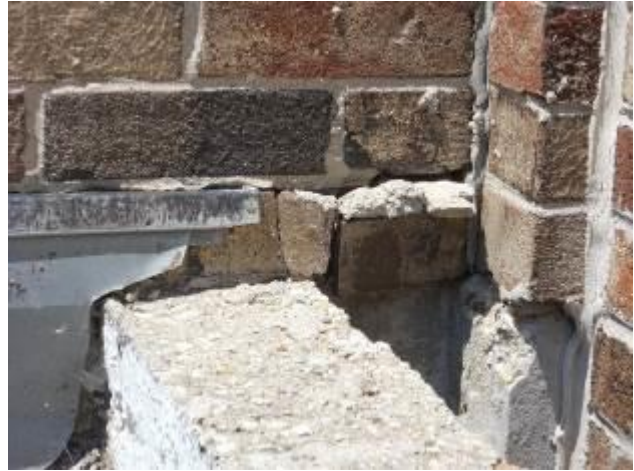
The liquid applied coating on top of the roof deck is in poor condition. We noted failed mortar joints within the adjacent masonry walls. Additionally we noted damage to the precast roof deck and debris on the surfacing.

The concrete roof deck with liquid applied coating is in serviceable condition and requires preventative and remedial maintenance at this time to facilitate its proper performance throughout the duration of its useful service life.

Engage IRS to develop an Annual Maintenance and Repair Specifications (AMRS) to address necessary preventative and remedial repairs.

Remedial repairs are necessary, and should be included in a future (AMRS).

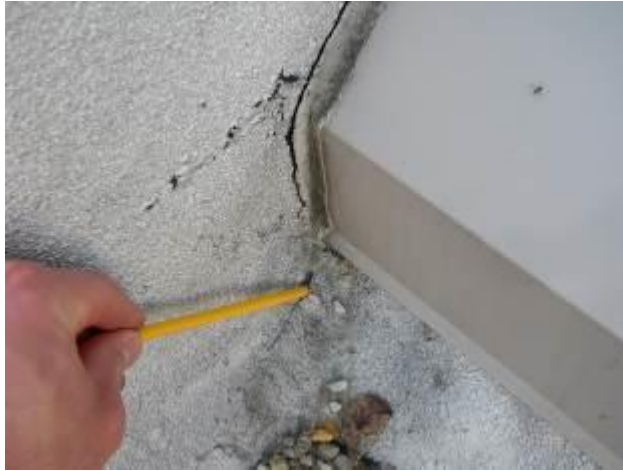
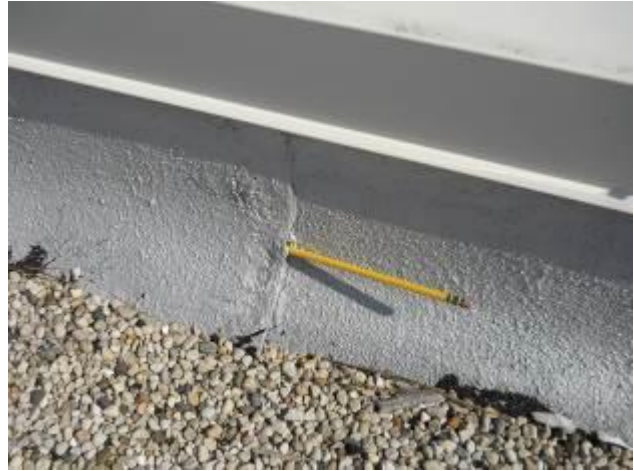
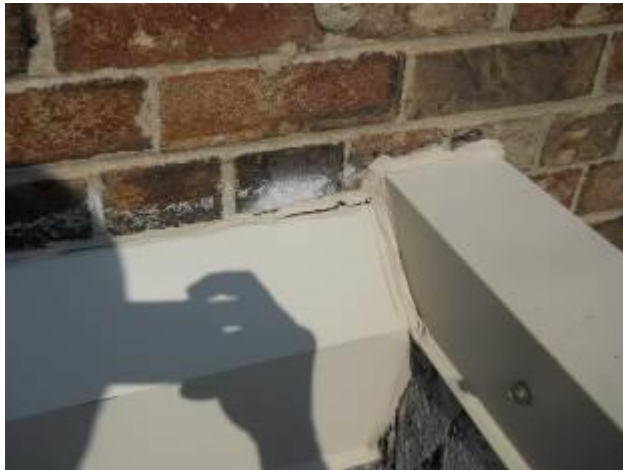
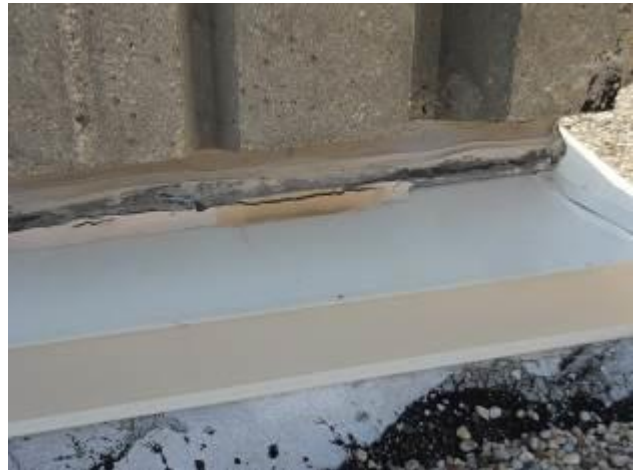
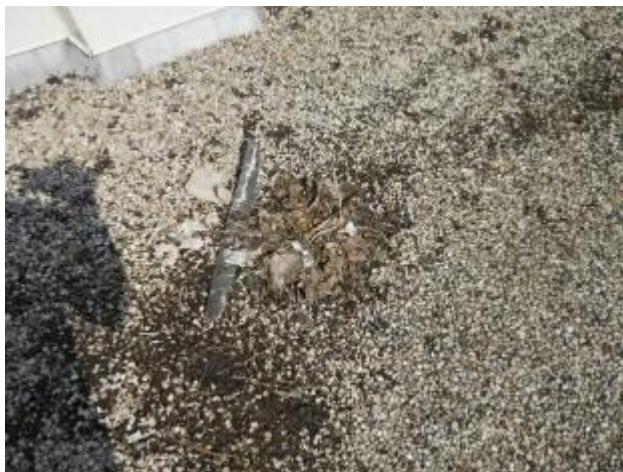
The roof membrane is in serviceable condition but we noted several open corner and base flashings along the perimeters of the roof system, failed sealant along the masonry wall, precast concrete walls and counter flashing. Debris was found throughout the surface of the roof and surrounding the drains.

The 14 year old asphalt built-up roof system in serviceable condition, but requires preventative and remedial maintenance to address the open flashings and failed sealants and normal maintenance to remove debris from the roof surface and roof drains to ensure it performs throughout the remainder of its 25 year designed service life.

Engage IRS to develop an Annual Maintenance and Repair Specifications (AMRS) to address necessary preventative and remedial repairs.

Remedial repairs are necessary, and should be included in a future (AMRS).

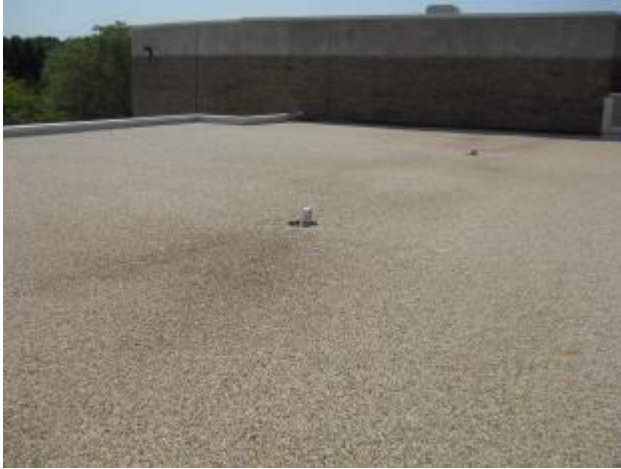
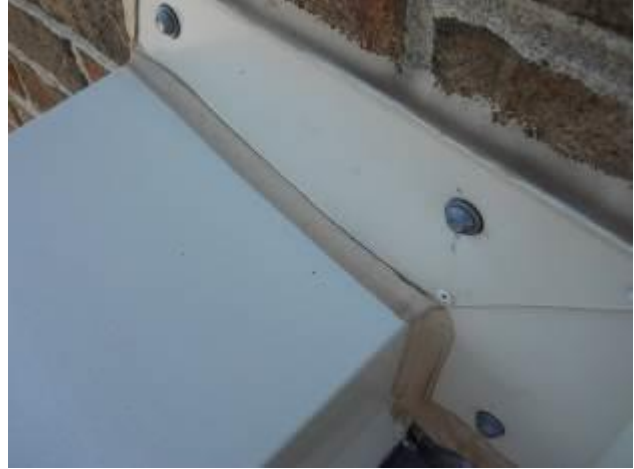
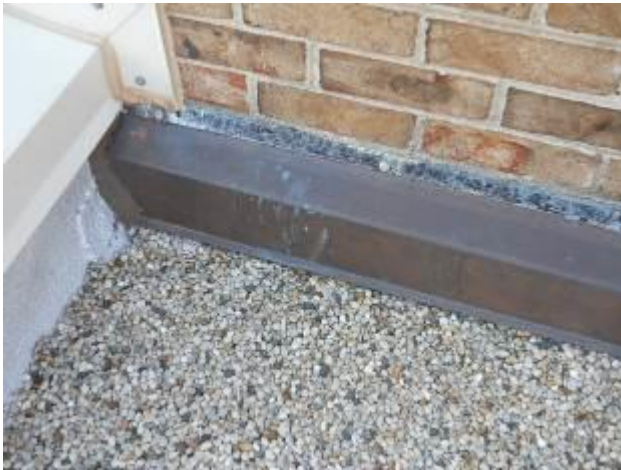
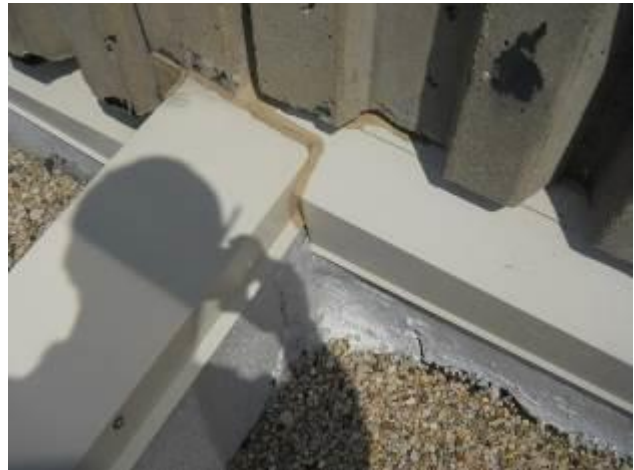
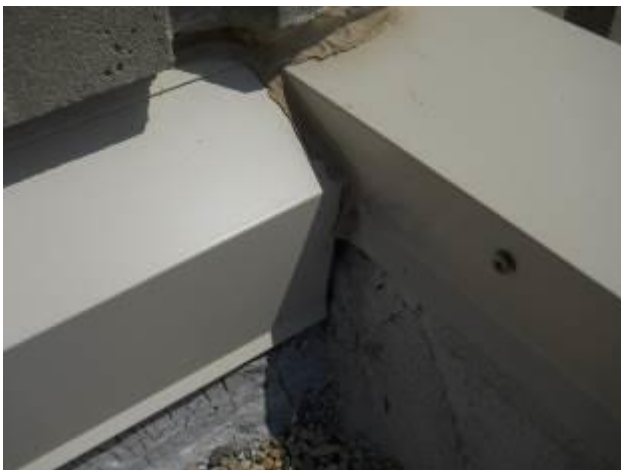
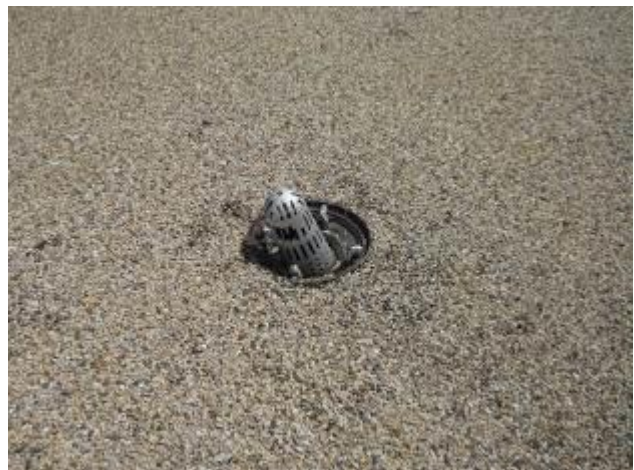
The roof membrane is in good condition but we noted failed sealant along the counter flashings and the masonry wall and precast concrete wall panels. As stated in previously reports, we noted a broken drain bonnet.

The 3 year old asphalt built-up roof system in serviceable condition, but requires preventative maintenance to address the failed sealants and broken drain bonnet to ensure it performs throughout the remainder of its 25 year designed service life.

Engage IRS to develop an Annual Maintenance and Repair Specifications (AMRS) to address necessary preventative and remedial repairs.

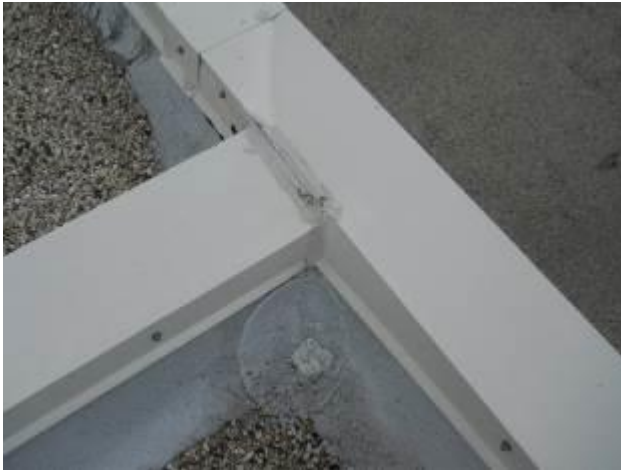
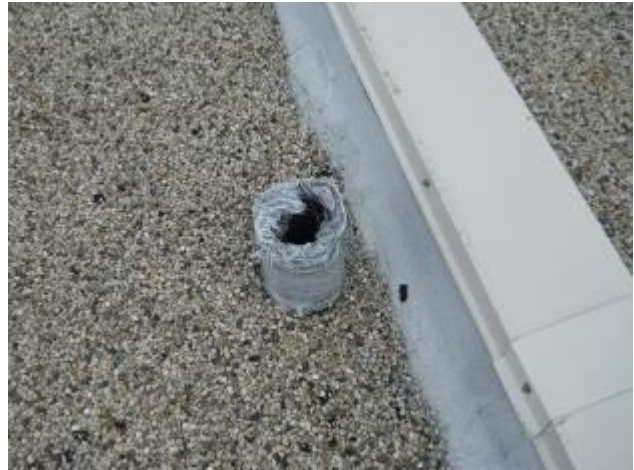
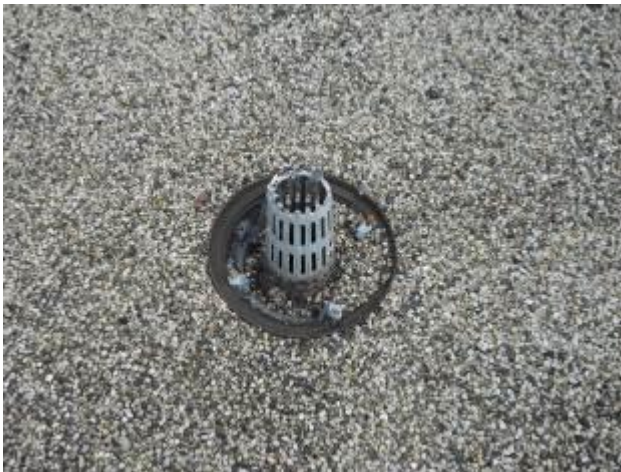
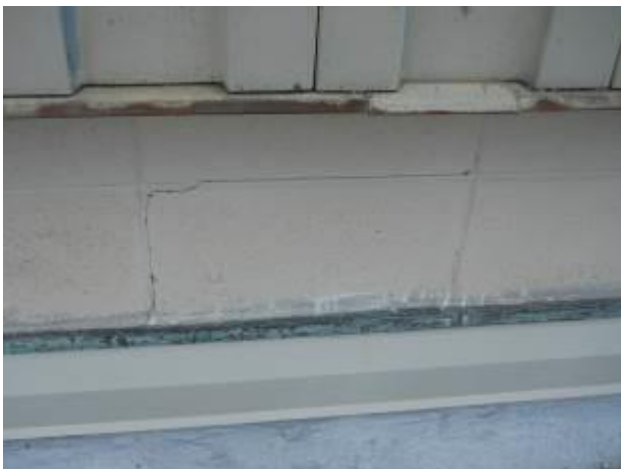
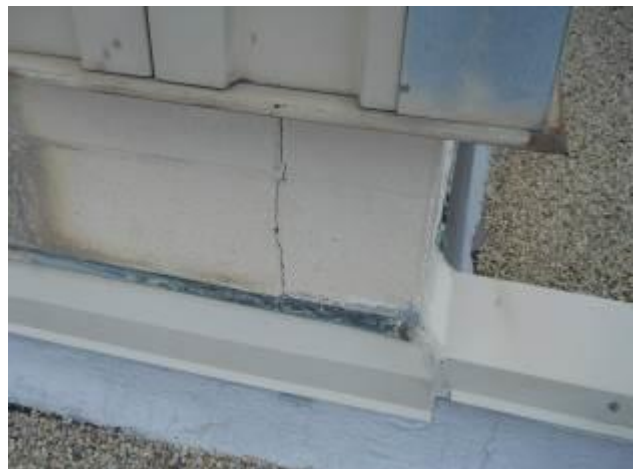
Roof Area 8

The roof membrane is in serviceable condition but we noted failed sealant along the counter flashings, a failed soil stack flashing, a damaged drain bonnet, and debris on the roof and failed mortar within the CMU wall adjacent to the roof area.

The 13 year old asphalt built-up roof system is in serviceable condition and requires preventative maintenance to address the failed sealant, damaged drain bonnet and debris on the roof surface. Remedial maintenance will be required to address the failed mortar and failed soil stack flashing. These repairs are required to ensure it performs through the remainder of its 25 year designed service life.

Engage IRS to develop an Annual Maintenance and Repair Specifications (AMRS) to address necessary preventative and remedial repairs.

Remedial repairs are necessary, and should be included in a future (AMRS).

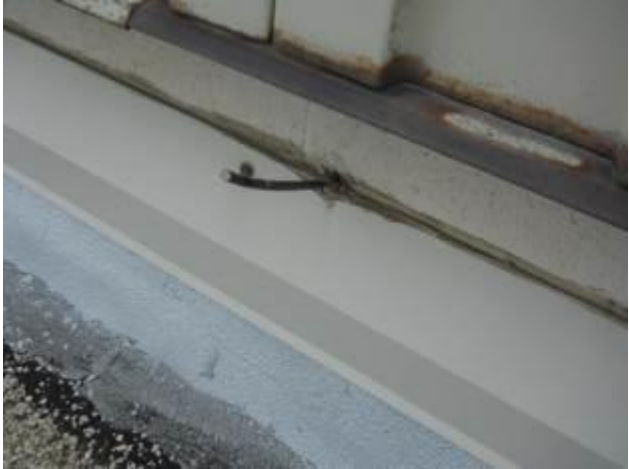
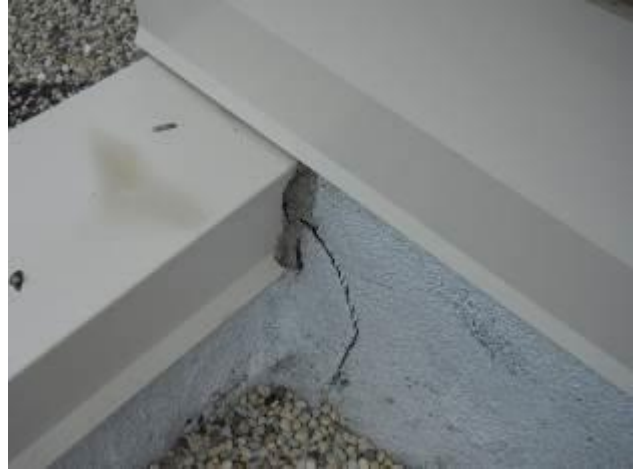
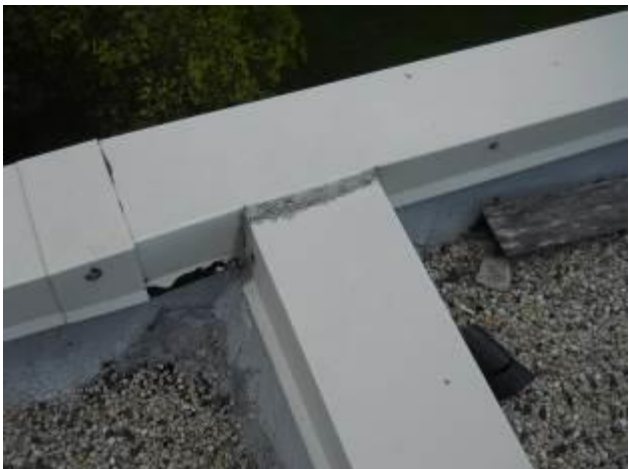
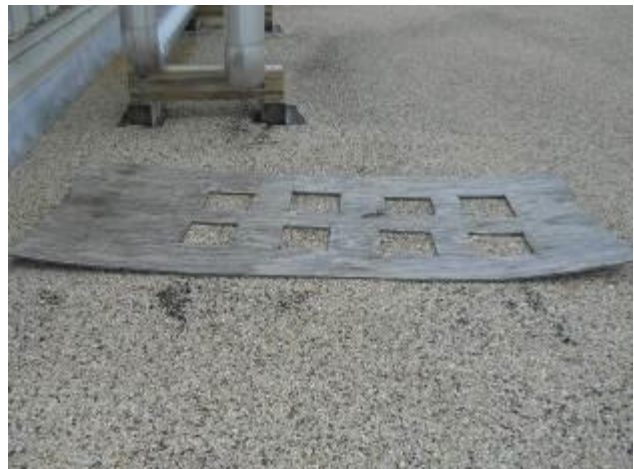
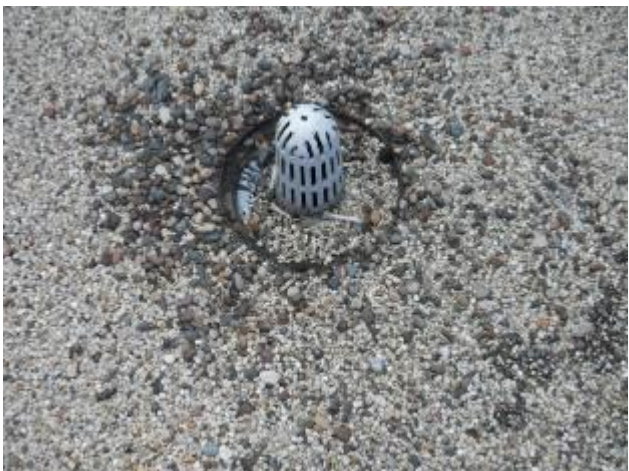
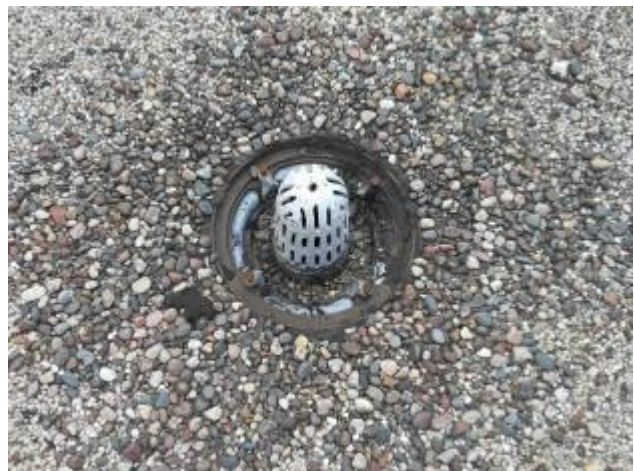
Roof Area 9

The roof membrane is in serviceable condition but we noted failed sealant along the counter flashings, debris on the roof surface and surrounding the drains.

The 9 year old asphalt built-up roof system is in serviceable condition and requires preventative maintenance to address the failed sealants to ensure it performs through the remainder of its 25 year designed service life.

Engage IRS to develop an Annual Maintenance and Repair Specifications (AMRS) to address necessary preventative and remedial repairs.

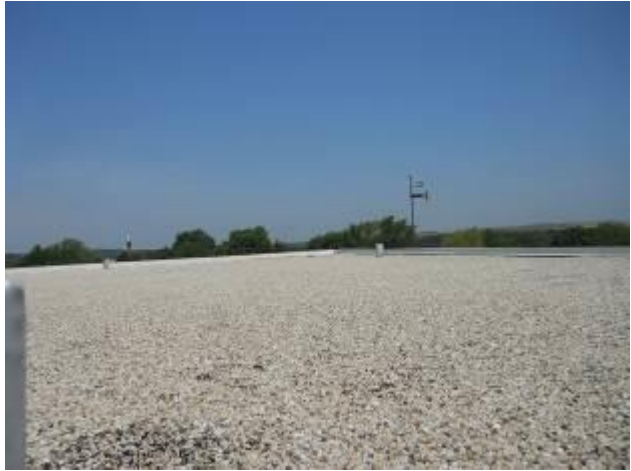
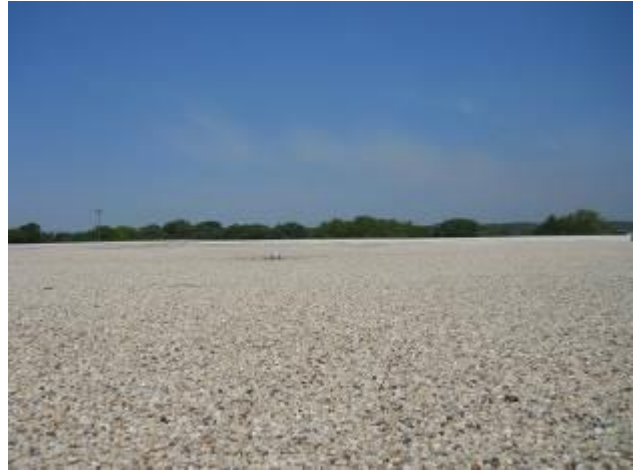
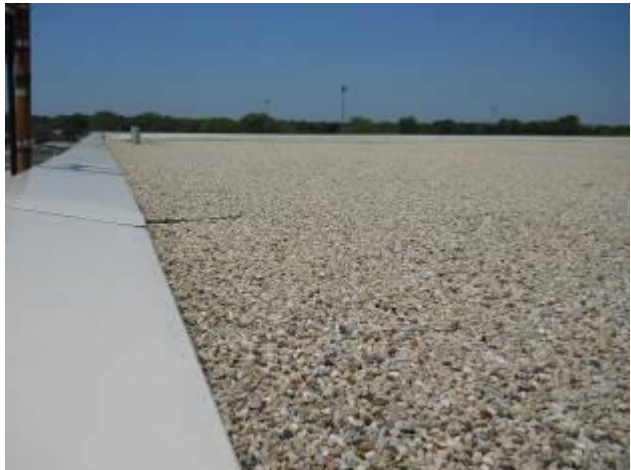
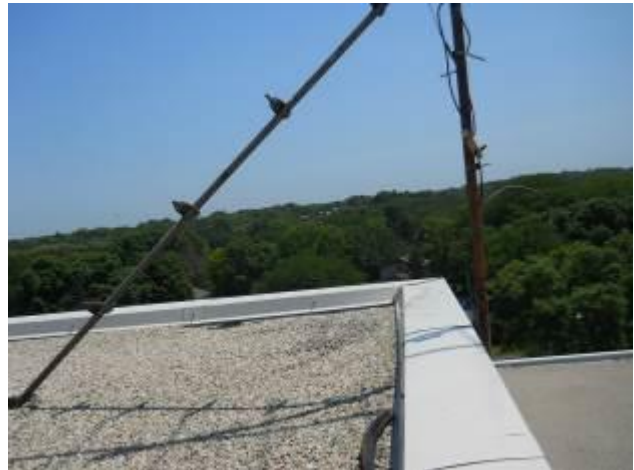
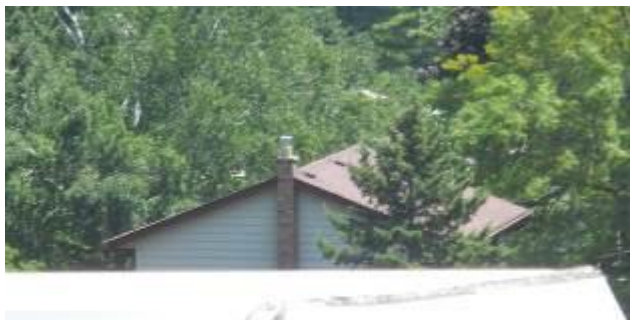
Roof Area 10

The roof system was not safely accessible during the time of our survey and was viewed from a ladder. Overall the roof system is believed to be in serviceable condition with failed sealant applied along the sheet metal copings.

The 9 year old asphalt built-up roof system is in serviceable condition and requires preventative maintenance to address the failed sealants to ensure it performs through the remainder of its 25 year designed service life.

Engage IRS to develop an Annual Maintenance and Repair Specifications (AMRS) to address necessary preventative and remedial repairs.

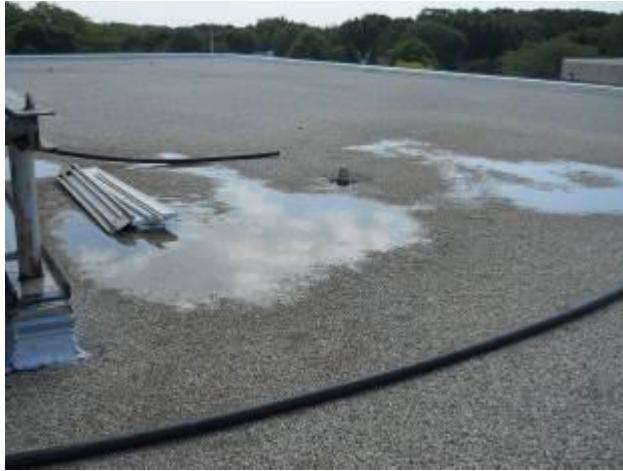
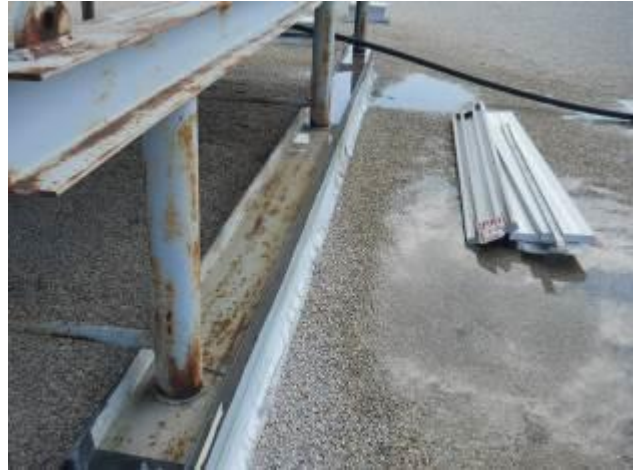
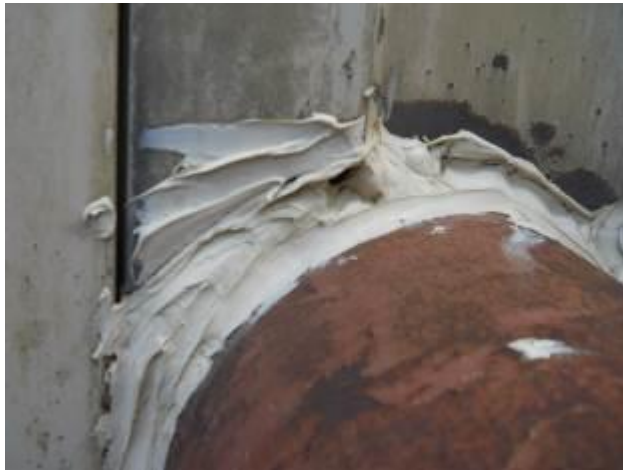
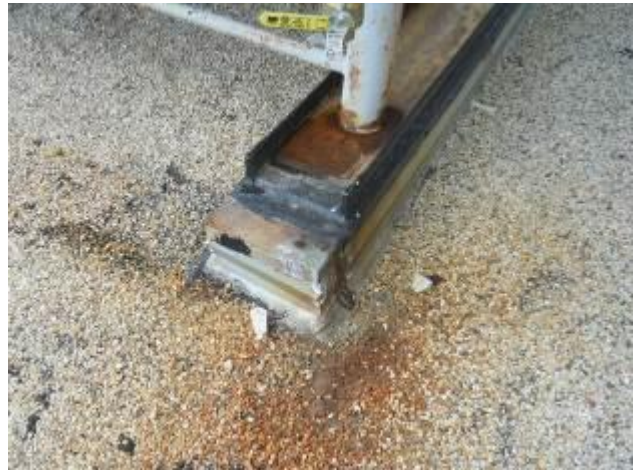
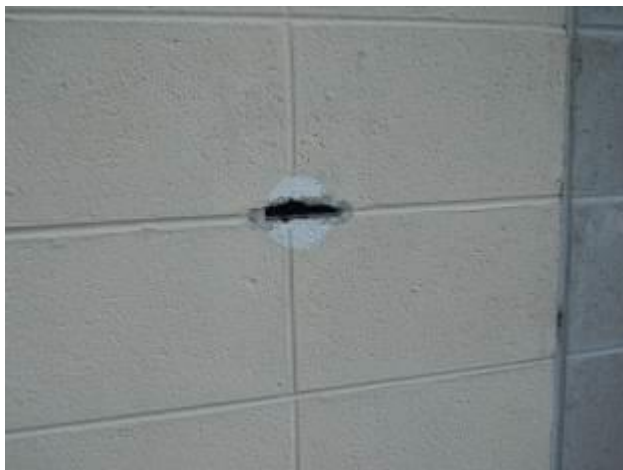
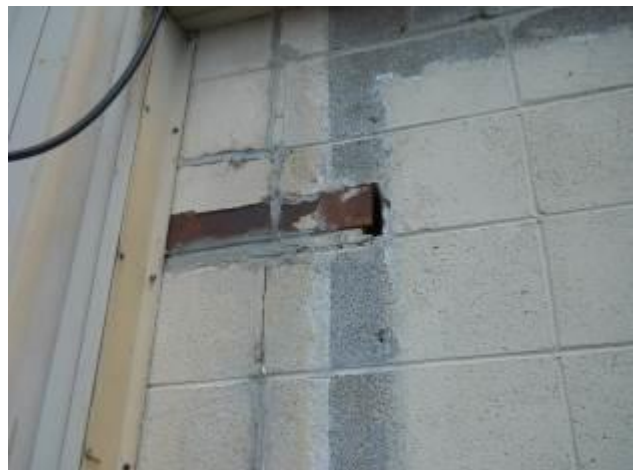
Roof Area 11

The roof system has moderate ponding water and gravel erosion surrounding the HVAC units. We also noted failed sealant along a pipe penetration, debris on the roof surface and a broken drain bonnet. Additionally, we noted a hole and exposed structural steel in the CMU wall.

The 12 year old coal tar pitch built-up roof system is in need of preventative and remedial maintenance to address the deficiencies discussed to ensure it performs throughout the remainder of its 25 year designed service life.

Engage IRS to develop an Annual Maintenance and Repair Specifications (AMRS) to address necessary preventative and remedial repairs.

Remedial repairs are necessary, and should be included in a future (AMRS).

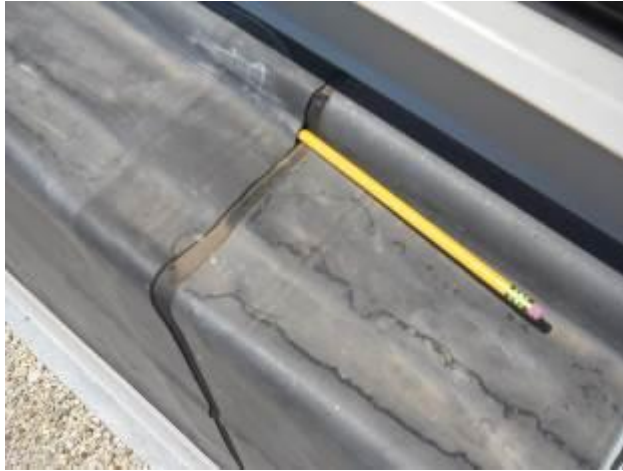
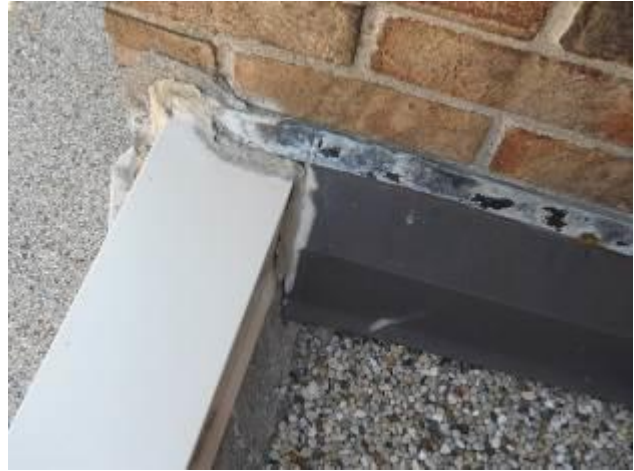
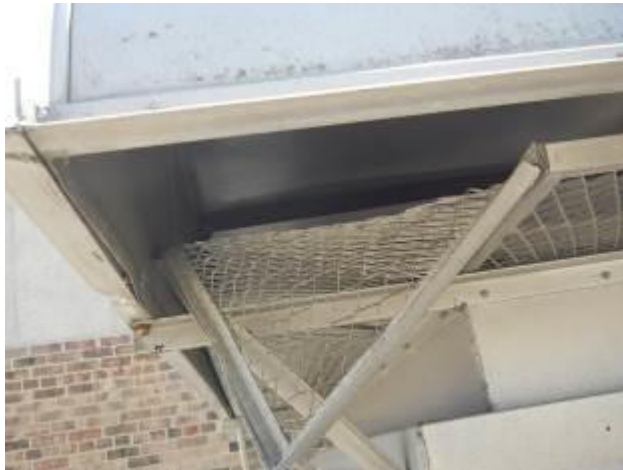
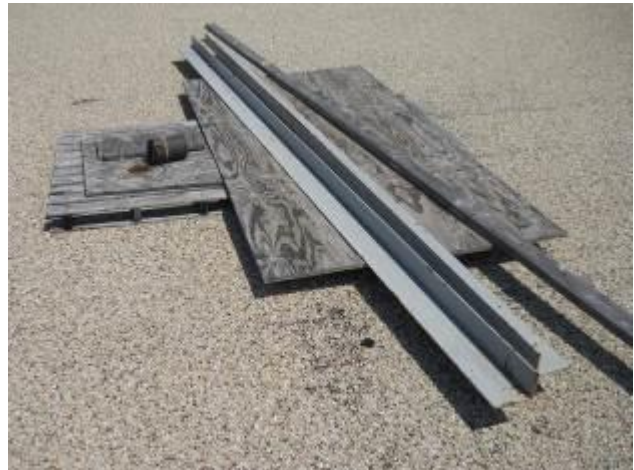
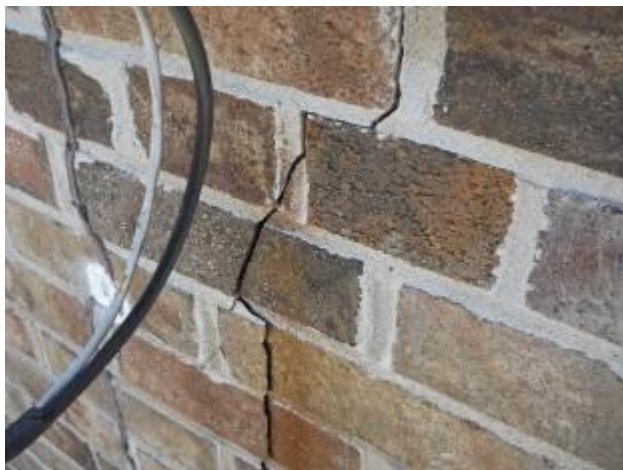
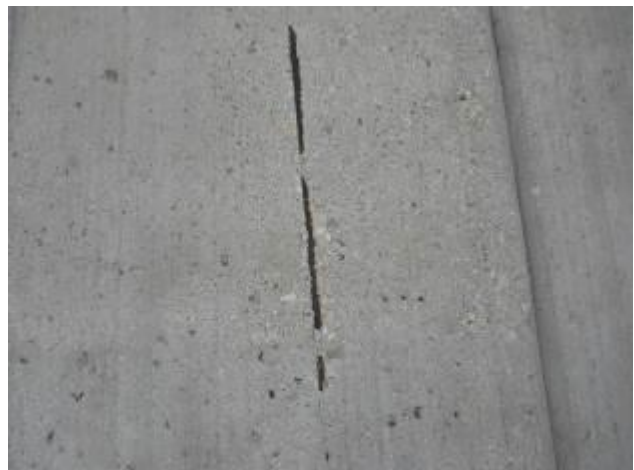
Roof Area 12

The roof membrane is in serviceable condition but we noted open base flashings and failed sealant along the perimeter, several damaged ventilation hoods, a deteriorated pitch pan, debris on the roof surface, cracking within the mortar and masonry bricks and exposed rebar in the precast concrete walls.

The 9 year old asphalt built-up roof system requires preventative and remedial maintenance to address the base flashings, damaged HVAC units, and adjacent walls systems to ensure it performs throughout the remainder of its 25 year designed service life.

Engage IRS to develop an Annual Maintenance and Repair Specifications (AMRS) to address necessary preventative and remedial repairs.

Remedial repairs are necessary, and should be included in a future (AMRS).

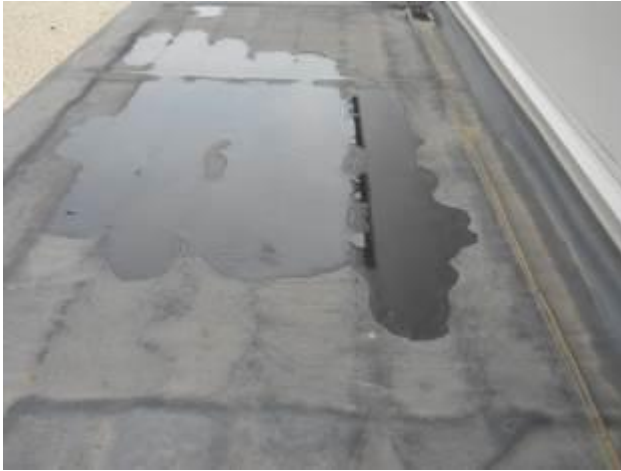
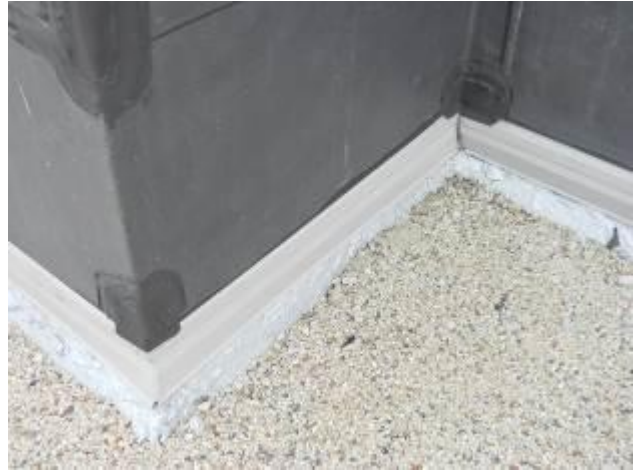
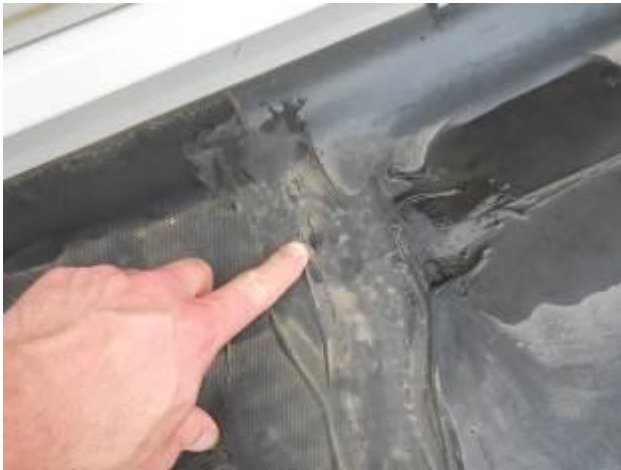
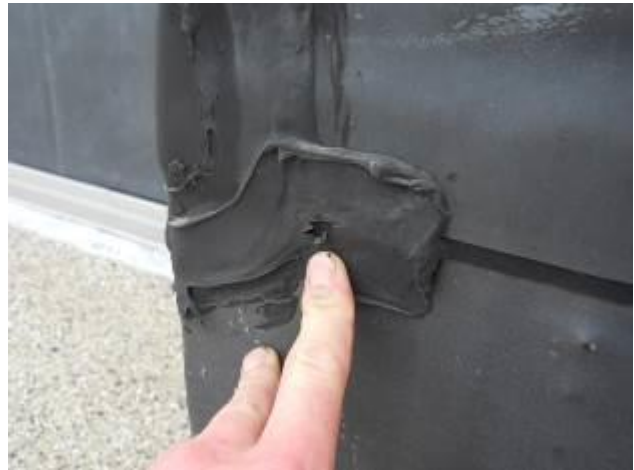
Roof Area 13

The roof membrane is in serviceable condition but we noted failed lap sealant applied along several of the corner flashings potentially allowing water to penetrate the flashings. Additionally, we observed ponding water atop the roof system.

Engage IRS to develop an Annual Maintenance and Repair Specifications (AMRS) to address necessary preventative repairs.

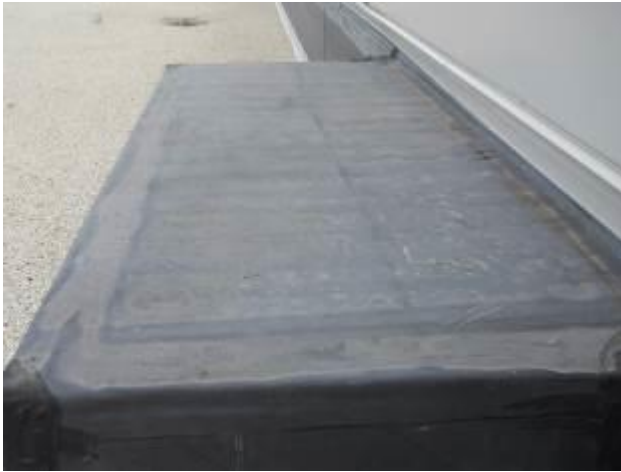
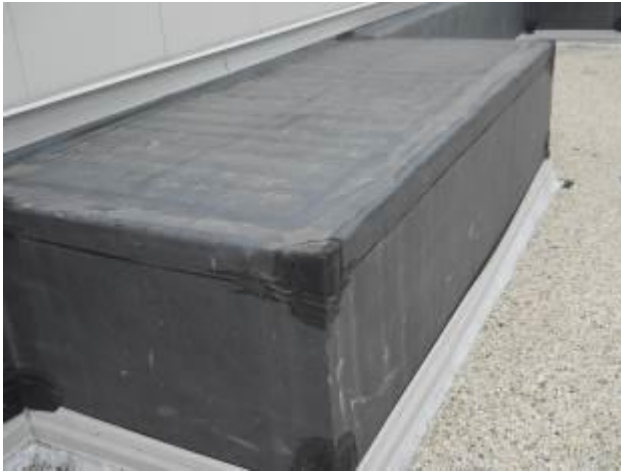
Roof Area 14

The roof membrane is in serviceable condition but we noted failed lap sealant applied along several of the corner flashings potentially allowing water to penetrate the flashings.

Engage IRS to develop an Annual Maintenance and Repair Specifications (AMRS) to address necessary preventative repairs.

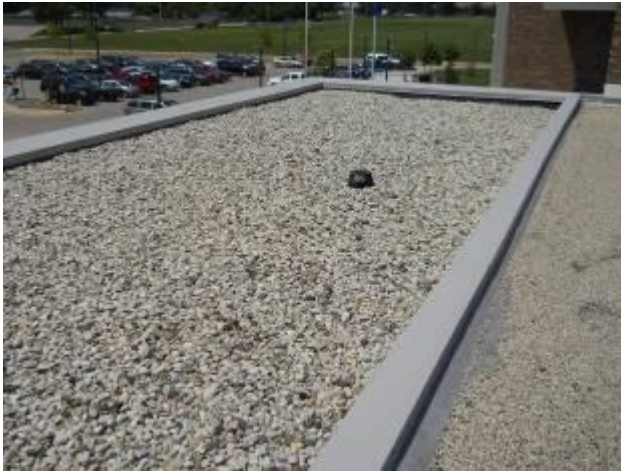
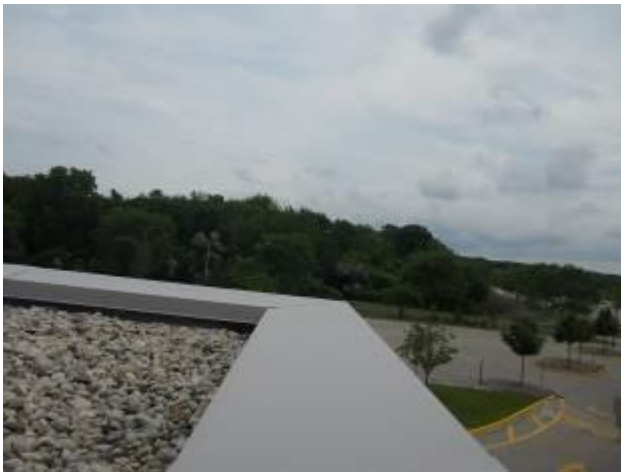
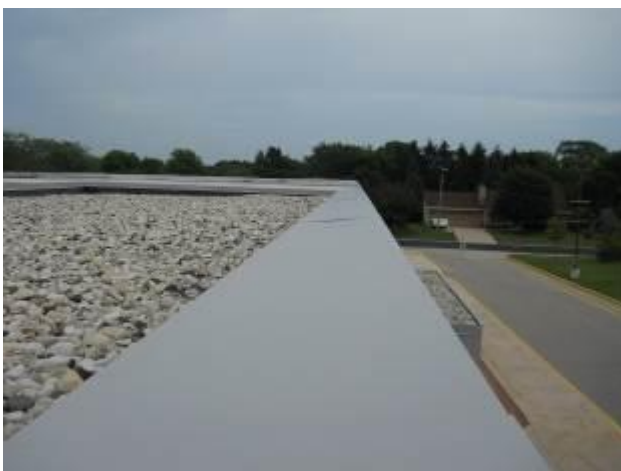
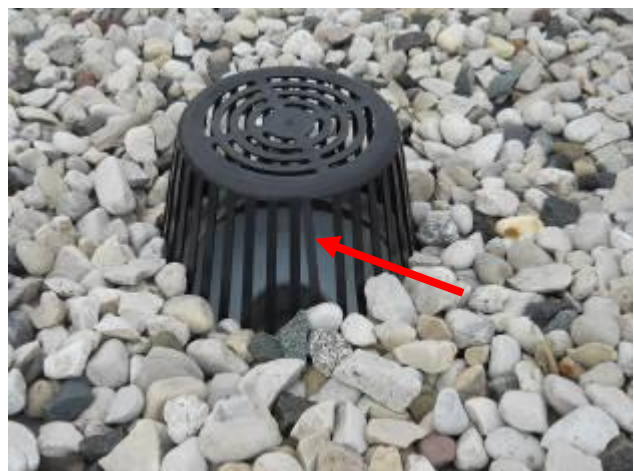
The stone ballasted EPDM single-ply roof system is in good condition. We noted a broken strainer on the plastic drain bonnet. No other deficiencies were noted during our survey.

The 9 year old stone ballasted EPDM single-ply roof system requires preventative maintenance to address the damaged drain bonnet to ensure it performs throughout the remainder of its 18 year designed service life.

Engage IRS to develop an Annual Maintenance and Repair Specifications (AMRS) to address necessary preventative repairs.
