Roof Survey Data

**Menomonee Falls, School District of
Ben Franklin Elementary School (342)
Roof Area Number: 01**

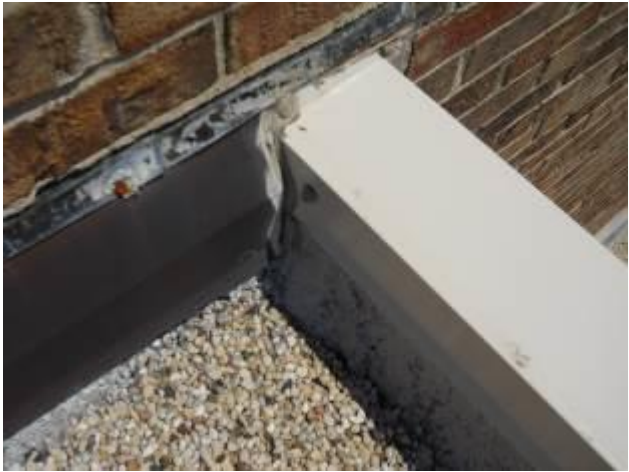
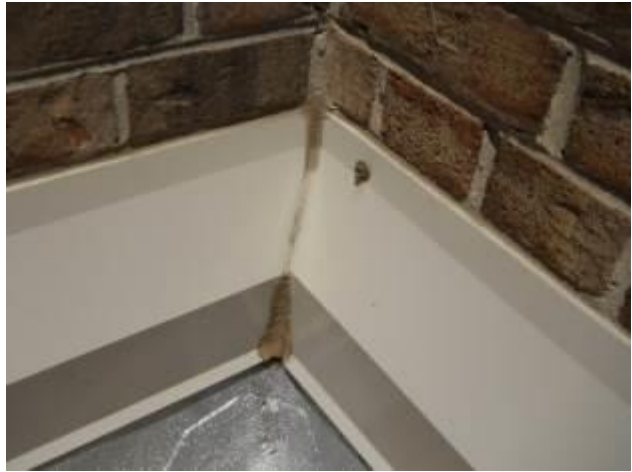
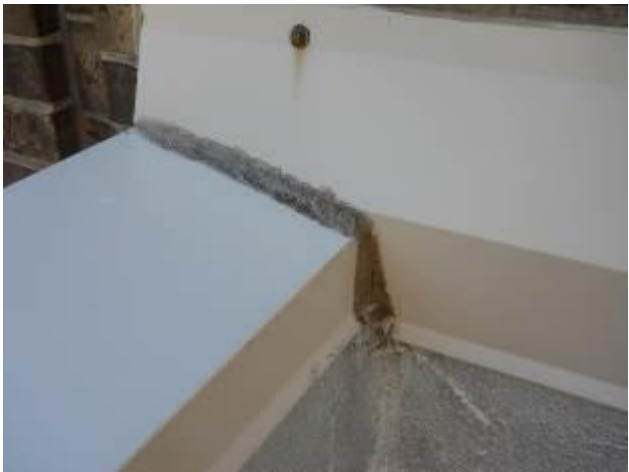
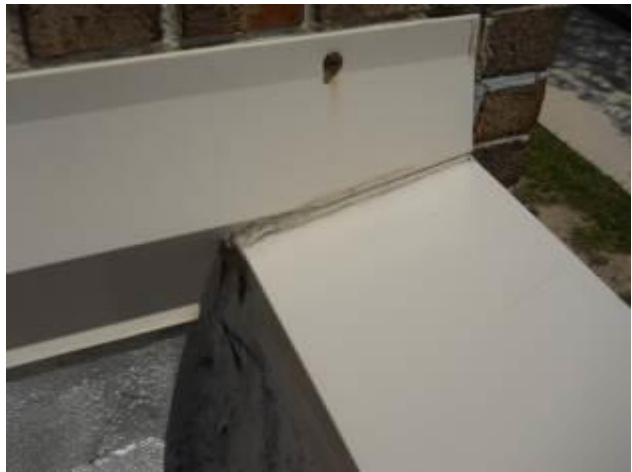
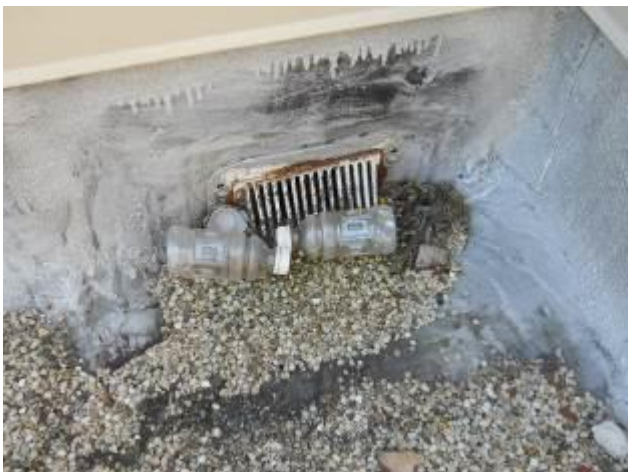
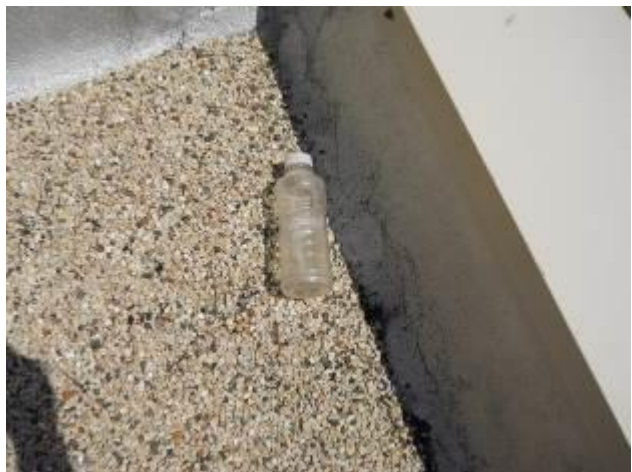
The roof membrane is in serviceable condition but we noted failed sealant along the perimeter counter flashings and debris on the roof surface.

The 9 year old asphalt built-up roof system requires preventative maintenance to address the failed sealant along the counter flashings to ensure it performs throughout the remainder of its 25 year designed service life.

Engage IRS to develop an Annual Maintenance and Repair Specifications (AMRS) to address necessary preventative repairs.

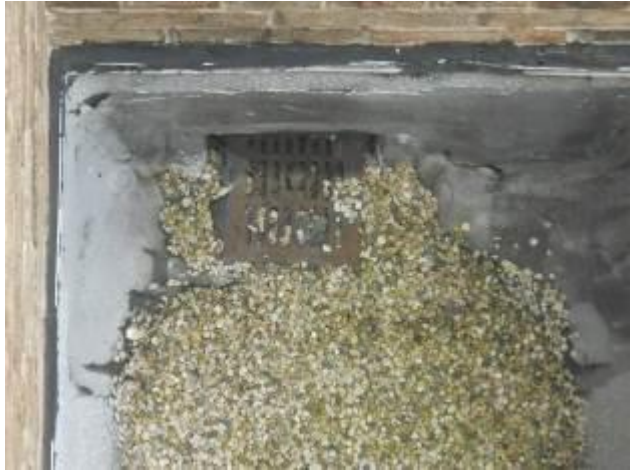
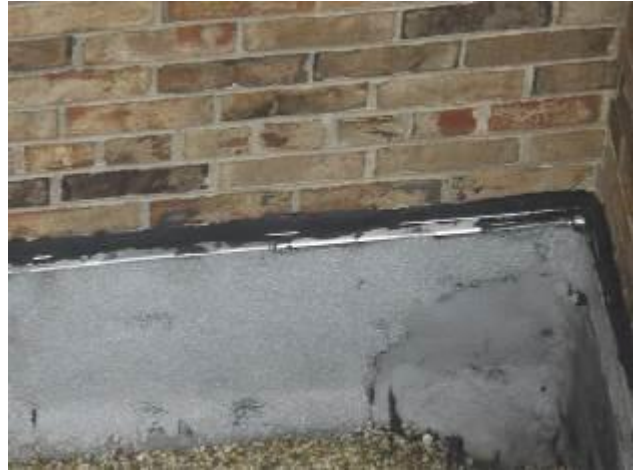
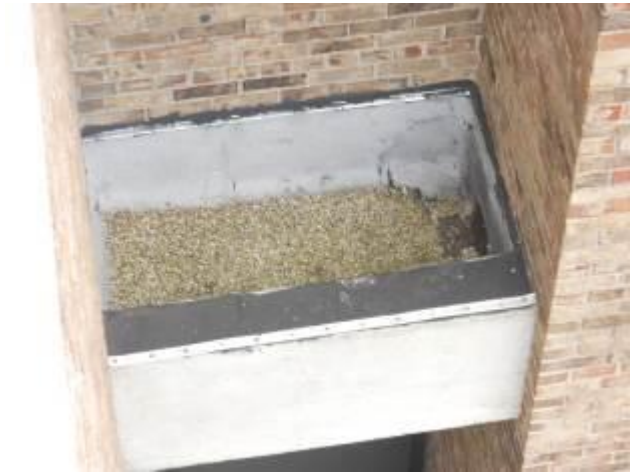
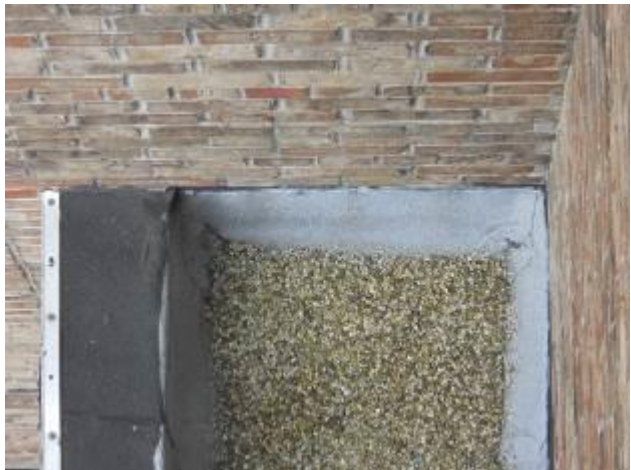
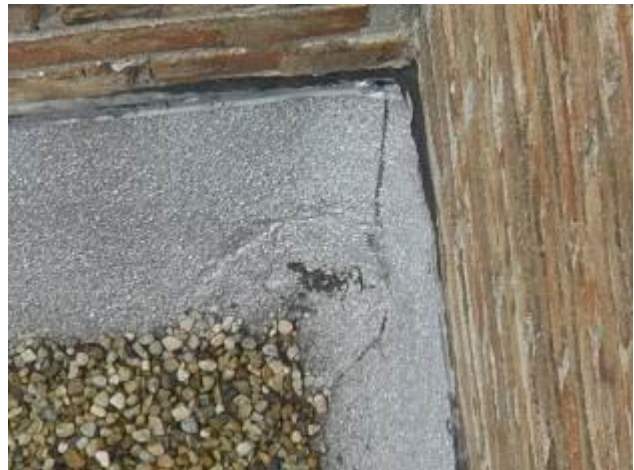
The roof system was not safely accessible during the time of our survey but was viewed from the distance of Roof Area 18. The roof membrane appeared to have been previously repaired around the drain and along the perimeter flashings.

The 9 year old asphalt built-up roof system requires preventative maintenance to address the failed sealant along the perimeters to ensure it performs throughout the remainder of its 25 year designed service life.

Engage IRS to develop an Annual Maintenance and Repair Specifications (AMRS) to address necessary preventative and remedial repairs.

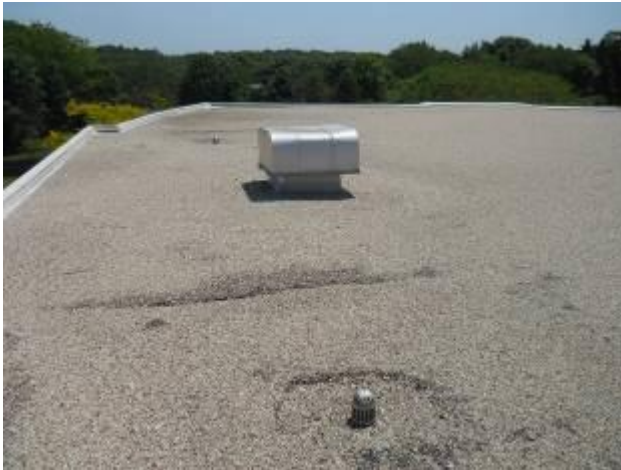
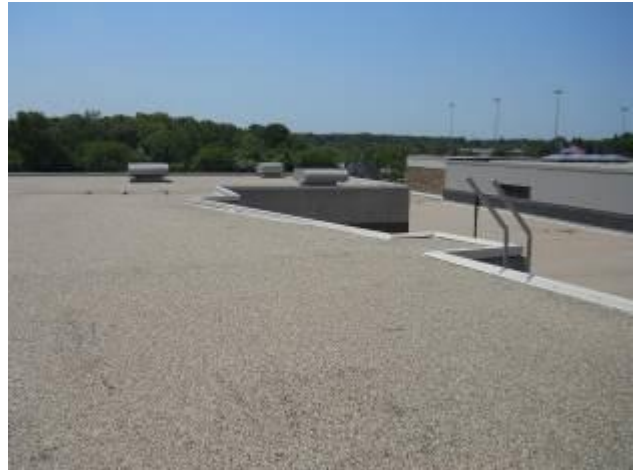
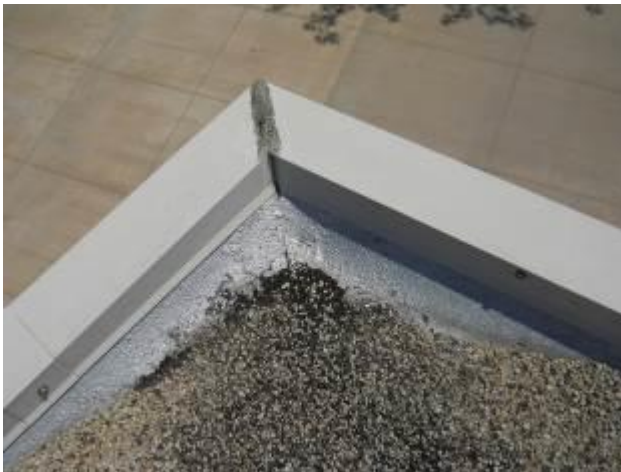
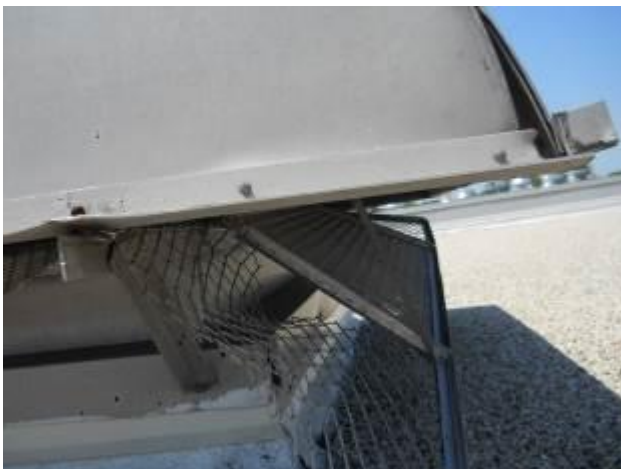
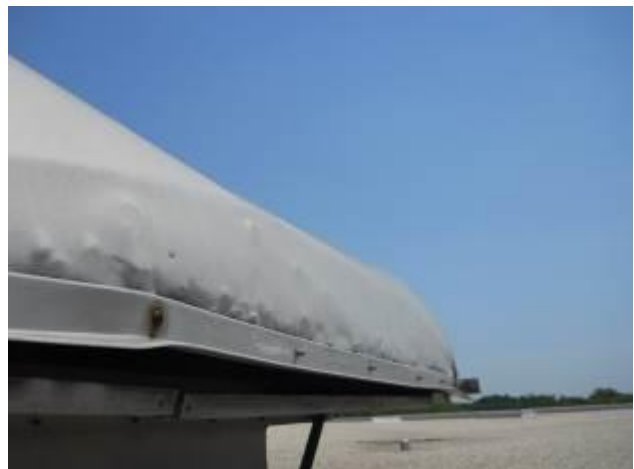
The roof membrane is in serviceable condition but we noted failed sealant along the perimeter and several damaged ventilation hoods.

The 9 year old asphalt built-up roof system requires preventative and remedial maintenance to address the failed sealant along the perimeters and damaged ventilation hoods to ensure it performs throughout the remainder of its 25 year designed service life.

Engage IRS to develop an Annual Maintenance and Repair Specifications (AMRS) to address necessary preventative and remedial repairs.

Remedial repairs are necessary, and should be included in a future (AMRS).

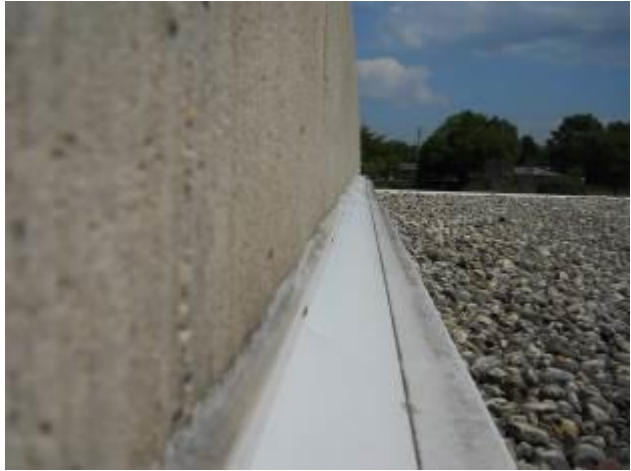
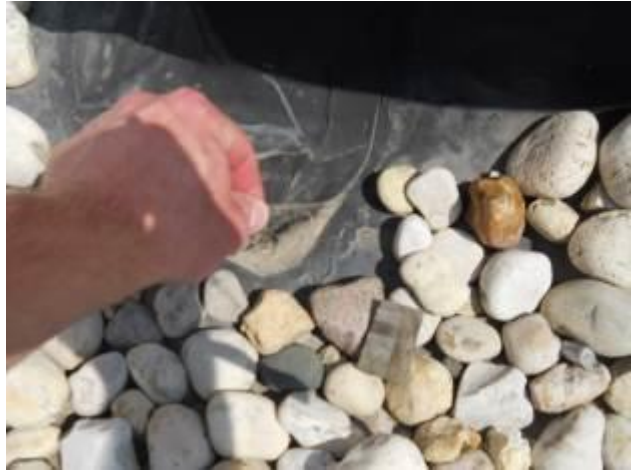
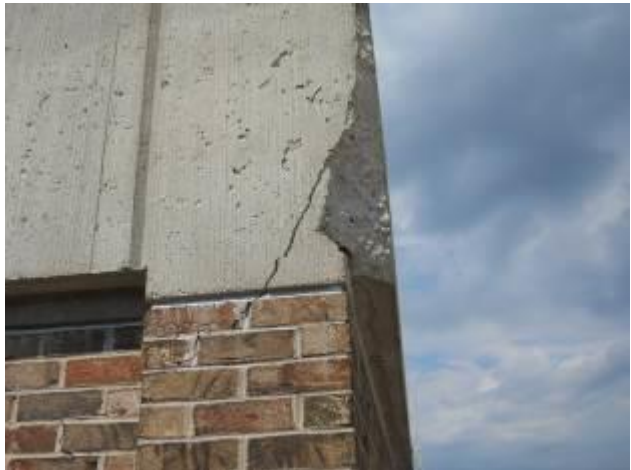
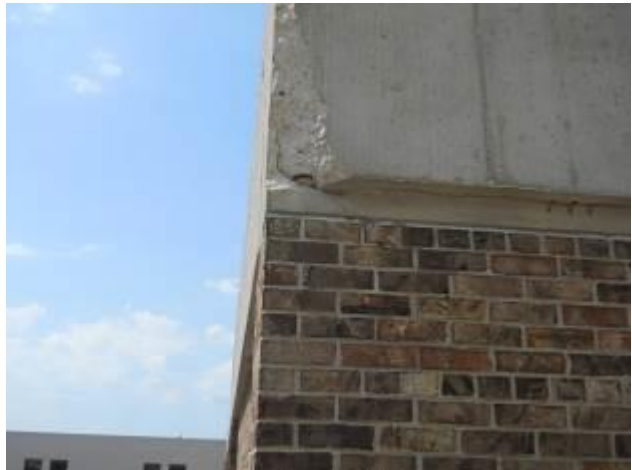
The roof membrane is in serviceable condition but we noted failed sealant along the perimeter counter flashings and control joints, one open corner flashing at curb and damaged corner on the precast concrete panels.

The 5 year old stone ballasted EPDM single-ply roof system requires preventative and remedial maintenance to address the failed sealant along the perimeters and walls, open corner flashing and spalled concrete corner to ensure it performs throughout the remainder of its 18 year designed service life.

Engage IRS to develop an Annual Maintenance and Repair Specifications (AMRS) to address necessary preventative and remedial repairs.

Remedial repairs are necessary, and should be included in a future (AMRS).

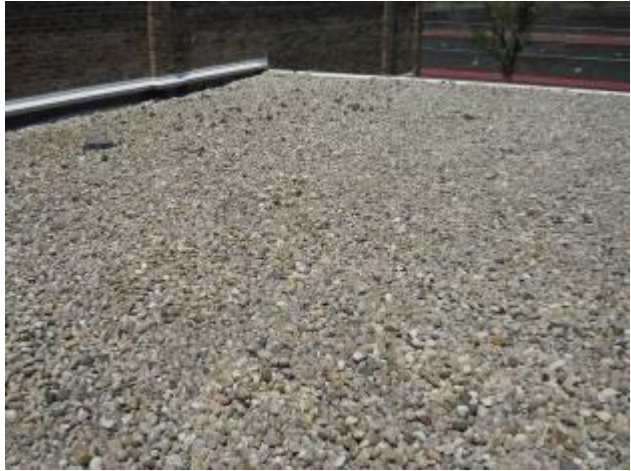
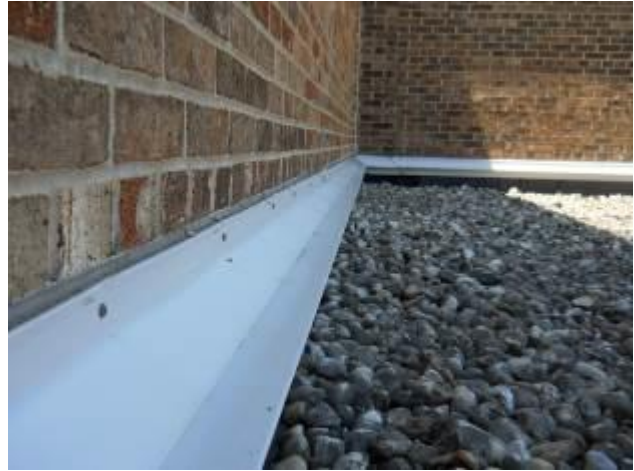
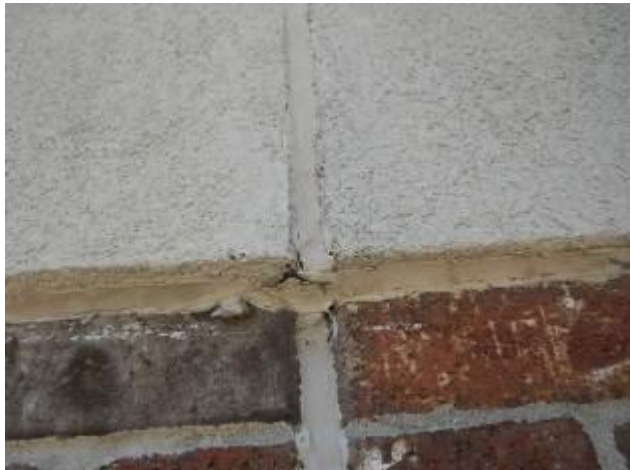
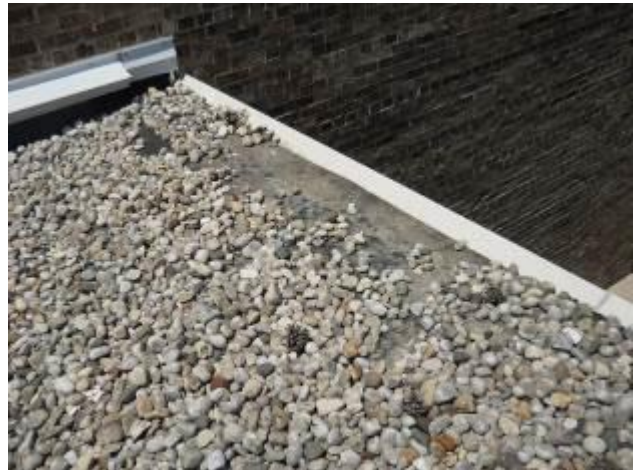
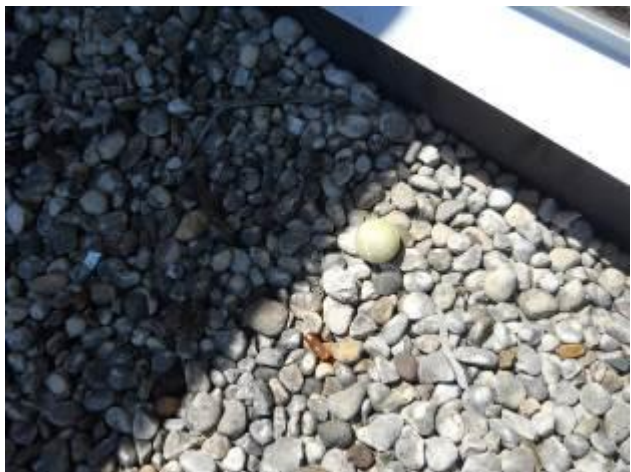
The roof membrane is in serviceable condition but we noted failed sealant along the perimeter counter flashings and masonry wall, wind erosion and debris on the roof surface. Additionally, an electrical box has been abandoned but not properly decommissioned, exposing the wires to water.

The 5 year old stone ballasted EPDM single-ply roof system is in serviceable condition and requires preventative maintenance to address the failed sealant and properly address the abandoned electrical box to ensure it performs throughout the remainder of its 18 year designed service life.

Engage IRS to develop an Annual Maintenance and Repair Specifications (AMRS) to address necessary preventative and remedial repairs.

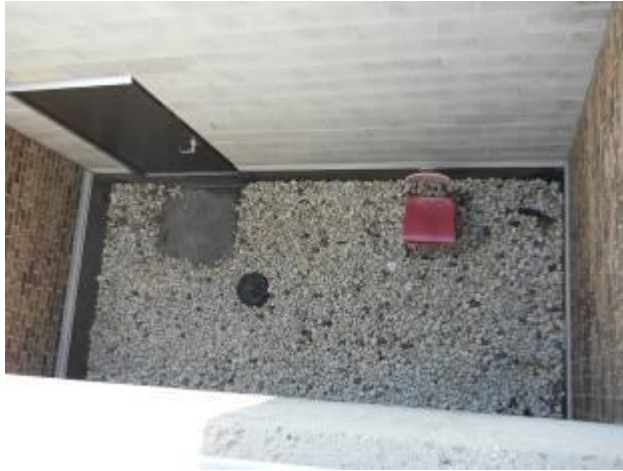
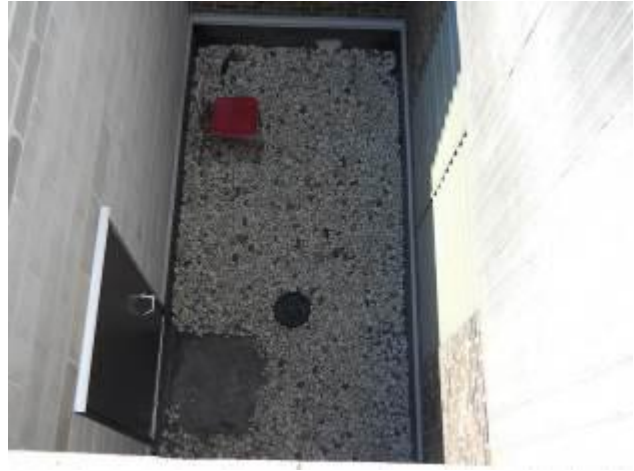
The roof system was not accessible during our survey but was viewed from the distance of Roof Area 4. The roof membrane appeared to be in serviceable condition with only minor accumulation of debris and a chair sitting on the roof membrane.

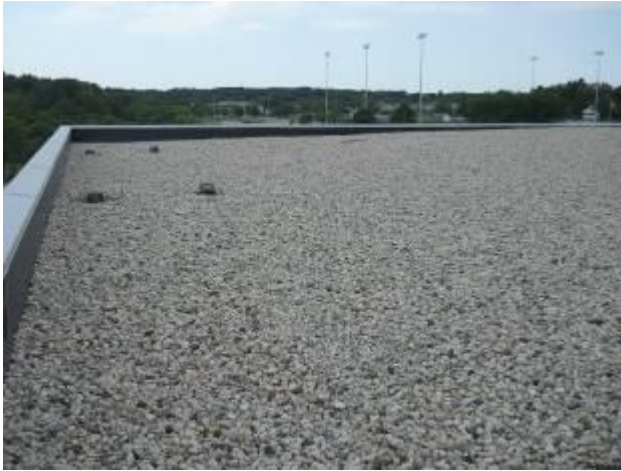
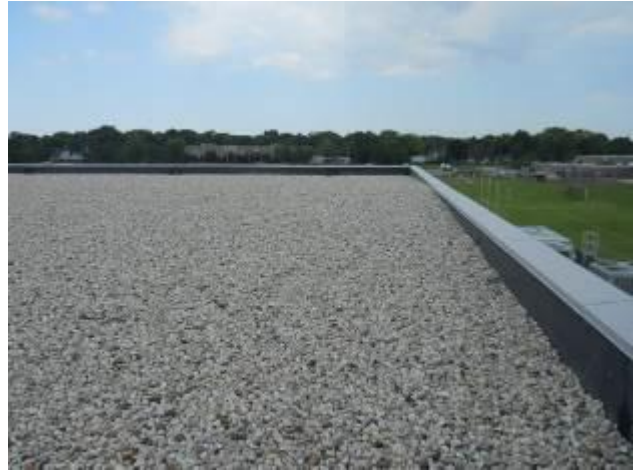
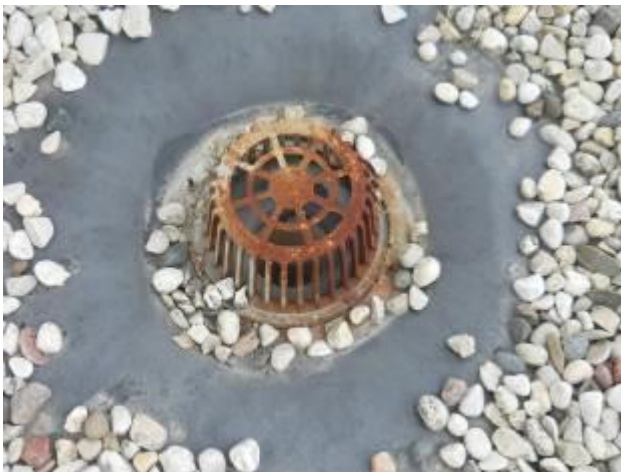
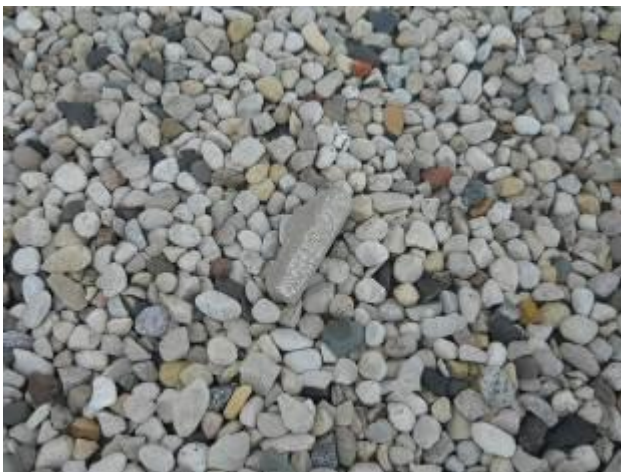
The roof membrane is in serviceable condition with minor locations of displaced ballast/windblown corners and debris on the roof membrane. We also noted a location which previously received repairs.

Engage IRS to develop an Annual Maintenance and Repair Specifications (AMRS) to address necessary preventative and remedial repairs.

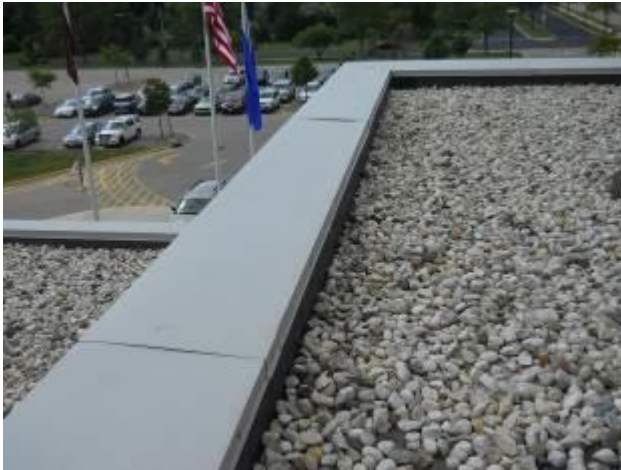
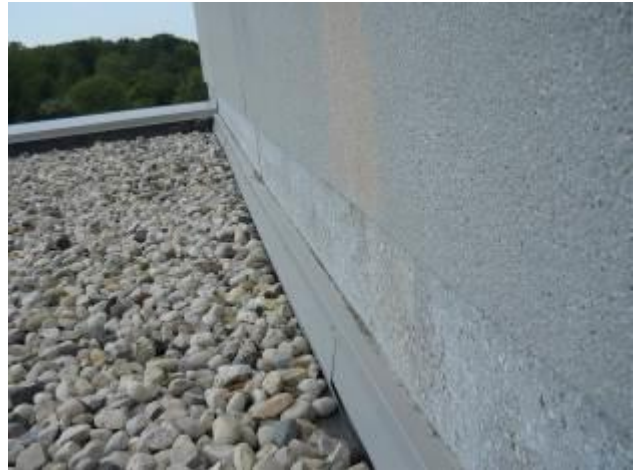
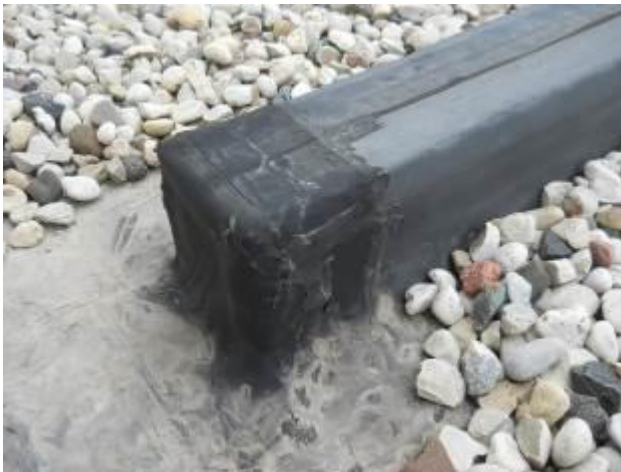
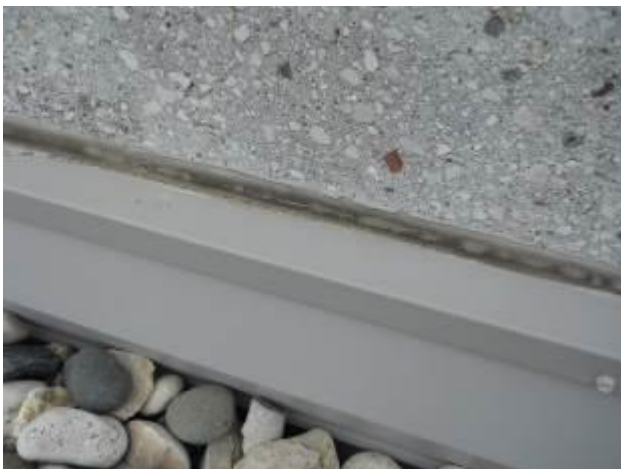
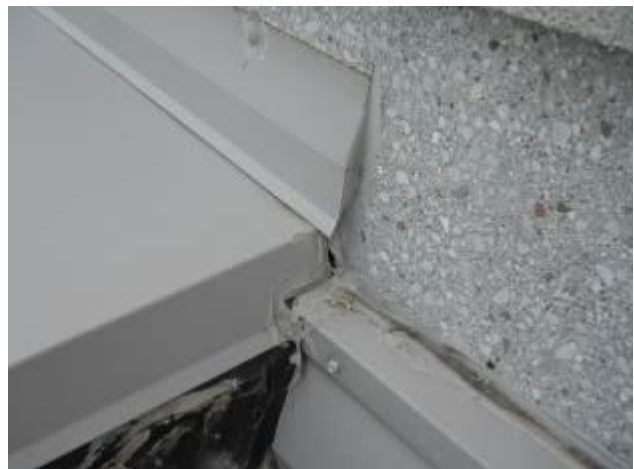
The roof membrane is in good condition but we noted failed sealant along the perimeter counter flashing.

The 5year old stone ballasted EPDM single-ply roof system requires preventative maintenance to address the failed sealant to ensure it performs throughout the remainder of its 18 year designed service life.

Engage IRS to develop an Annual Maintenance and Repair Specifications (AMRS) to address necessary preventative and remedial repairs.

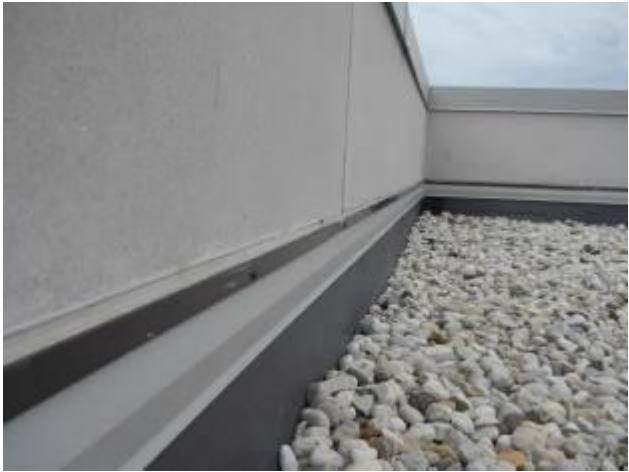
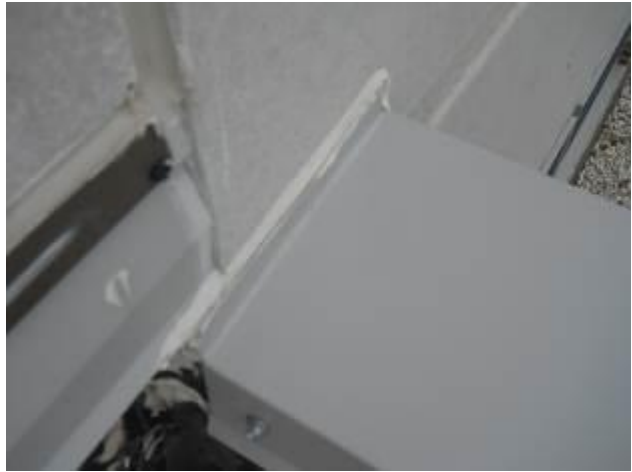
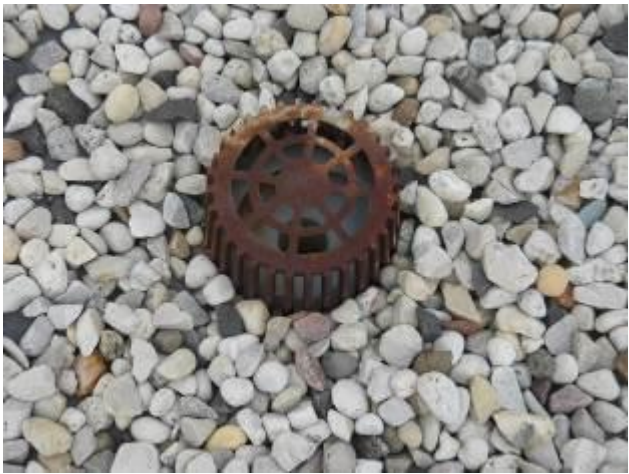
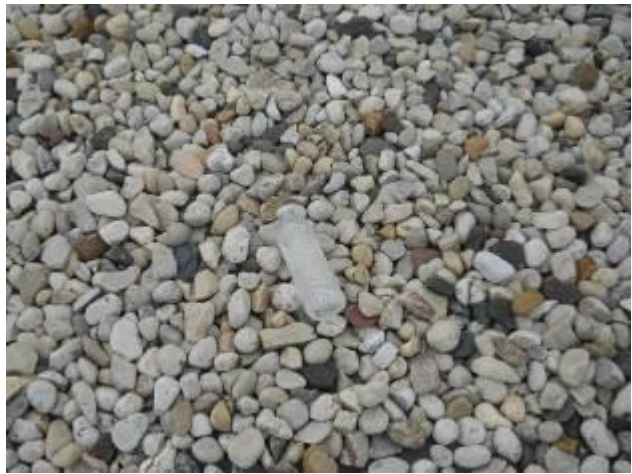
The roof system is in good condition. We did not note any deficiencies of the roof membrane or components beyond minor debris on the roof system.

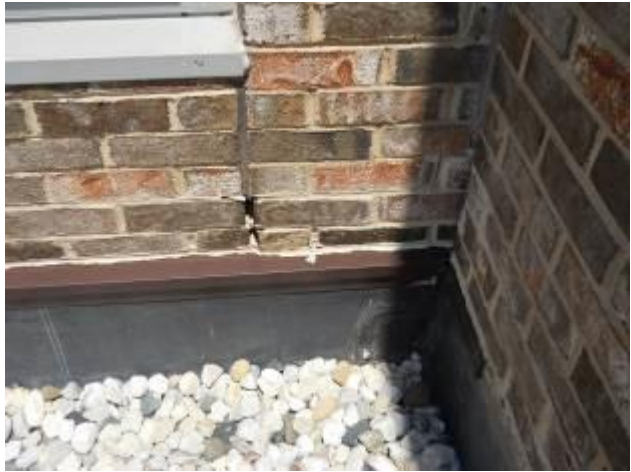
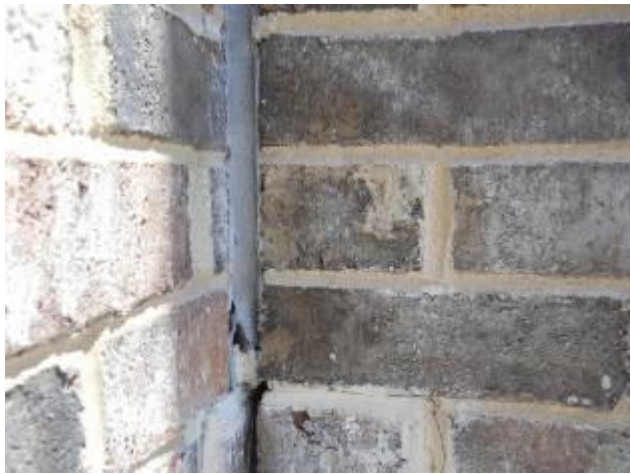
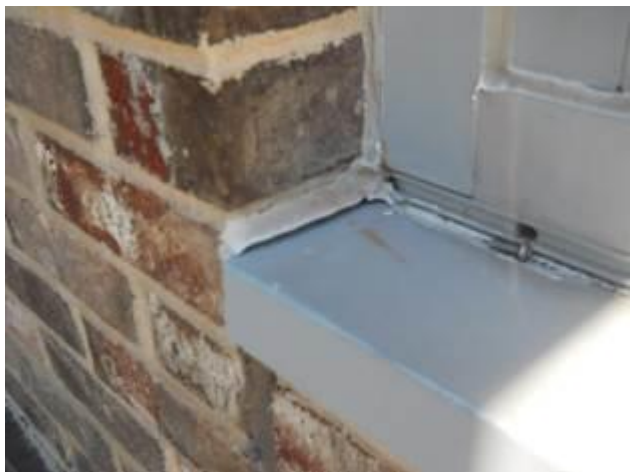
The roof membrane is in good condition however we noted failed sealant along the windows within the adjacent masonry wall, failed mortar joints and debris on the roof system.

The 5 year old stone ballasted EPDM single-ply roof system requires preventative and remedial maintenance to address the failed sealants and mortar joints to ensure it performs throughout the remainder of its 18 year designed service life.

Engage IRS to develop an Annual Maintenance and Repair Specifications (AMRS) to address necessary preventative and remedial repairs.

Remedial repairs are necessary, and should be included in a future (AMRS).

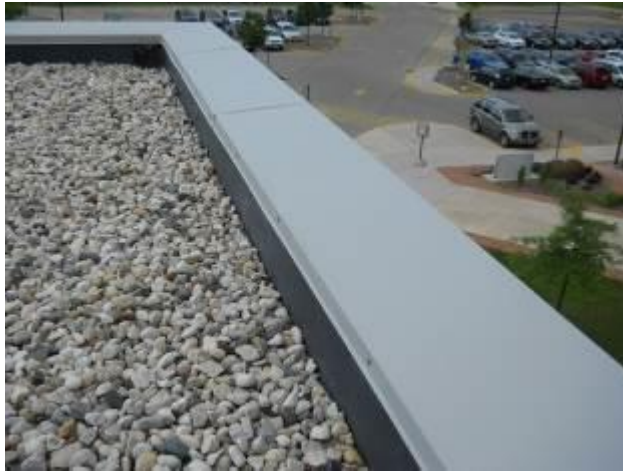
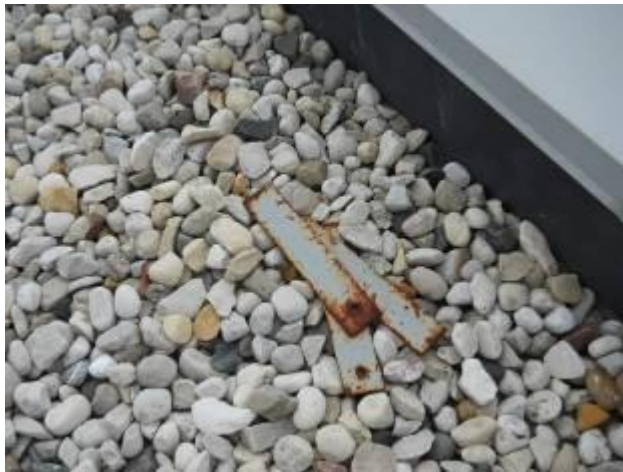
The roof membrane is in serviceable condition with isolated locations of debris and glass on the roof surface.

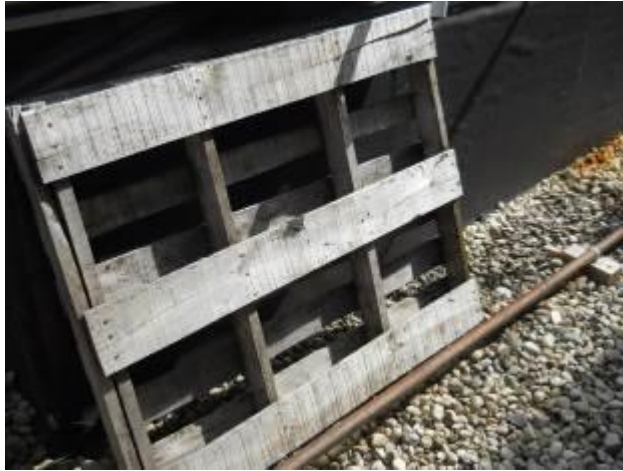
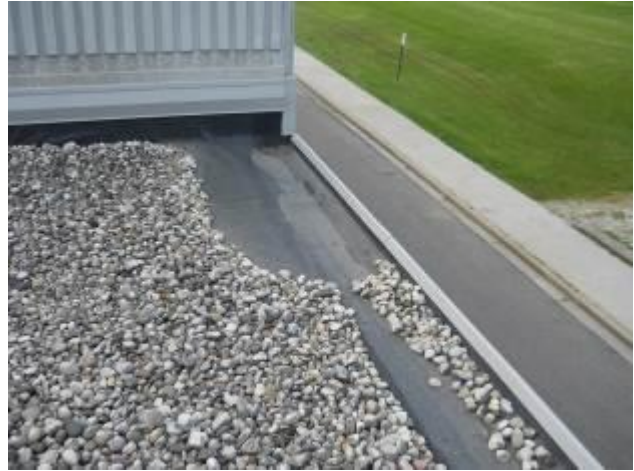
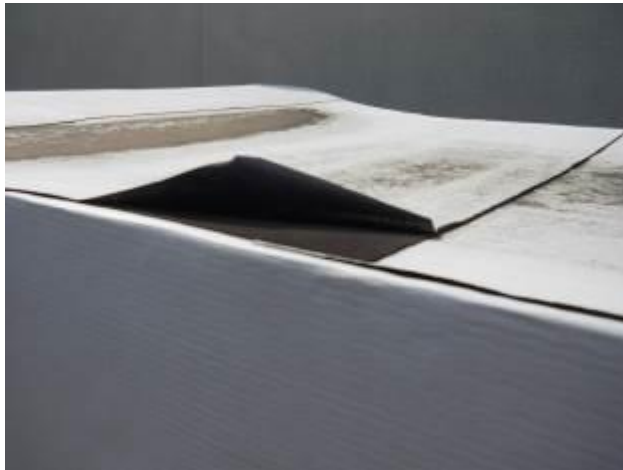
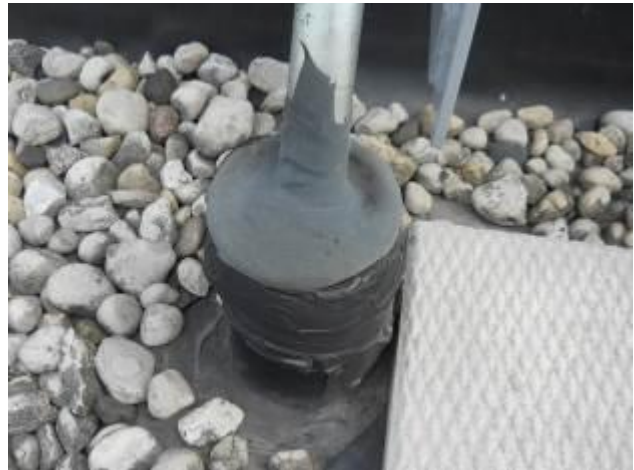
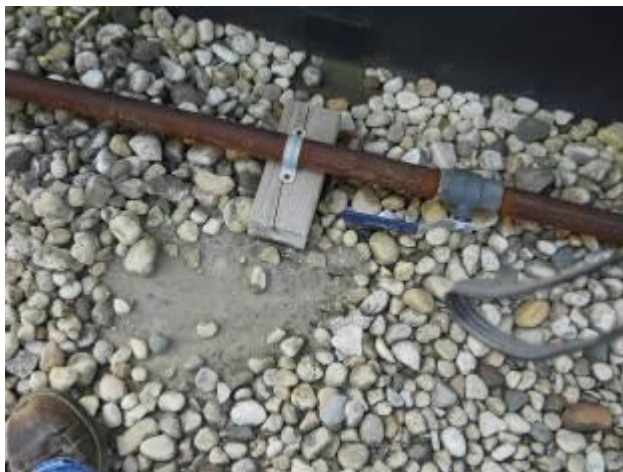
The roof membrane is in serviceable condition with areas of debris on the roof surface and displaced ballast. We also noted failed duct wrap around the HVAC duct work, deteriorated pitch pans, conduit pipe supports lack proper membrane protection and failed sealant in the construction joints of the precast wall panels.

Engage IRS to develop an Annual Maintenance and Repair Specifications (AMRS) to address necessary preventative and remedial repairs.

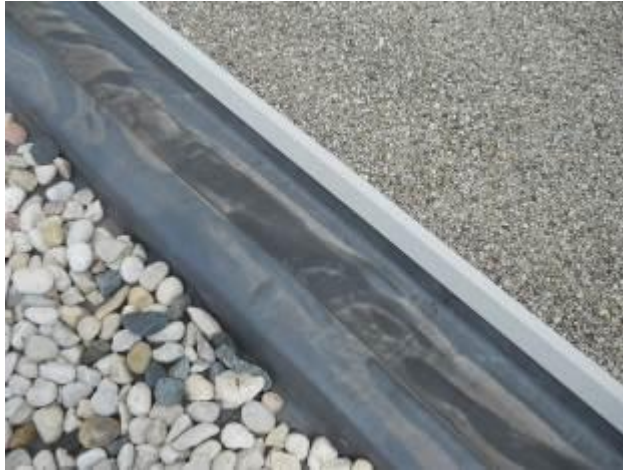
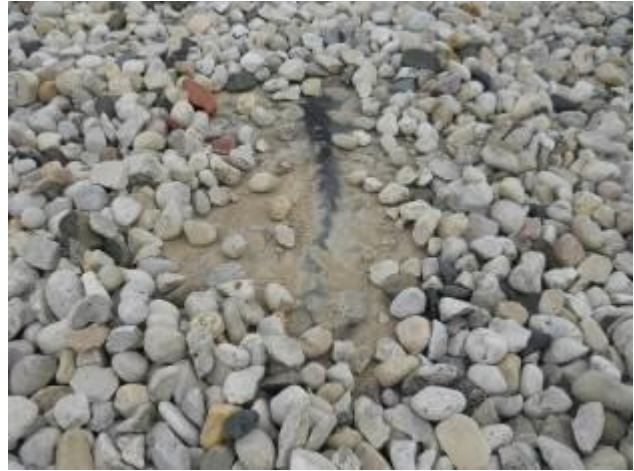
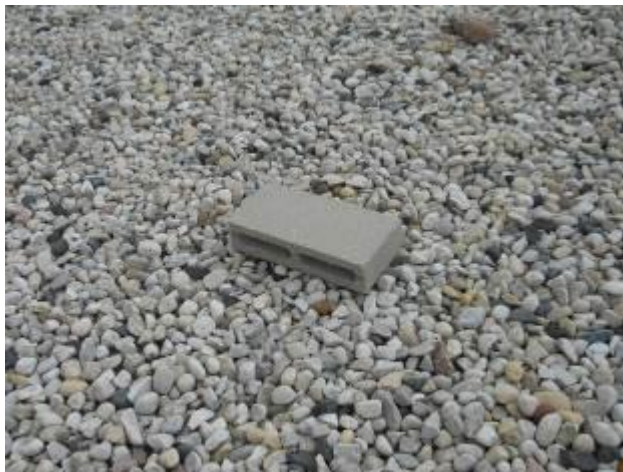
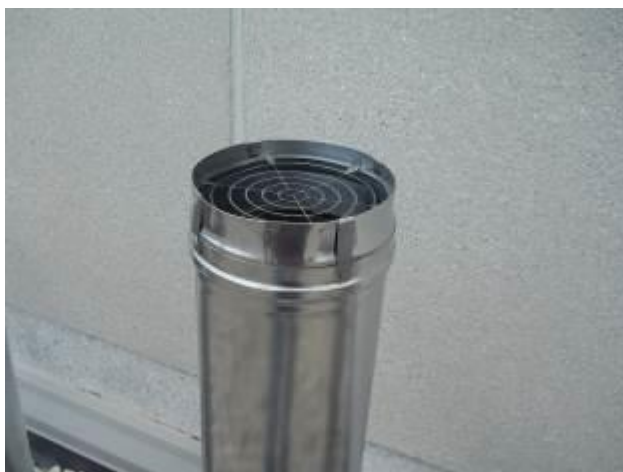
The roof membrane is in serviceable condition with minor shrinkage noted along the perimeter flashings and debris accumulation. We also noted failed sealant along the ladder supports, the lack of a rain cap on pipe vent and an area of precast concrete wall panel that is damaged.

Engage IRS to develop an Annual Maintenance and Repair Specifications (AMRS) to address necessary preventative and remedial repairs.

Remedial repairs are necessary, and should be included in a future (AMRS).

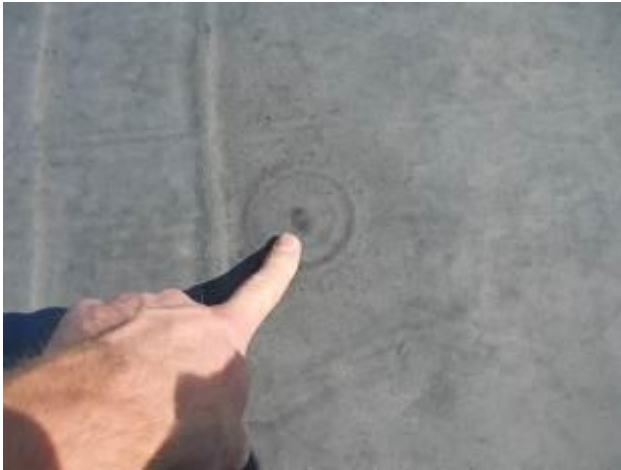
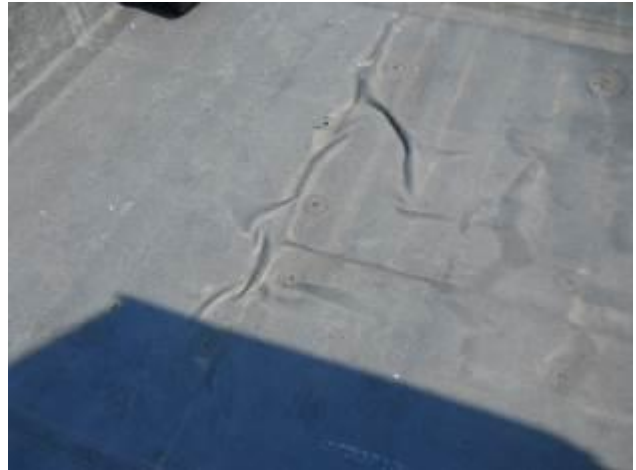
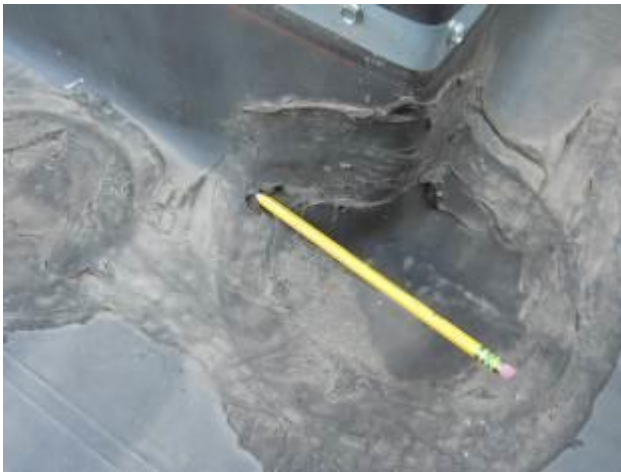
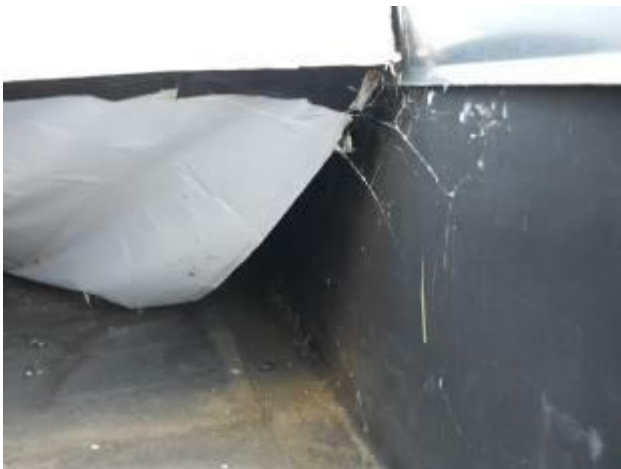
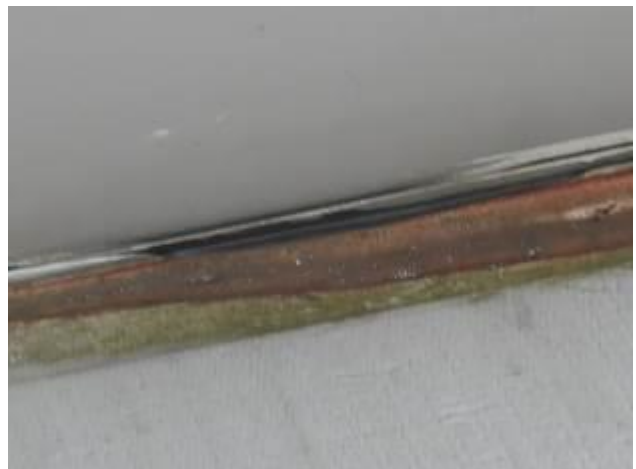
The roof membrane is in serviceable condition with several locations of fasteners backing out, membrane shrinkage, open corner flashings, debris on the roof surface and loose duct wrap.

Engage IRS to develop an Annual Maintenance and Repair Specifications (AMRS) to address necessary preventative and remedial repairs.

Remedial repairs are necessary, and should be included in a future (AMRS).

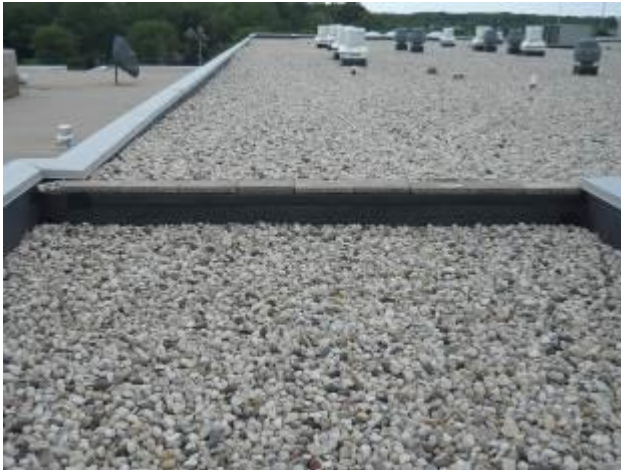
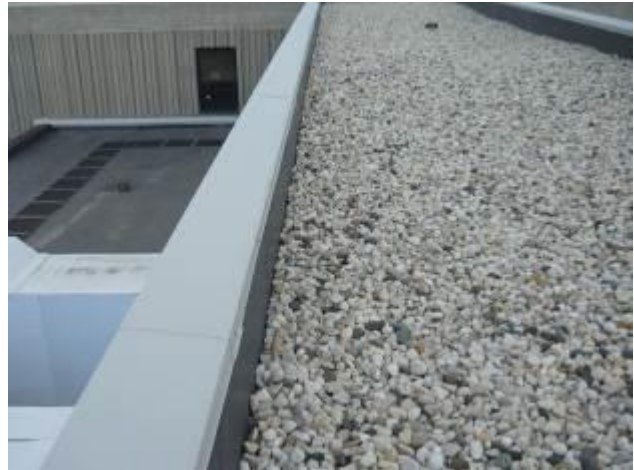
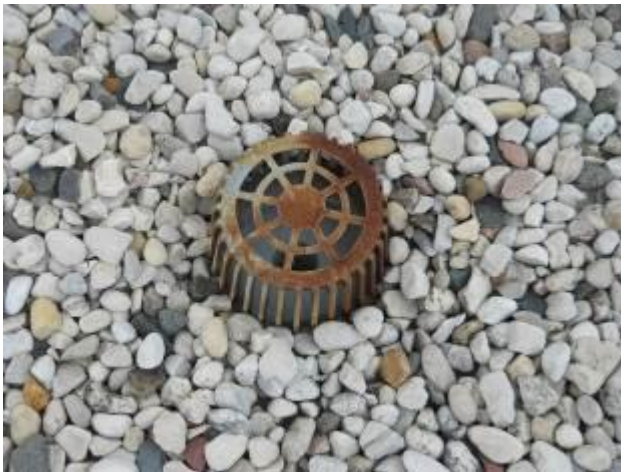
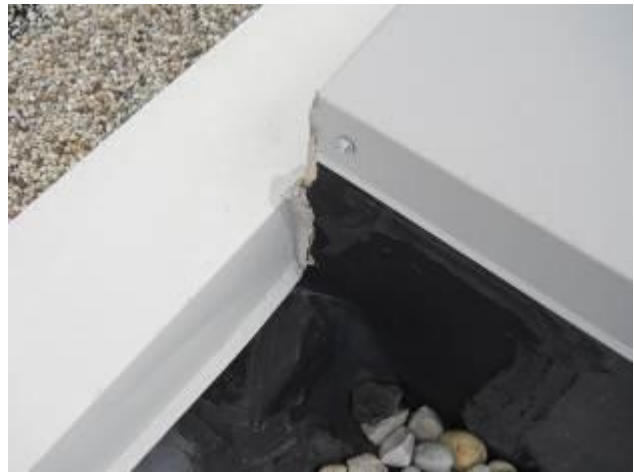
Conditions

The roof system is in good condition. We did not note any deficiencies of the roof system during our survey.

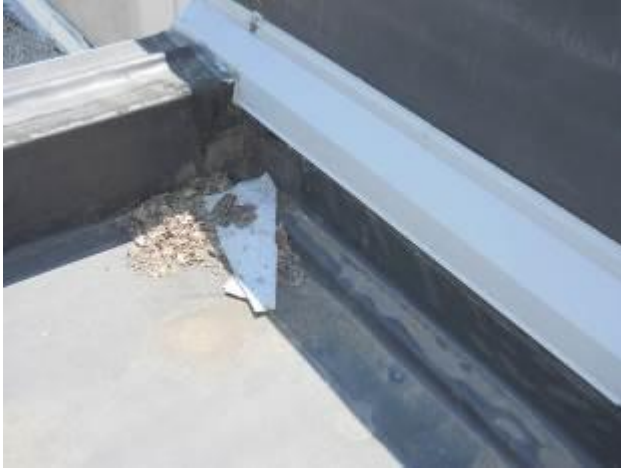
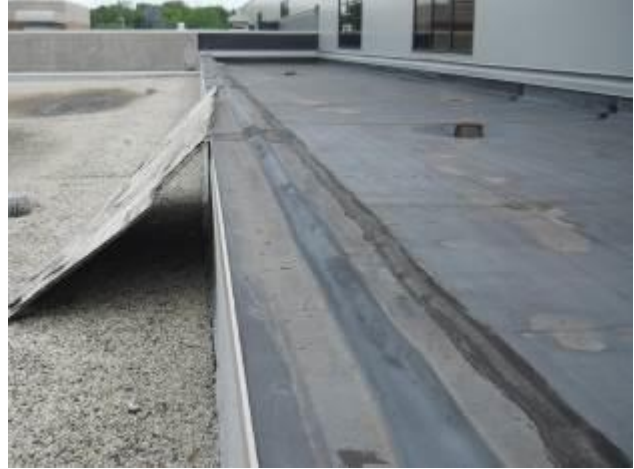
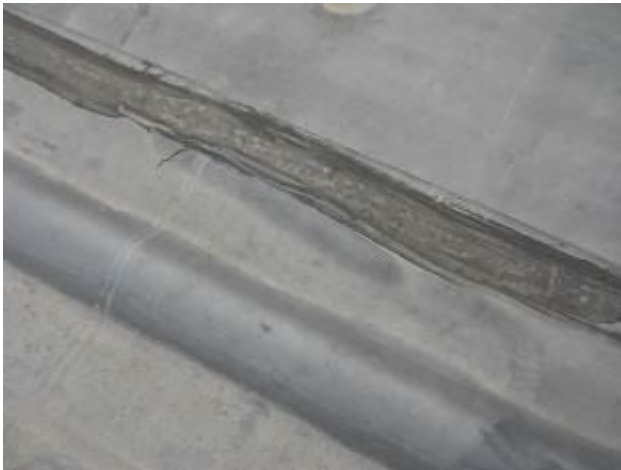
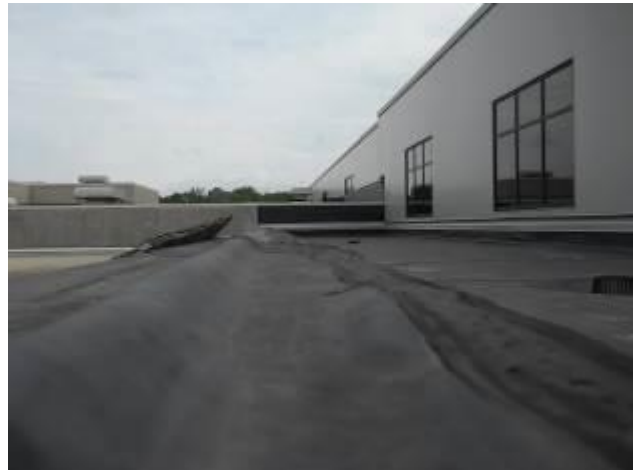
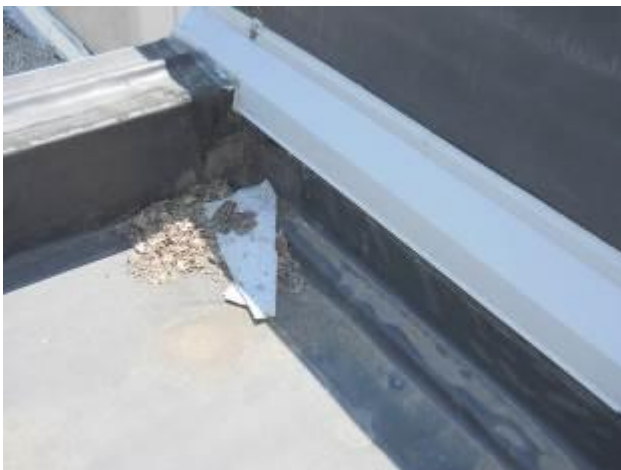
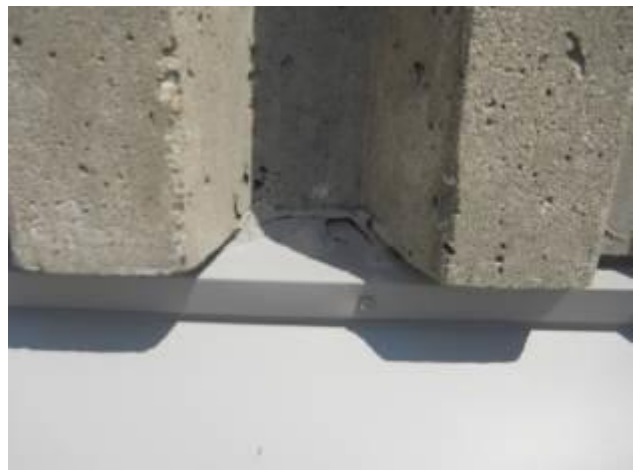
Roof Area 31

The roof membrane is in good condition with only minor accumulation of debris on the roof surface and minor shrinkage noted along the expansion joint. We also noted failed sealant along the counter flashing and precast concrete wall panels.

The 6 year old fully-adhered EPDM single-ply roof system requires preventative maintenance to address the failed sealant at this time to ensure it performs throughout the remainder of its 20 year designed service life.

Engage IRS to develop an Annual Maintenance and Repair Specifications (AMRS) to address necessary preventative and remedial repairs.
