Roof Survey Data

**Menomonee Falls, School District of
Ben Franklin Elementary School (342)
Roof Area Number: 01**

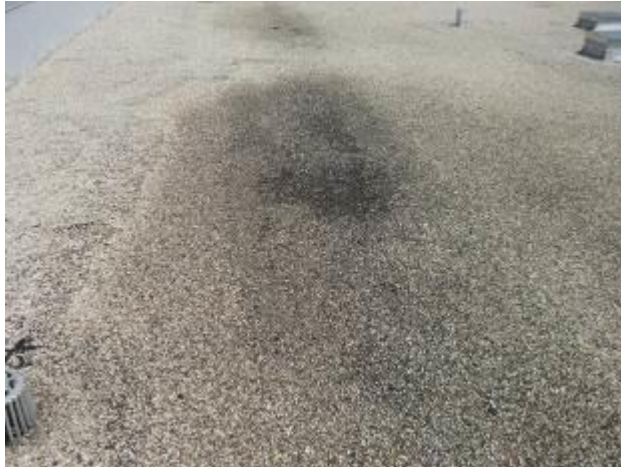
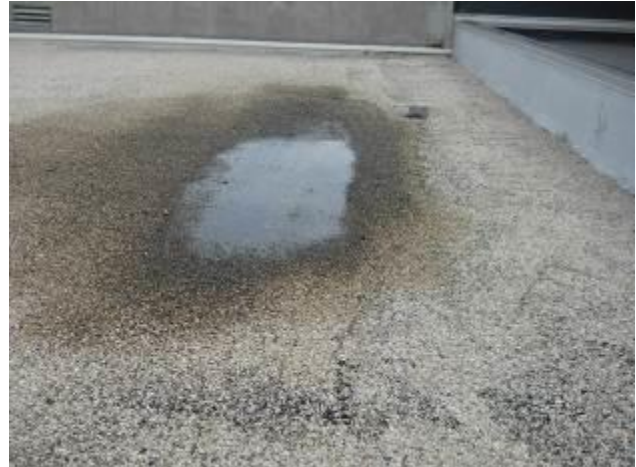
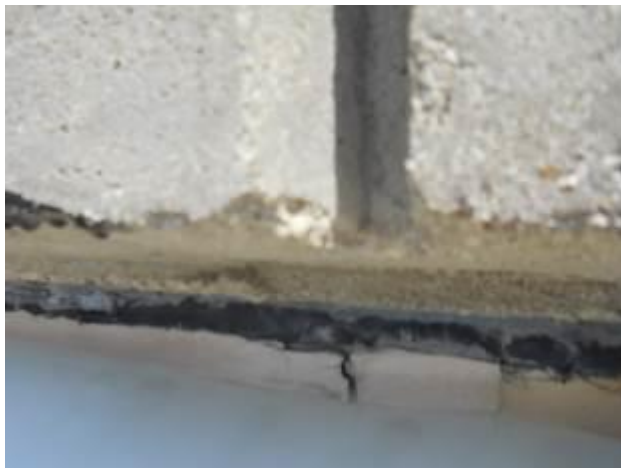
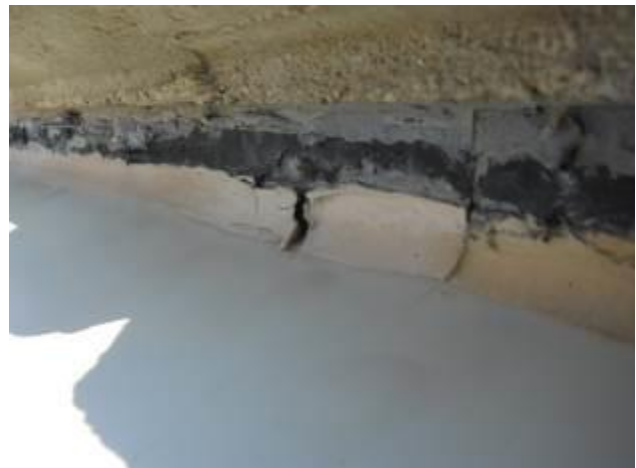
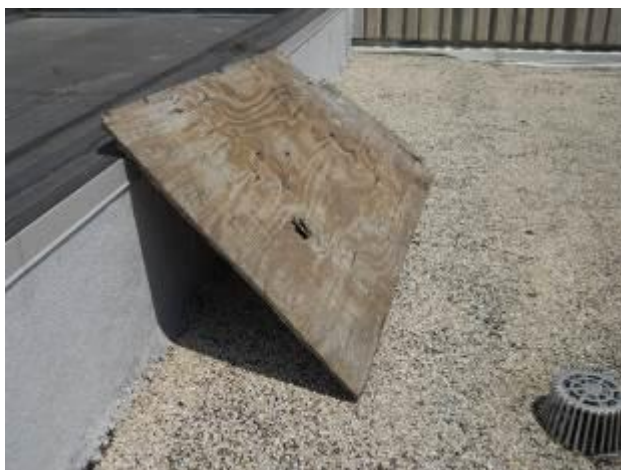
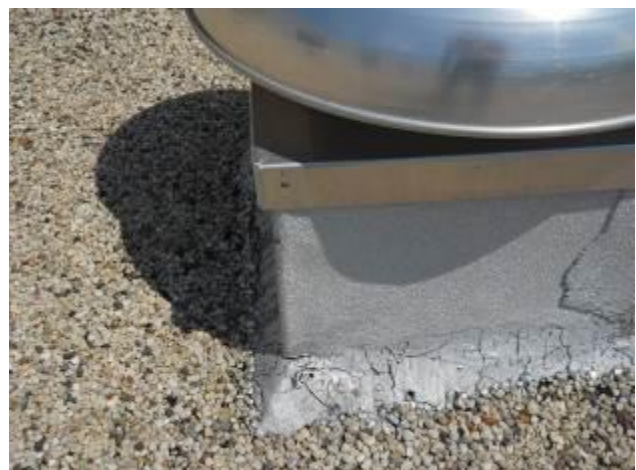
Roof Area 32

The roof membrane is in serviceable condition with evidence of ponding water noted near an internal roof drain and debris on the roof surface. Additionally we noted failed sealant along the perimeter counter flashings and wall systems and a ventilation hood not secured to its curb.

Engage IRS to develop an Annual Maintenance and Repair Specifications (AMRS) to address necessary preventative and remedial repairs.

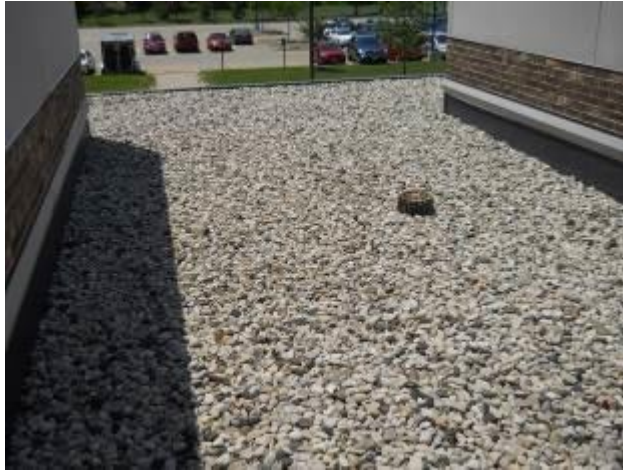
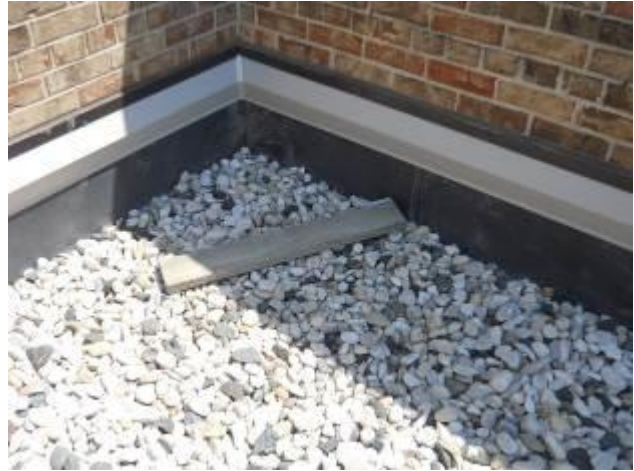
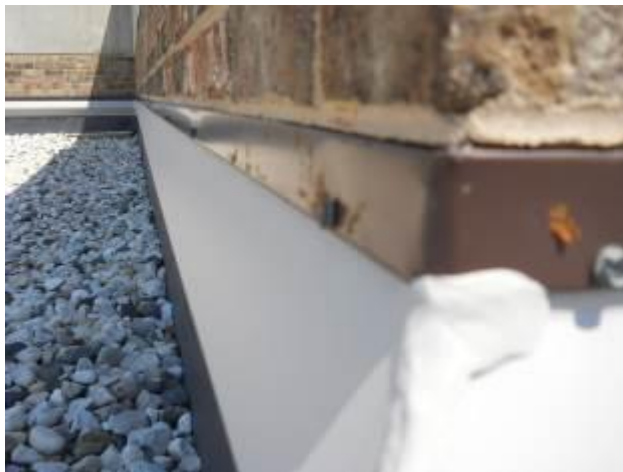
Roof Area 33

The roof membrane is in good condition with only an isolated area of construction debris on the membrane. Additionally, we noted failed sealant applied along the perimeter counter flashings and a failed mortar joint.

The 6 year old stone ballasted EPDM single-ply roof system requires preventative maintenance address the failed sealant along the perimeters to ensure it performs throughout the remainder of its 18 year designed service life.

Engage IRS to develop an Annual Maintenance and Repair Specifications (AMRS) to address necessary preventative and remedial repairs.

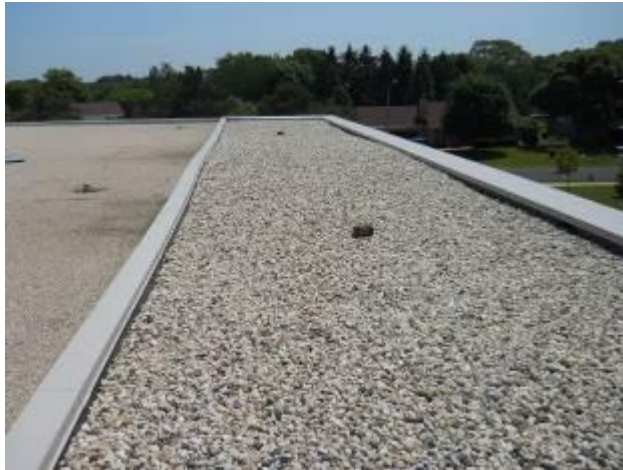
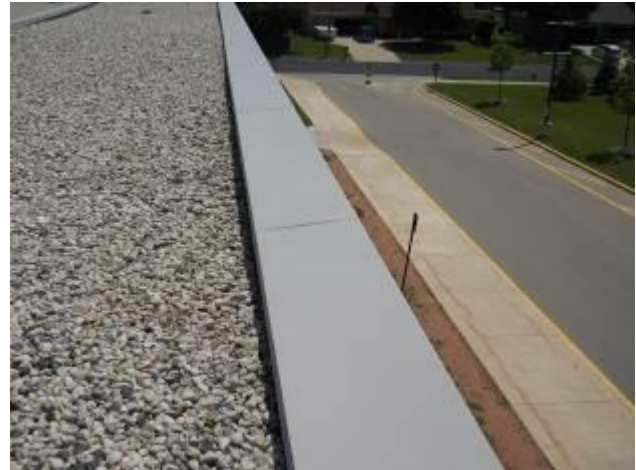
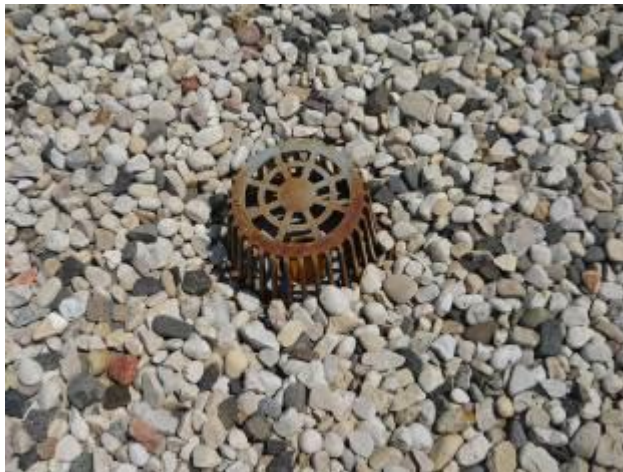
Roof Area 34

The roof system is in good condition with only minor accumulation of stone ballast around the sump pans of the internal roof drains.

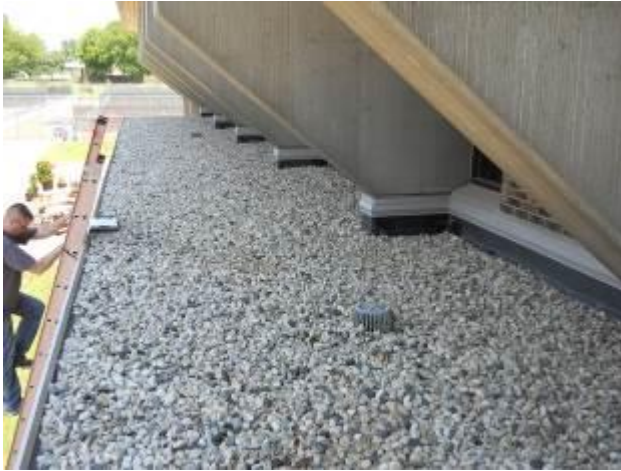
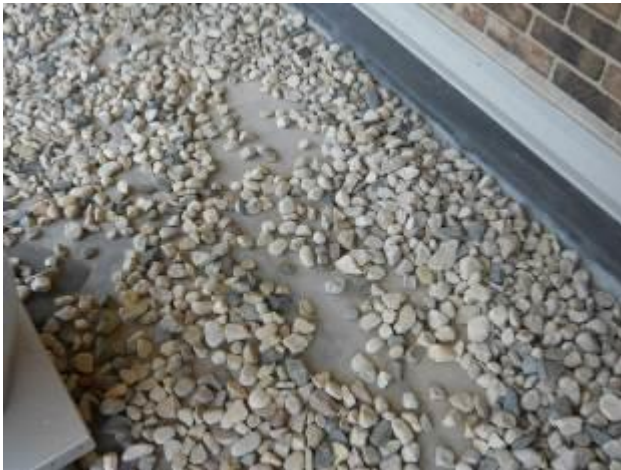
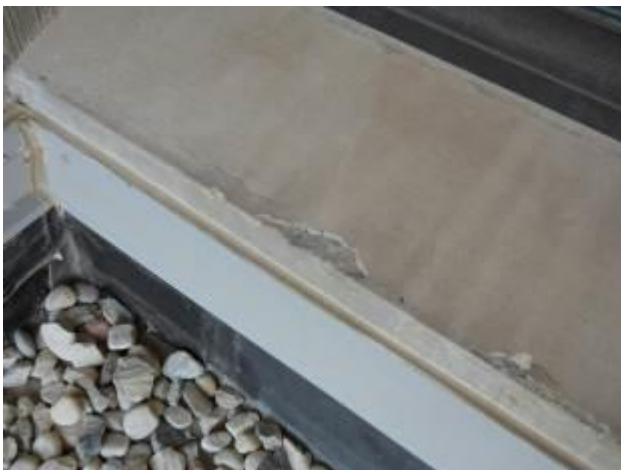
Roof Area 35

The roof system is in good condition with the only deficiencies noted was minor displaced ballasted and debris on the roof system. Additionally, we noted cracking in the concrete sill and failed sealant along the perimeter of a window adjacent to the roof system.
