Menomonee Falls School District
North Middle School - Facility Study
 Historical Plan

SCHOOL DISTRICT OF
MENOMONEE FALLS

BUILDING INSPECTION REPORT

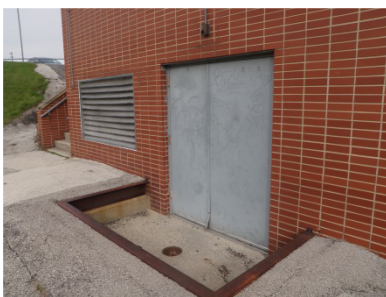
Maintenance door

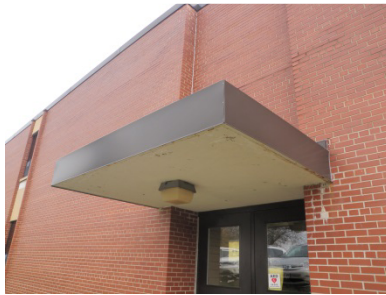
Chipping paint on overhang

1. Replace/repair any damaged mechanical louvers.
2. Repaint entrance soffits.
3. As roof replacements are required, replace metal fascia.
4. Repair/tuckpoint concrete canopy structure at pool roof overhang.

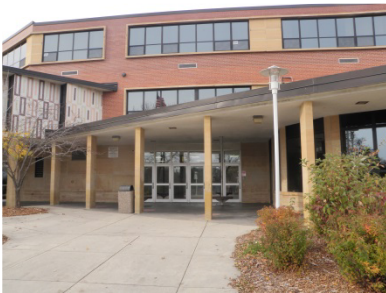
Metal fascia

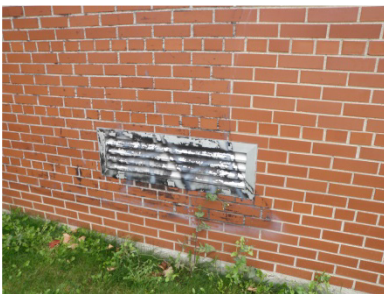
Mechanical louver

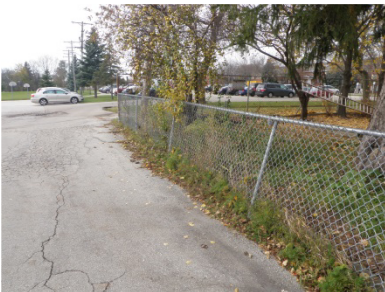
- Concrete and asphalt were reviewed independently. See appendix for reference reports.
- Replace all site railings and handrails, including railing at pool patio.
- Site fencing is failing down.

Site fencing

1. Replace site railings and handrails.
2. Replace/repair site fencing.
3. Repair retaining walls at loading.

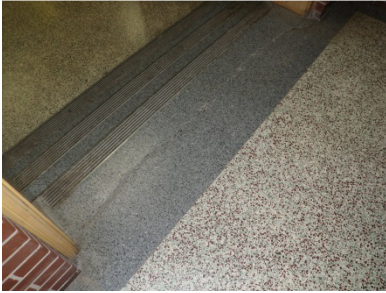
Aging terrazzo

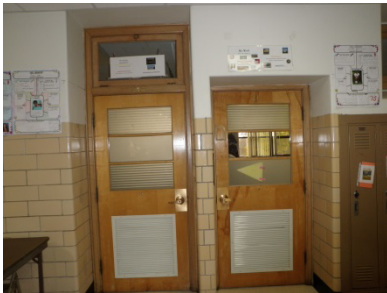
Doors in 1969 building

- Expected life span 40 years with periodic maintenance
- Current Condition –75% fair, 20% good, 5% poor
- A majority of doors appear to be in fair condition, however due to the use and continued operation of interior wood doors the facing veneer will chip and tear over time and experience scrapes and dents.
- There are areas of the building that still have original wood doors with wood frames.
- All locksets were replaced in 2004 to be ADA compliant. These appear to be in good shape.
- Metal door frames can be repaired and painted. Door chips and scratches can be sanded, filled and restrained to revive an old door. Depending on severity of door or frame damage, it may be cost effective to replace the entire door and frame.

1. Replace doors in poor condition.
2. Paint all metal door frames.

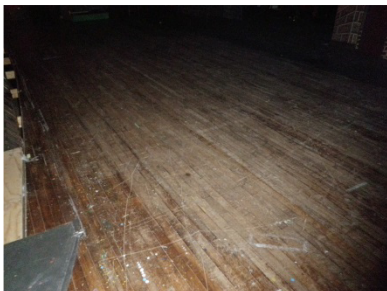
Stage floor

- Current Condition – fair condition
- Stage has a wooden floor which is well-worn.
- Carpet in seating area aisles is old and worn. VAT is provided underneath the seats.
- Ceiling Structure – fair.
- Seating fabric is old and worn. There are tears and rips in several seats.

1. Replace seating.
2. Refinish stage floor.
3. Update finishes in seating area (paint, flooring, etc.). Update finishes in Auditorium lobby, including ceiling and flooring.
4. See Section 3 – Educational Adequacy Assessment for additional recommendations.

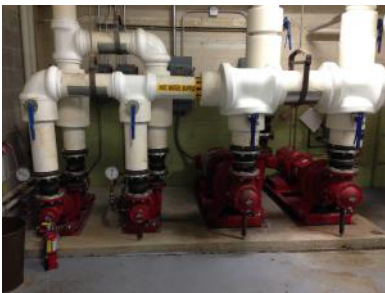
Hot Water Pumps

1. Continue preventative maintenance on the systems.
2. Replace the dual motor switchable variable frequency drives with individual drives for each pump.
3. Provide automation through the digital control system to automatically switch the system pumps based on actual conditions. Currently, the two separate hot water pumping systems must be manually switched over.

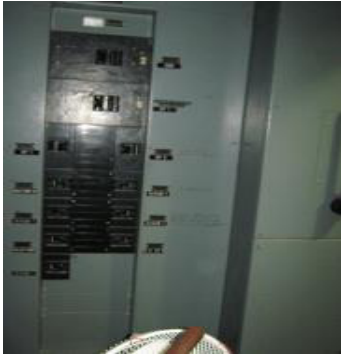
Service Panel 1

1. The main distribution panels have capacity for future loads but do not have space for additional fused disconnects. These panels are approximately 50 years old and are nearing the end of their useful lifespans. New main distribution panel should be installed at this time.
2. We do recommend all electric services be provided with surge devices.
3. Add phase monitoring relays to both services for electrical system protection.

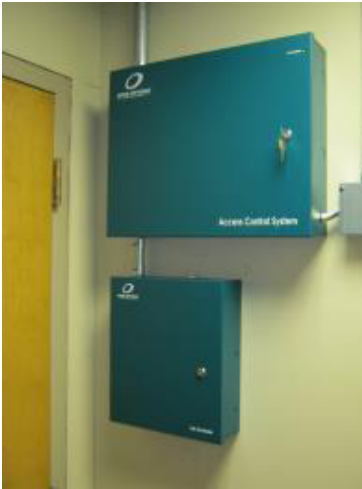
Keyless Entry

1. Expand the CCTV system as required.
2. Expand the Door Access system as required.

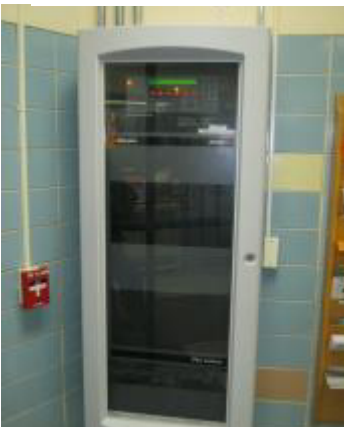
Fire Alarm Control Panel

1. Continue to test the system to ensure proper operation and code compliance.

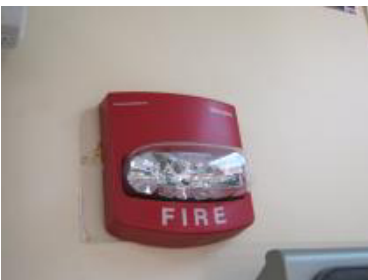
Fire Alarm Notification Appliance

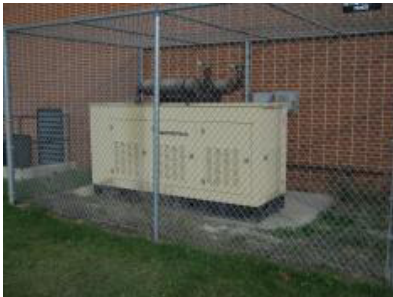
Emergency Generator

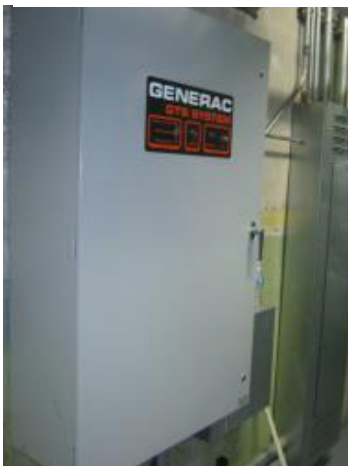
Transfer Switches

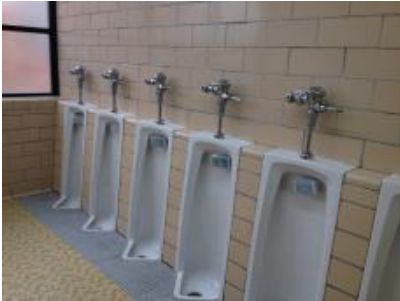
- Toilet rooms in the school and pool areas are generally in poor condition and in most locations these fixtures are original to the building.
- Water closets are wall-hung flush valve style fixtures. Urinals are floor outlet flush valve style fixtures which are not ADA compliant.
- Lavatories are wall-hung and appear to have been replaced within the last 15 years. The fixtures are in good condition whereas the faucets are in fair condition.
- Auditorium toilet rooms have also been remodeled. Water closets and urinals are wall-hung flush valve fixtures. The lavatories are drop in bowl fixtures with push button faucets. These fixtures are in fair condition.

Typical Floor Outlet Urinals

1. All toilet room fixtures in the school and pool area should be scheduled for replacement. The rooms would need to be renovated to comply with current ADA requirements.
2. Toilet rooms in the Auditorium should be scheduled for renovation.

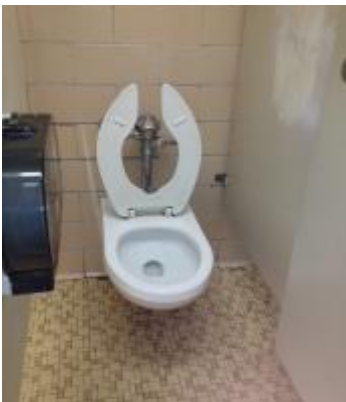
Typical Water Closet

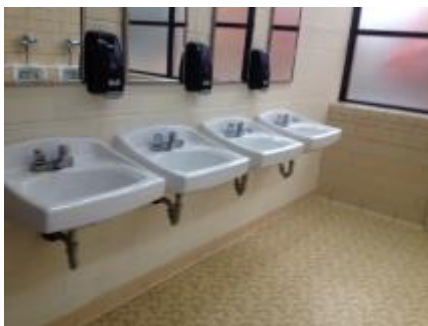
Typical Wall-Hung Lavatories

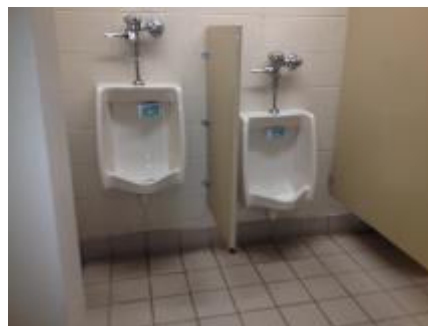
Auditorium Toilet Room

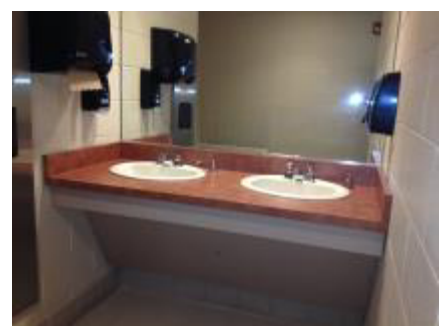
Auditorium Lavatory

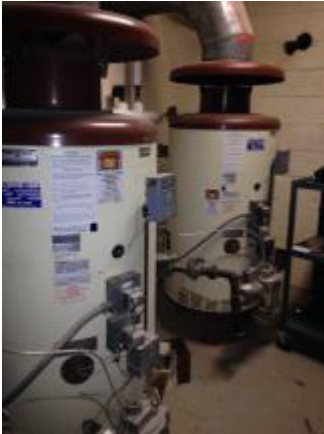
- The domestic water heating system for the school consists of two (2) A.O. Smith boilers and a 180 gallon domestic water storage tank. The boilers are old and inefficient. The storage tank is new and in good condition.
 - The water heating system is at the end of its expected life expectancy.
- The domestic water heating system for the school appears to be grossly oversized for the actual building demand.
- Water softening equipment is located within the mechanical room. The water softening equipment is in excellent condition however it is no longer required and is currently in by-pass mode.
- The domestic water heating equipment for the pool consists of an atmospheric boiler and a large storage tank. Both items appear to be in fair condition and sized appropriately for the building demand. Currently, this water heating system does not have redundancy.

Domestic Water Heaters - School

1. Replace the existing domestic water heating system with new gas-fired, sealed-combustion, modulating domestic water heaters. The equipment should be sized appropriately for the actual building demand.
2. Schedule the domestic water heaters for the pool to be replaced. The new heaters shall be gas-fired, sealed-combustion, modulating domestic water heaters.

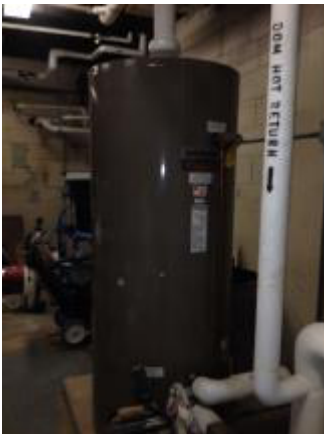
Storage Tank - School

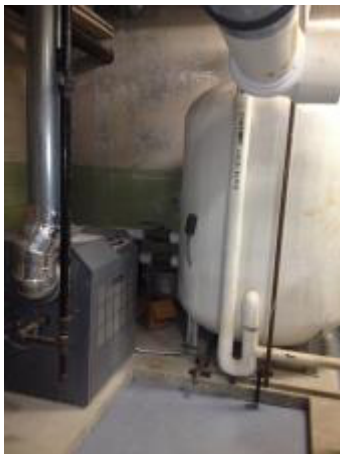
Domestic Water Heater - Pool

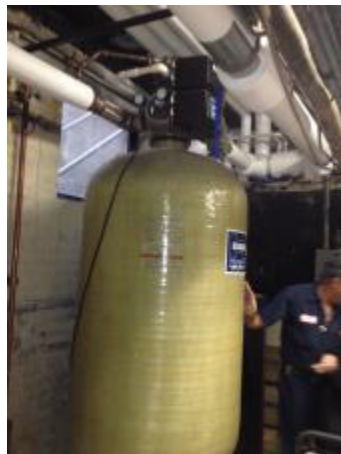
Water Softener

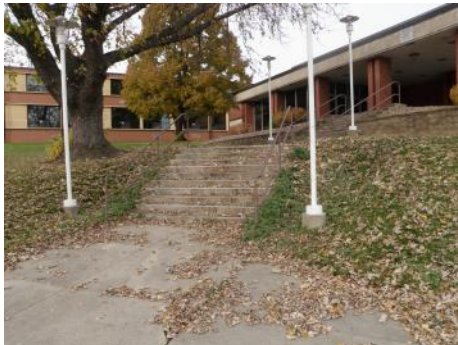
Auditorium entrance

ITEM	ADA /ANSI A117.1 REFERENCE
1.	Striped and marked accessible vehicle parking spaces are provided.	F208, 502
2.	There is a marked accessible route from the parking to the “designated” main entrance.	502.3
3.	Public sidewalk pavement around the property is compliant at the “front” of the building. Public sidewalk to Auditorium entrance is not complaint.	302, 402, 403
4.	There is no identified accessible loading zone.	503
RECOMMENDATION:		
1. Provide an accessible loading zone. 2. Provide ramp to Auditorium entrance

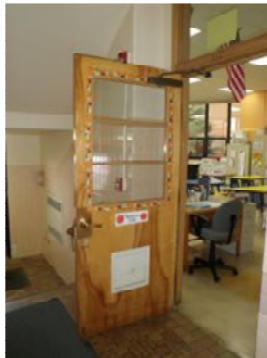
ITEM	ADA REFERENCE
1.	Main Entrance (attendance office) is accessible.	402, 404
2.	Door hardware was typically updated in 1999 to be accessible.	404
3.	Main Office reception desk meets the requirements for accessibility.	308
4.	Pool bleachers are not accessible.	402, 404
5.	Access to the Auditorium is not accessible from the main entrance. (However a ramp is provided from the parking lot in the alley.)	
RECOMMENDATION:		
1. Consider providing a ramp for access to the auditorium from within the existing building.		
2. Consider providing an accessible entrance for the main exterior entrance off of Garfield Drive.

Accessible
door lever

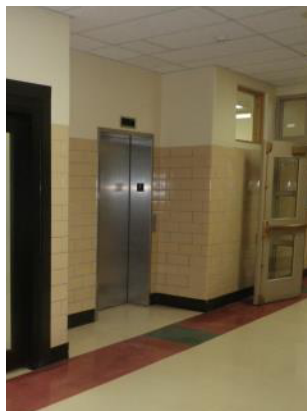
ITEM	ADA REFERENCE
1.	An elevator is provided to service all three floors.	407
2.	A lift is provided for the two Tech Ed rooms.	
RECOMMENDATION: 1. None.

Elevator

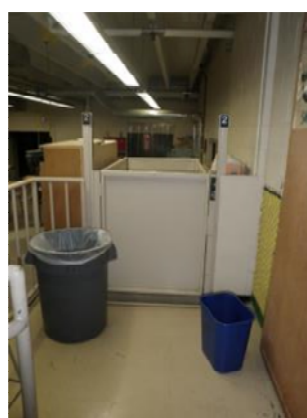
Lift at Tech Ed

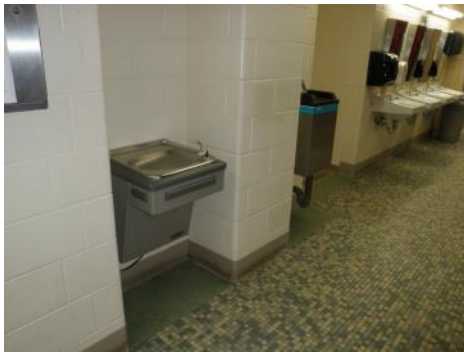
ITEM	ADA REFERENCE
1.	All drinking fountains are not accessible.	602
RECOMMENDATION: 1. Replace any non-compliant drinking fountains.

ADA-compliant drinking fountain
